Final Report

Brewerton Water Pollution Control Plant Comprehensive Facility Assessment

Prepared for: Onondaga County Department of Water Environment Protection, Onondaga County, New York

CRA Infrastructure & Engineering

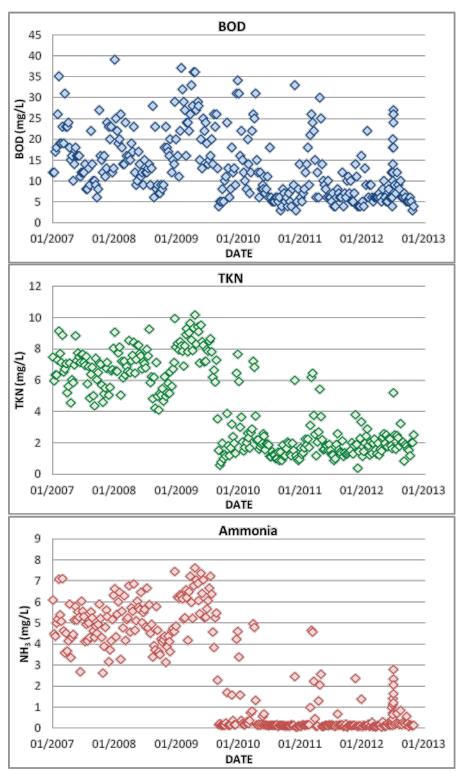
figure 4-1

NOTE: THE FACILITY SWITCHED FROM CONTACT STABILIZATION TO EXTENDED AERATION MODE OF OPERATION IN SEPTEMBER 2009. THIS COINCIDES WITH THE REDUCTIONS IN EFFLUENT TKN AND AMMONIA SHOWN ABOVE.

HISTORICAL BOD AMMONIA AND TKN FROM JAN 2007 TO OCTOBER 2013 WPCP COMPREHENSIVE FACILITY ASSESSMENT ONONDAGA COUNTY WEP Brewerton, New York

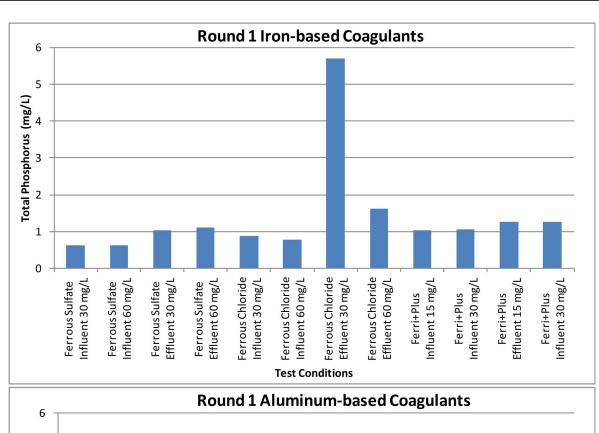
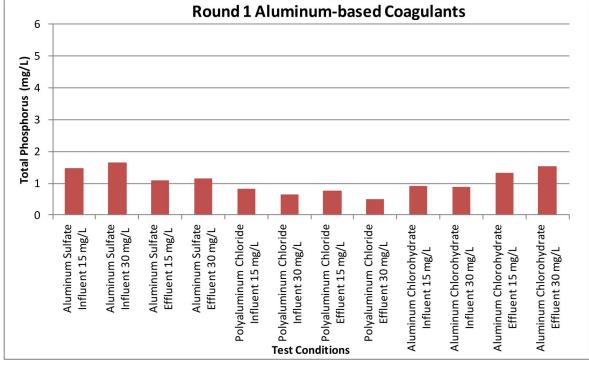
figure 4-2

ROUND 1 JAR TESTING RESULTS WPCP COMPREHENSIVE FACILITY ASSESSMENT ONONDAGA COUNTY WEP Brewerton, New York

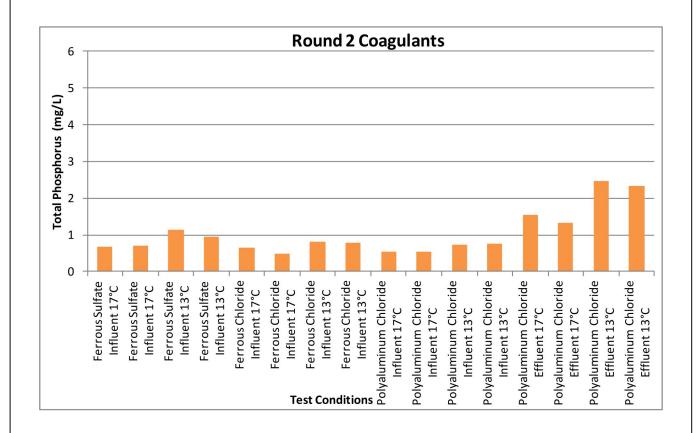
figure 4-3

ROUND 2 JAR TESTING RESULTS WPCP COMPREHENSIVE FACILITY ASSESSMENT ONONDAGA COUNTY WEP Brewerton, New York

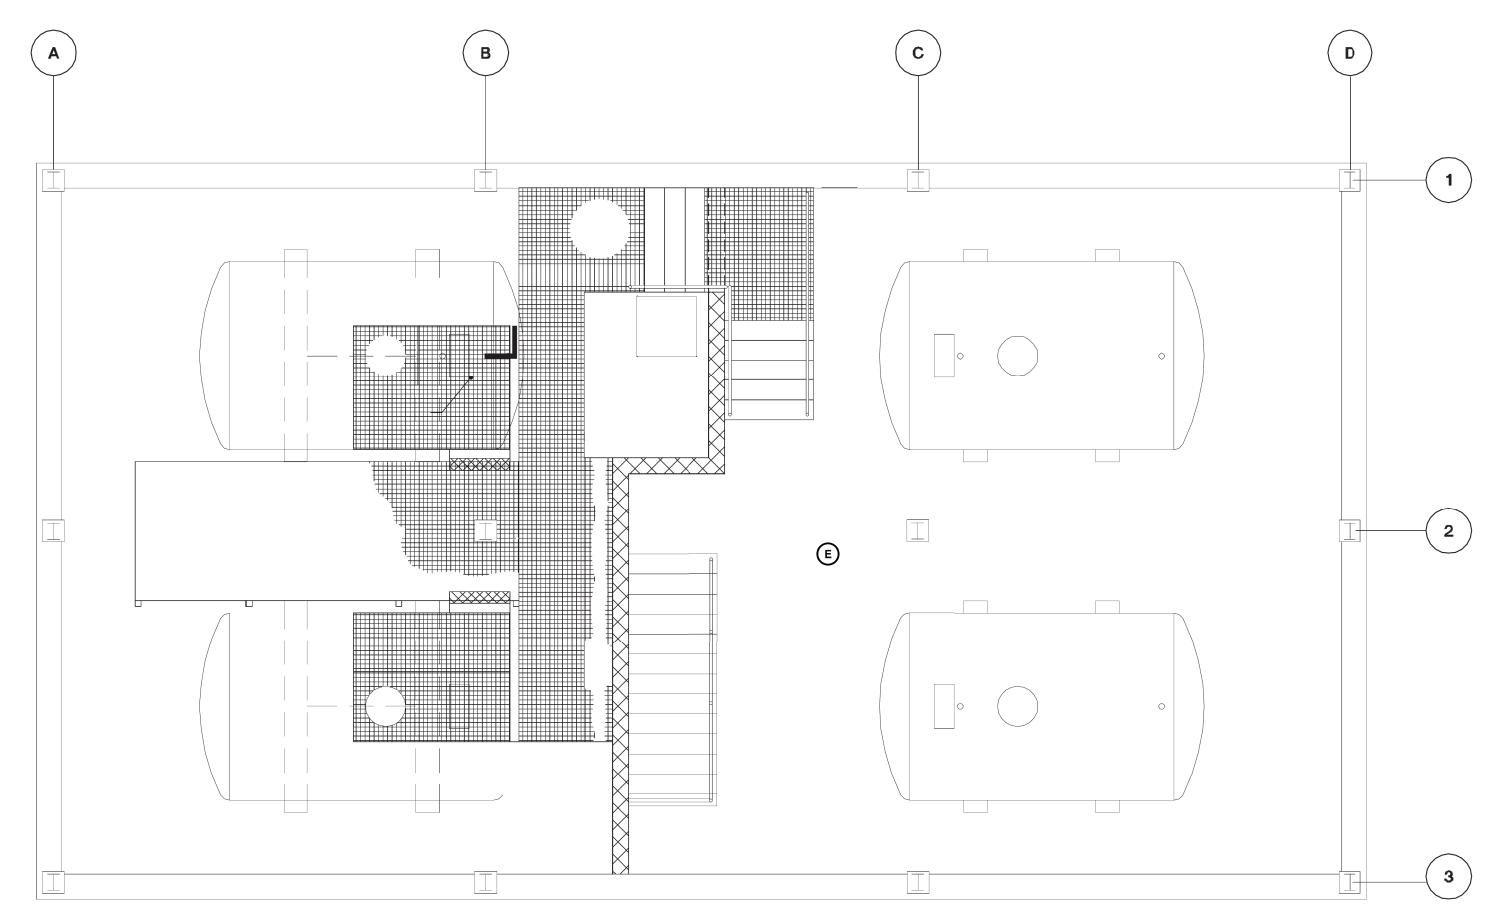
and components are failing. Replacement parts are increasingly difficult to

find.

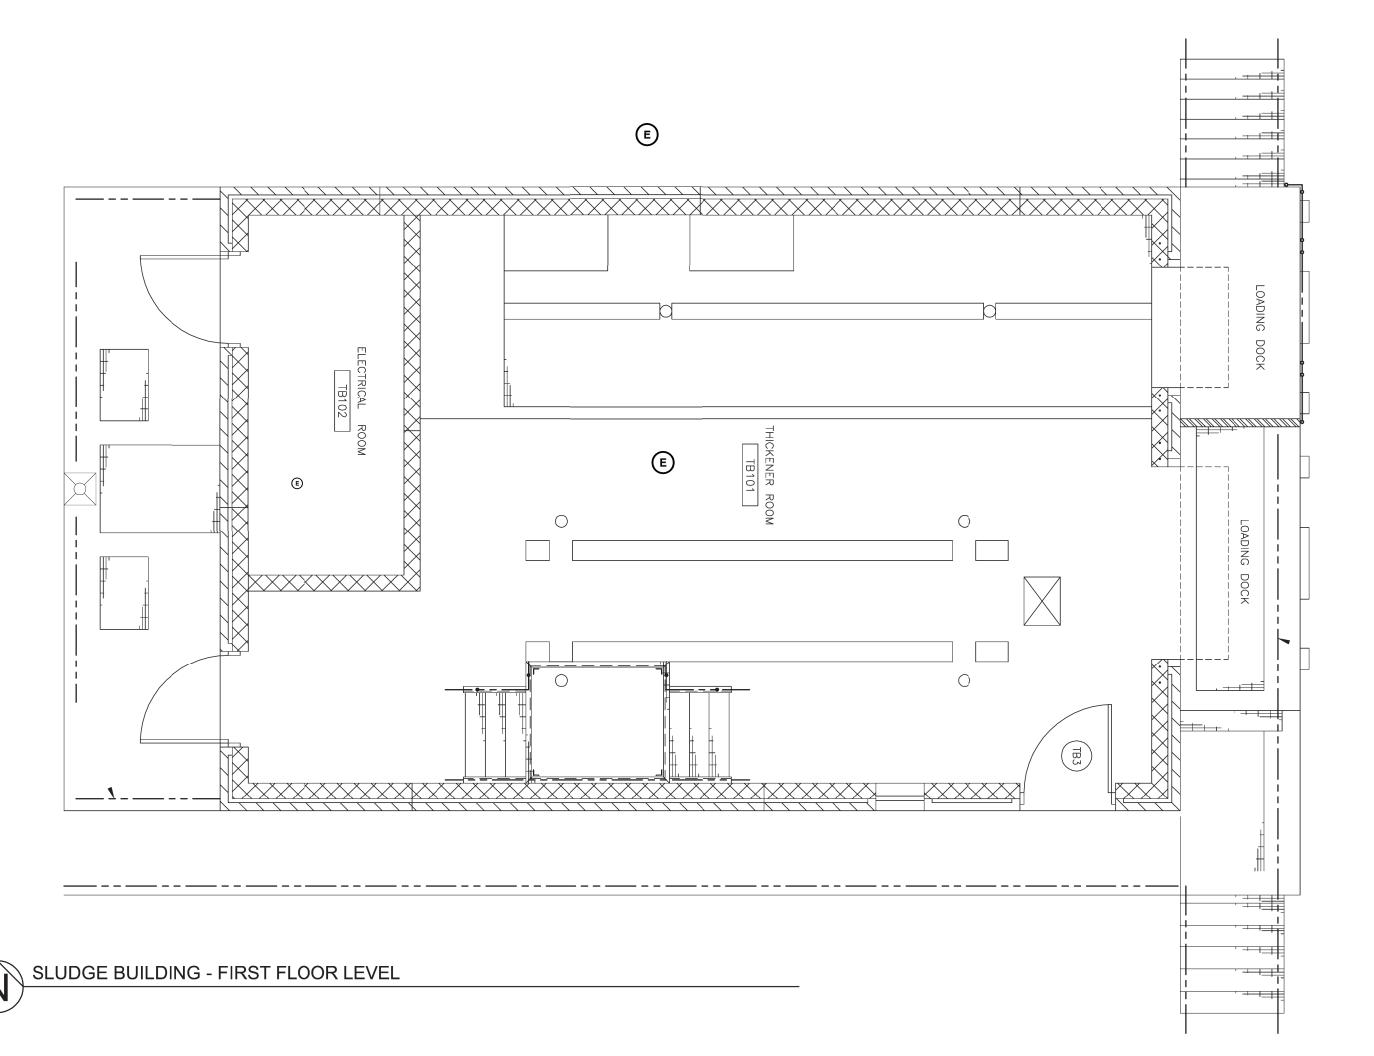
Components are failing and replacement parts are increasingly difficult to

find.
