**ONONDAGA COUNTY
WATER ENVIRONMENT PROTECTION**

**METRO WWTP
SYRACUSE, NY**

**DIGESTER #4 STEEL COVER
ASSESSMENT**

September 11, 2015

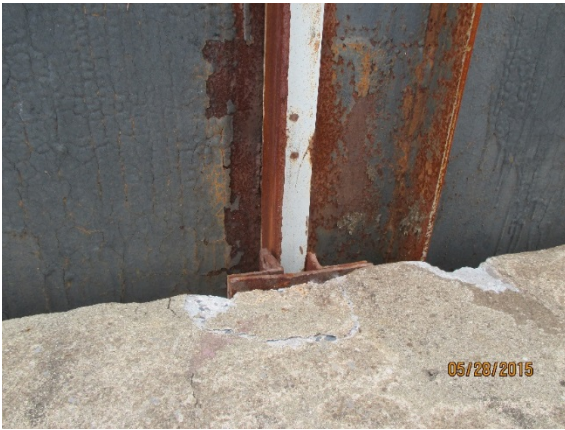
7. There is some minor cracking in the concrete wall adjacent to the guide angles located at east quadrant. This concrete cracking should be repaired when the tank is taken out of service.

Guide C-D, Position 2 (Spalled Concrete)

- i. Empty and clean the tank during the summer months of 2015 or 2016 to inspect the interior tie rods and center column assembly.
- ii. Repair the cracked concrete.

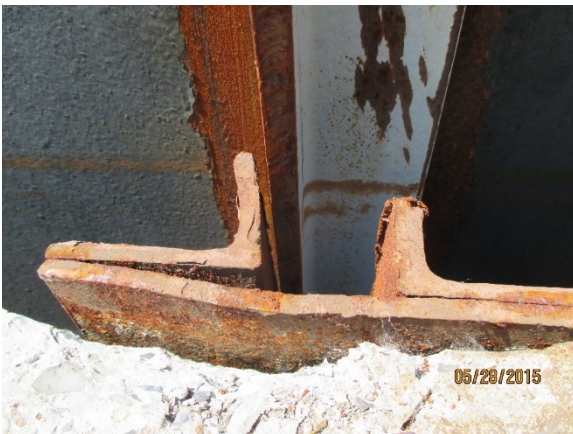
8. There are some loose anchor bolts and nuts and bent guide angles along with gaps between the back of the guide angles and the concrete wall. These damaged guides require repair when the tank is taken out of service. We note that the existing guides are not part of the original design. According to some existing drawings, we believe these surface mounted angle guides and fins were added/modified in 1977 and 1999.

Guide C-D, Position 3 (Spalled Concrete & Bent Angles)

- iii. Replace the anchors and guide angle assemblies while the tank is empty. The replacement of the cover guide system includes removing the existing guide component and providing a new modern system as recommended by an approved cover manufacturer. The work will include balancing the cover prior to placing back in service and adjust counterweights as required.

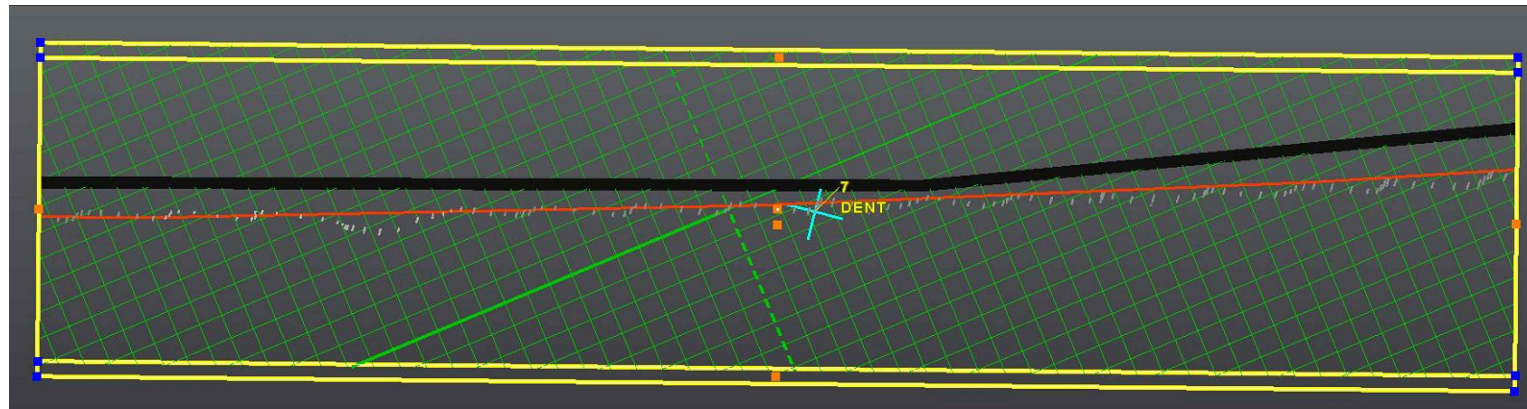
DENT 7 APPROXIMATELY 1.5"

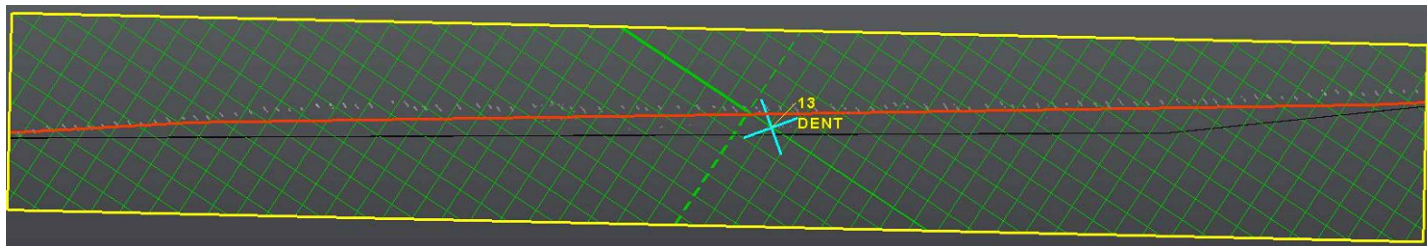
DENT 13 APPROXIMATELY 1"

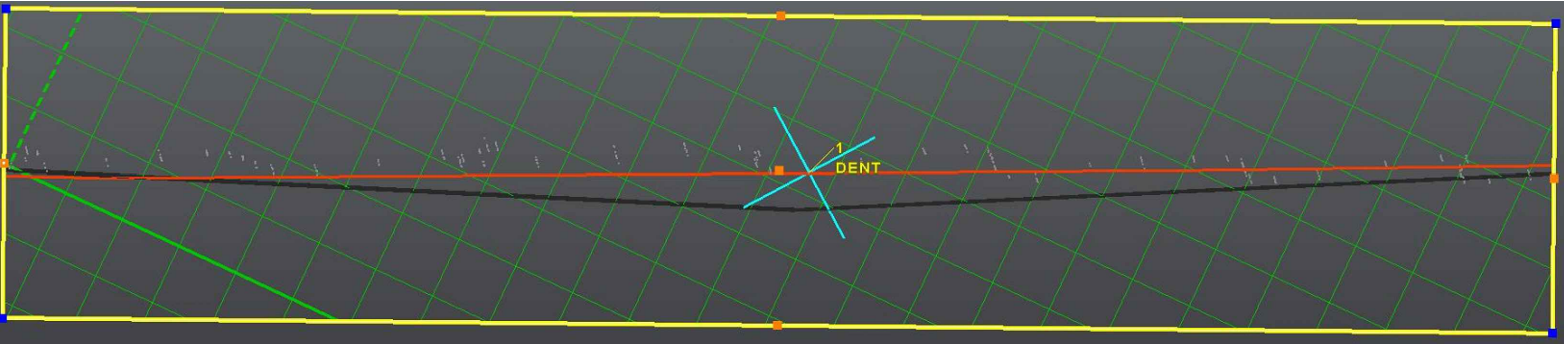
DENT 1 APPROXIMATELY 0.75"

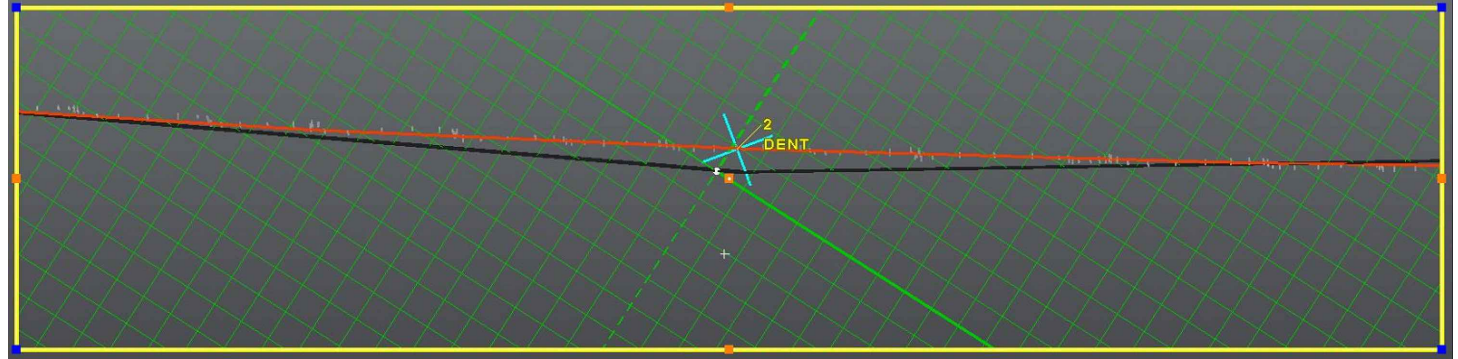
DENT 2 APPROXIMATELY 0.75"

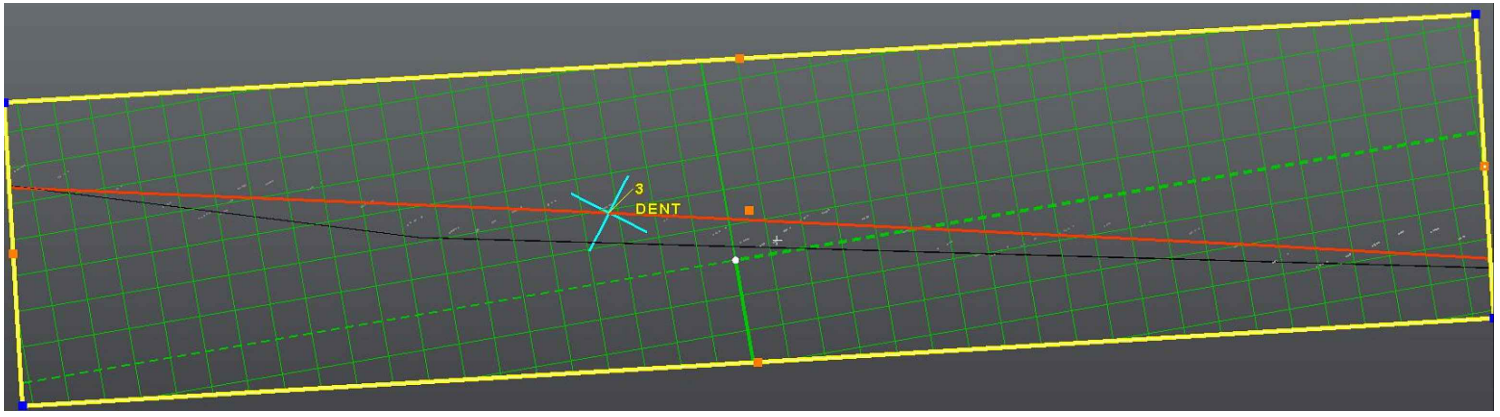
DENT 3 APPROXIMATELY 1"
