Onondaga County, NY  
Condition Assessment Report  
Baldwinsville-Seneca Knolls Wastewater Treatment Plant

January 2015

# 7. Disinfection Evaluation

## Appendix K - Condition Assessment Photos

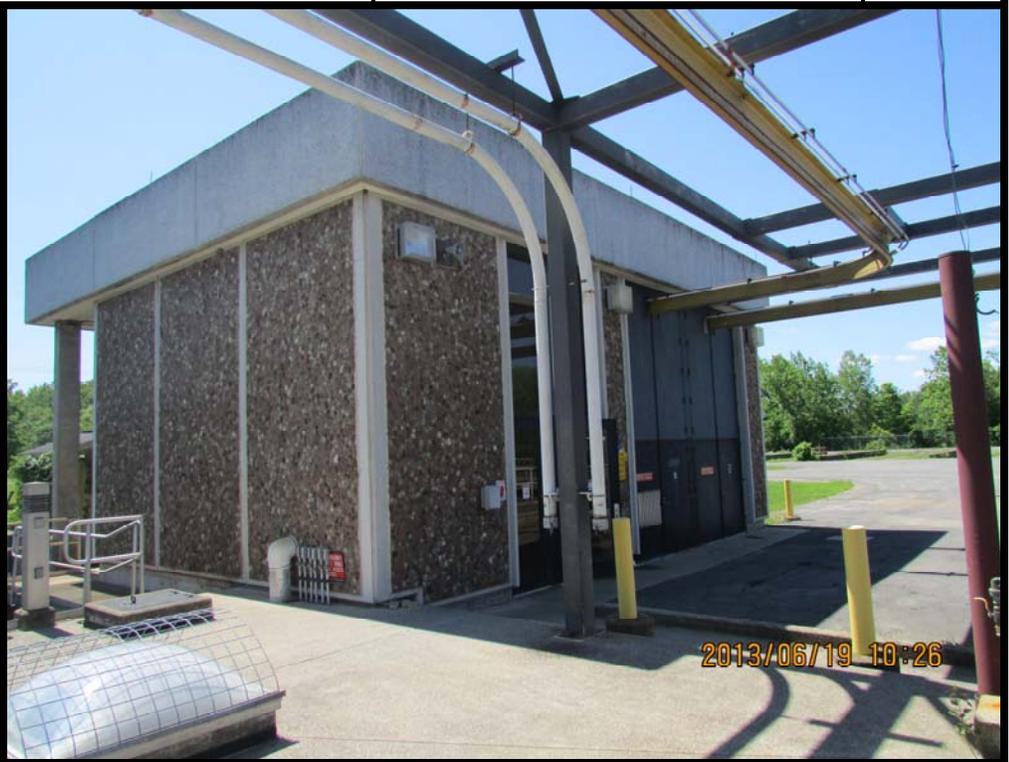
Location: Chlorine Contact Tanks	Photo Name:	Photo #:
Northeast elevation, looking southwest	CHL-BLDG_001.jpg	1
<p>Description(s):</p> <p>No deterioration to note.</p>

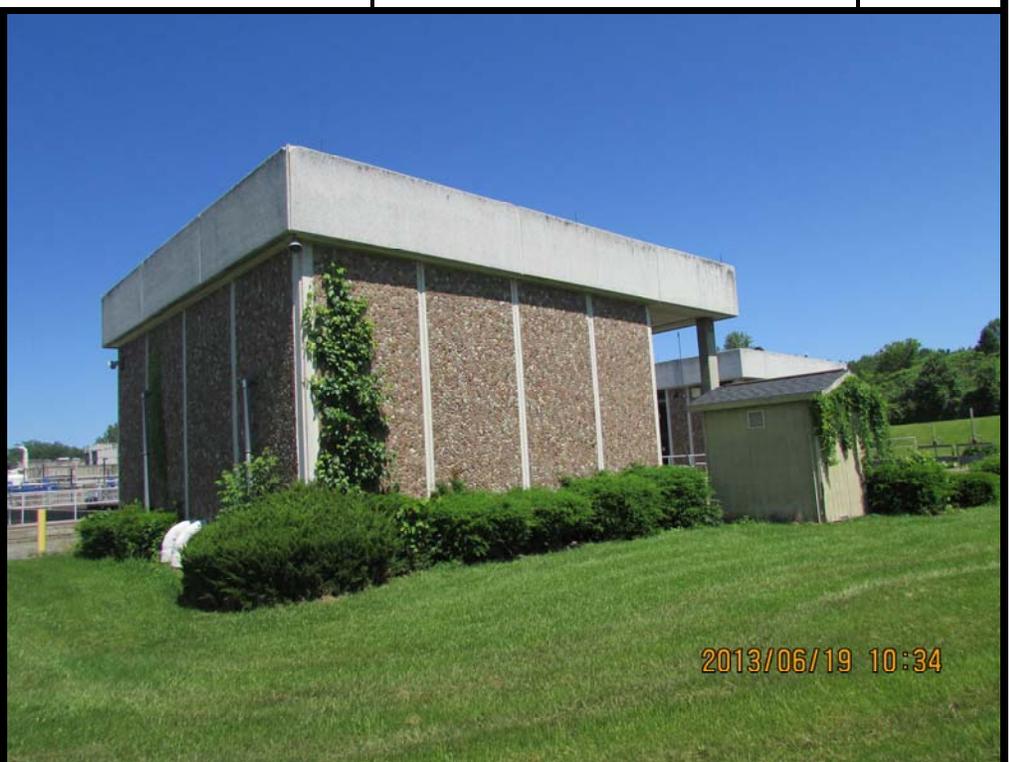
Location: Chlorine Contact Tanks	Photo Name:	Photo #:
Southwest elevation, looking northeast	CHL-BLDG_002.jpg	2
<p>Description(s):</p> <p>No deterioration to note.</p>

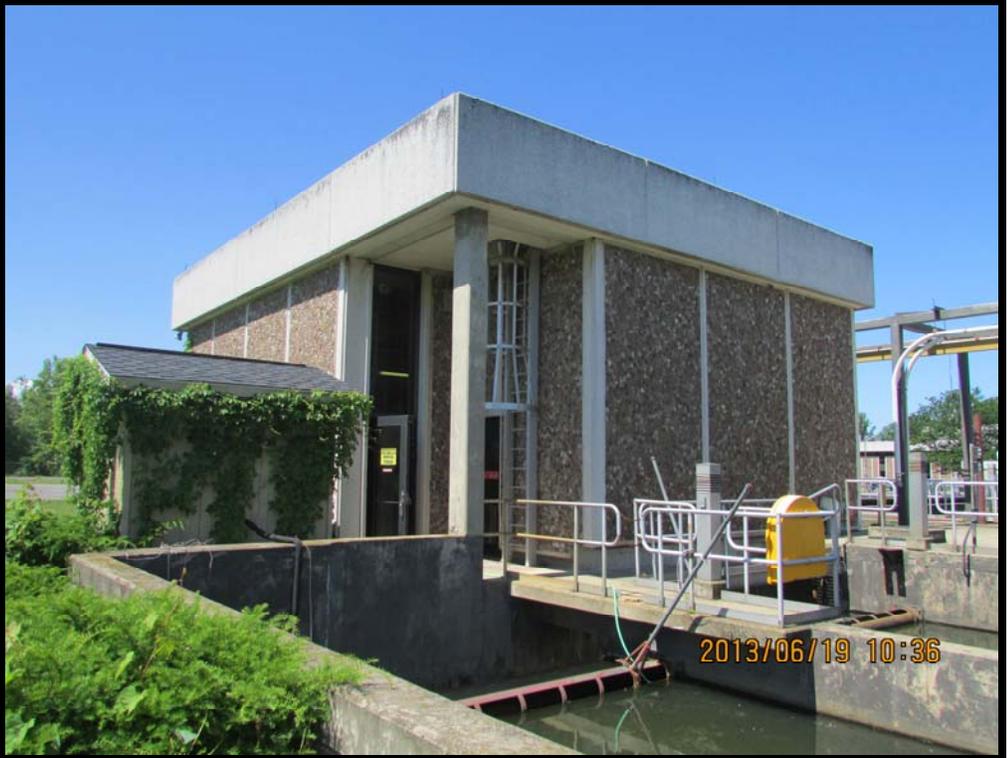
Location: Chlorine Contact Tanks	Photo Name:	Photo #:
Southeast elevation, looking northwest	CHL-BLDG_007.jpg	3
<p>Description(s):</p> <p>No deterioration to note.</p>

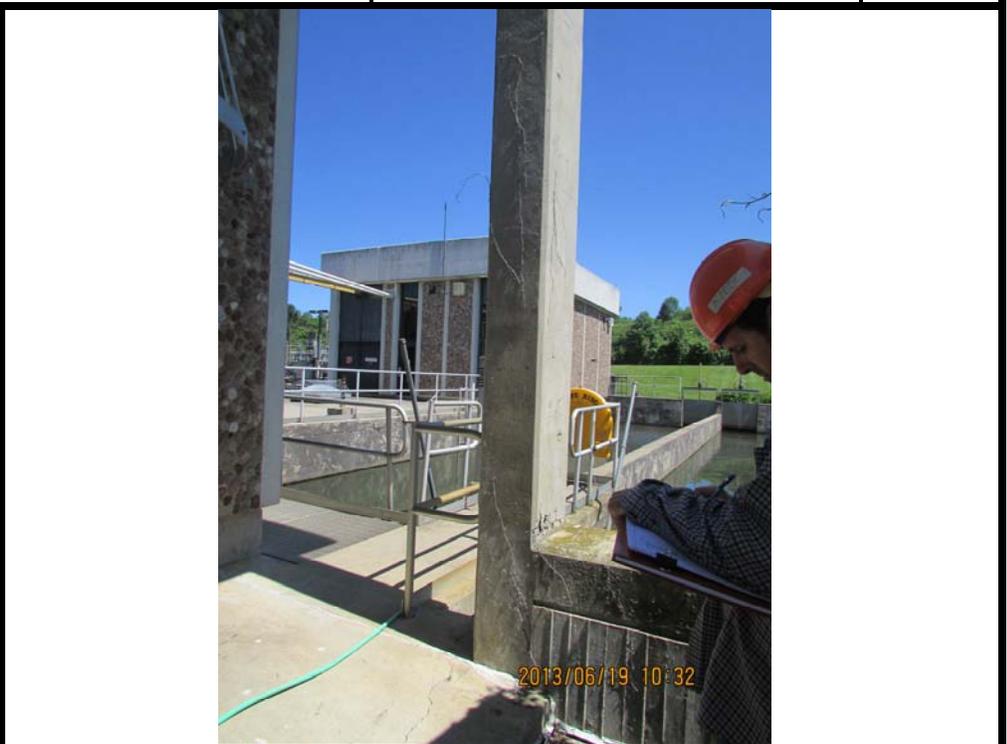
Location: Chlorine Contact Tanks	Photo Name:	Photo #:
West elevation, looking east	CHL-BLDG_004.jpg	4
<p>Description(s):</p> <p>Column has some minor pattern cracking.</p> <p>The concrete slab has some minor cracking.</p>

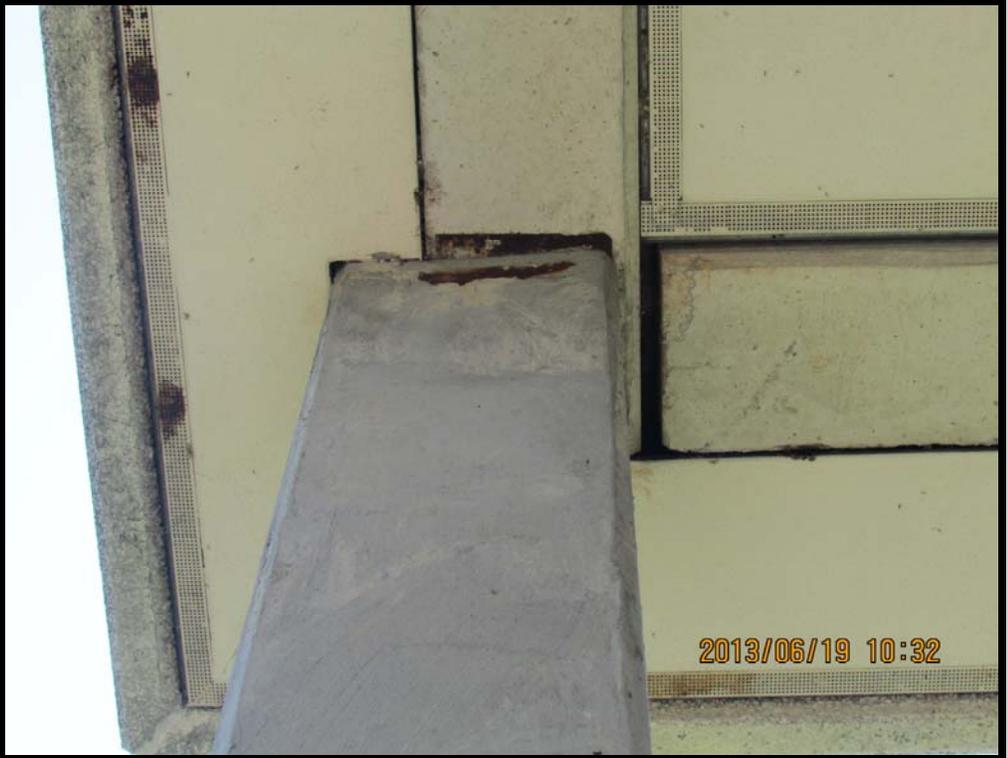
Location: Chlorine Contact Tanks	Photo Name:	Photo #:
North elevation, looking south	CHL-BLDG_003.jpg	5
<p>Description(s):</p> <p>Minor crack with rust staining at the top of the column.</p>

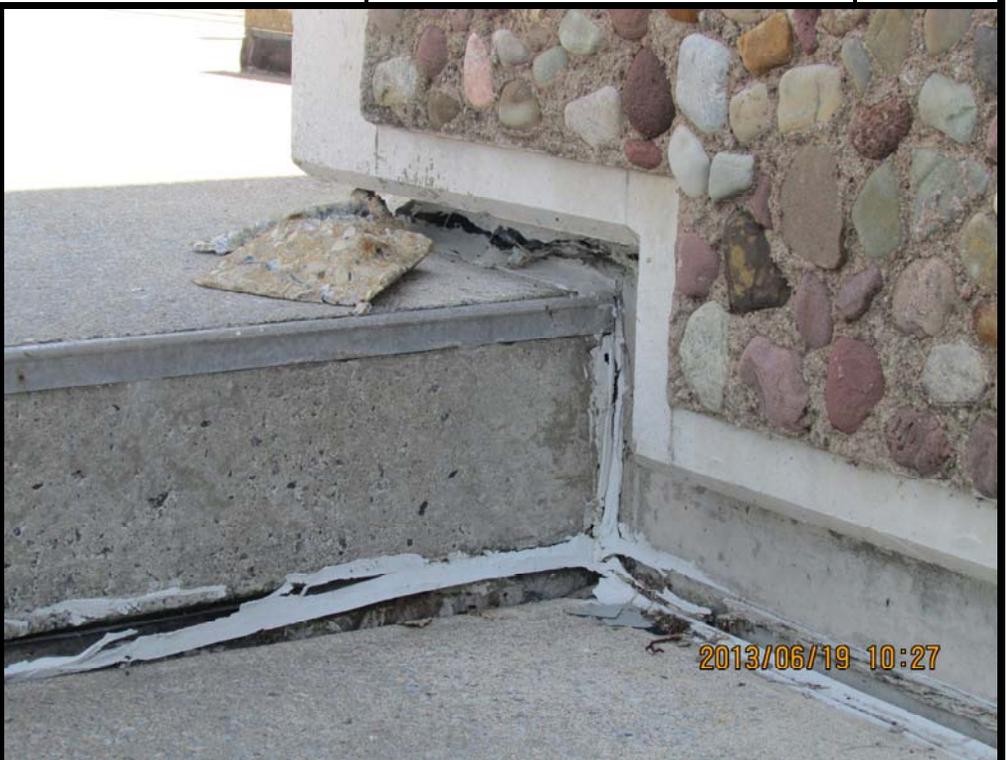
Location: Chlorine Contact Tanks	Photo Name:	Photo #:
Northwest corner	CHL-BLDG_002.jpg	6
<p>Description(s):</p> <p>Joint seal at base of building foundation and along the curb/sidewalk has failed. The sidewalk on grade has settled slightly.</p>

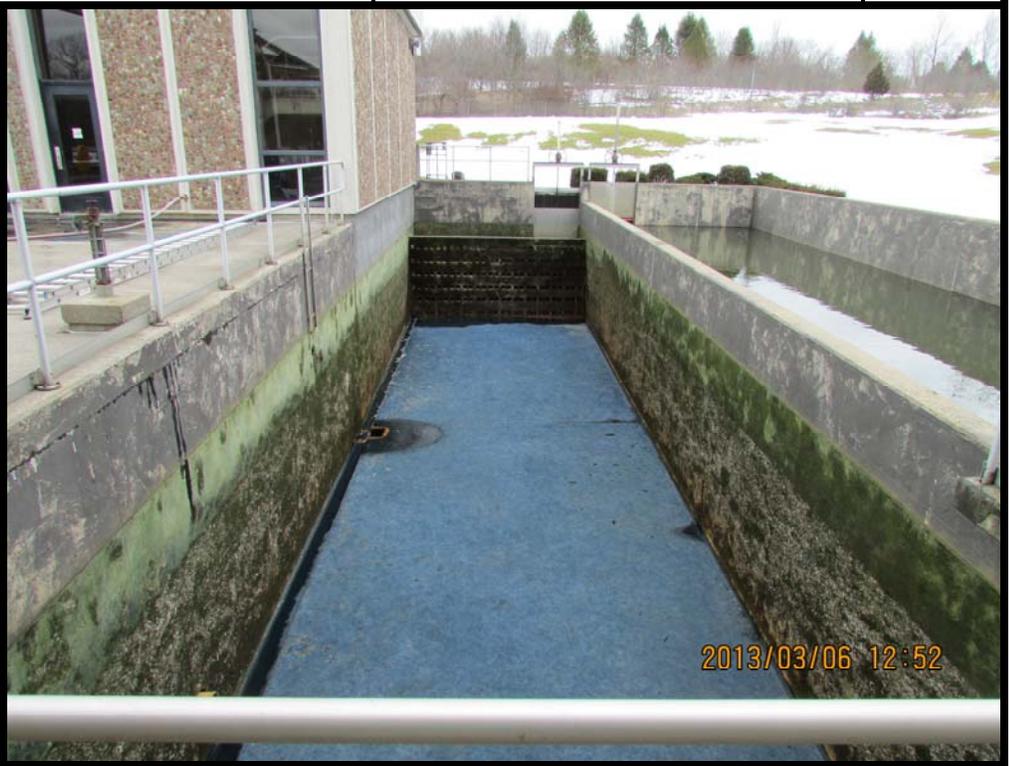
Location: Chlorine Contact Tank No. 1	Photo Name:	Photo #:
West elevation, looking east	CCT1_001.jpg	1
<p>Description(s):</p> <p>All wall surfaces below black/green protective coating are worn down to exposed aggregate. There is a 1/8" difference between the wall and coating and small popouts up to 3/8" deep. When chiseled the wall is very spongy and disintegrates to a powdery consistency.</p> <p>The blue colored residue on the floor is an unknown material; it appears not to be a protective coating. It disintegrates to a powdery consistency under the lightest pressure.</p>

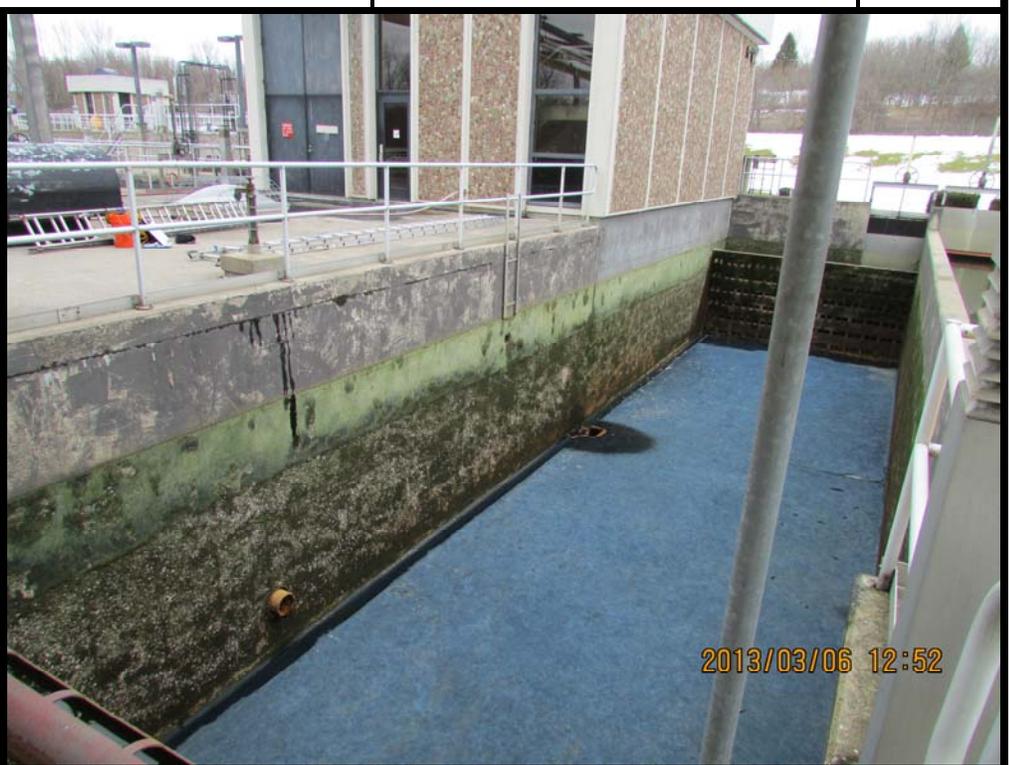
Location: Chlorine Contact Tank No. 1	Photo Name:	Photo #:
North wall, looking northeast	CCT1_002.jpg	2
<p>Description(s):</p> <p>Refer to Photo # 1.</p>

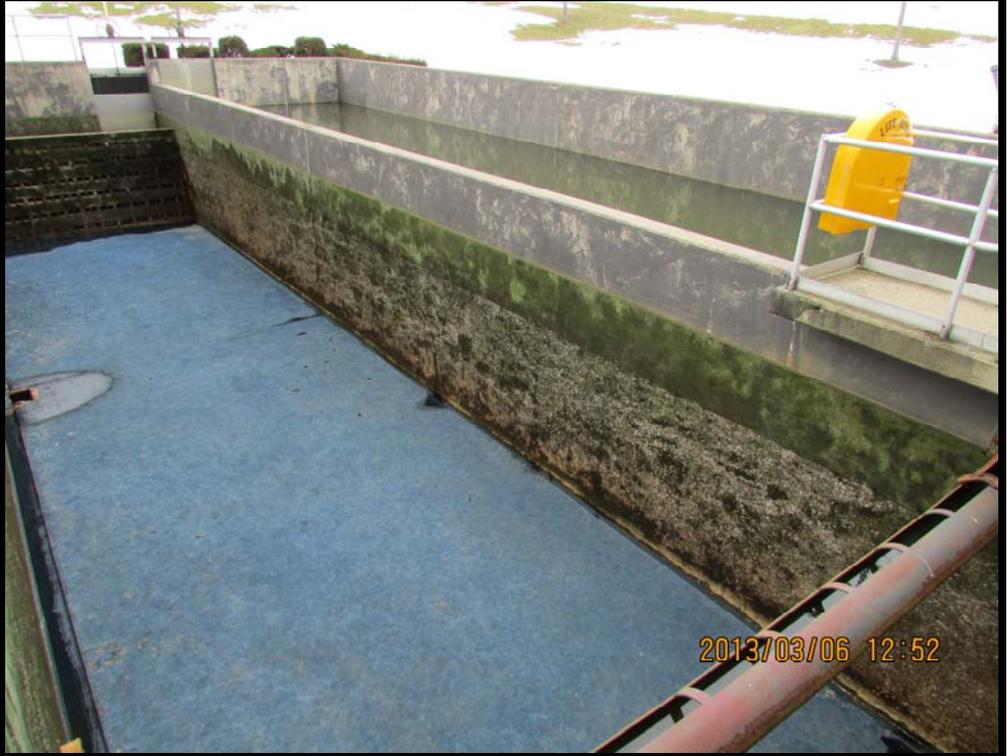
Location: Chlorine Contact Tank No. 1	Photo Name:	Photo #:
South wall, looking southeast	CCT1_003.jpg	3
Description(s):  Refer to Photo # 1.

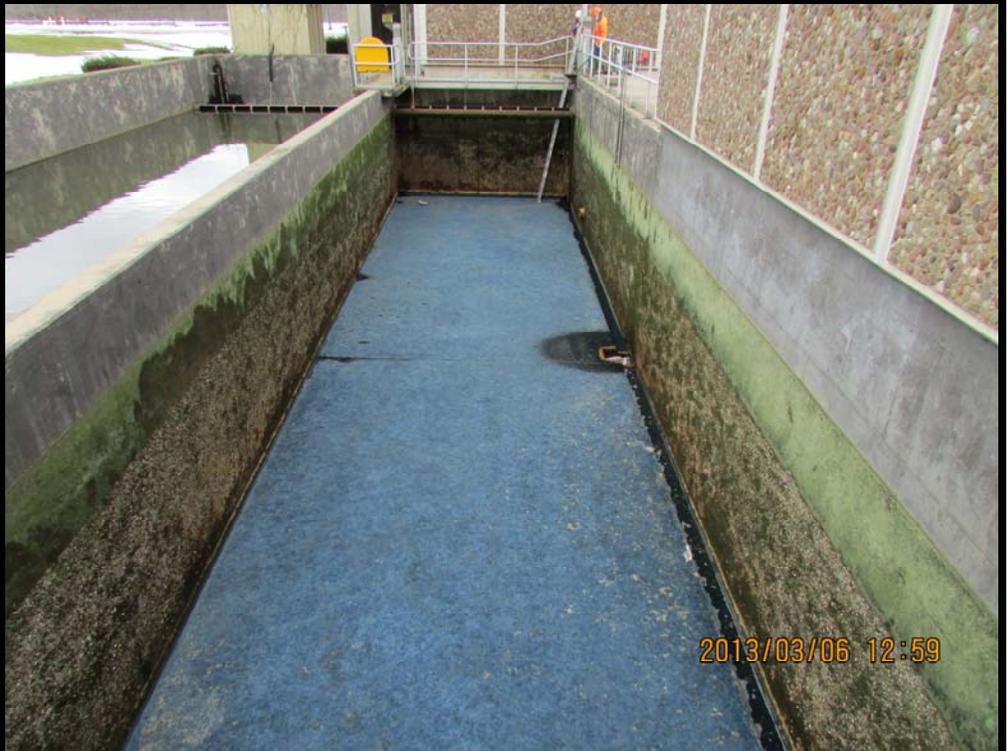
Location: Chlorine Contact Tank No. 1	Photo Name:	Photo #:
East elevation, looking west	CCT1_015.jpg	4
Description(s):  Refer to Photo # 1.

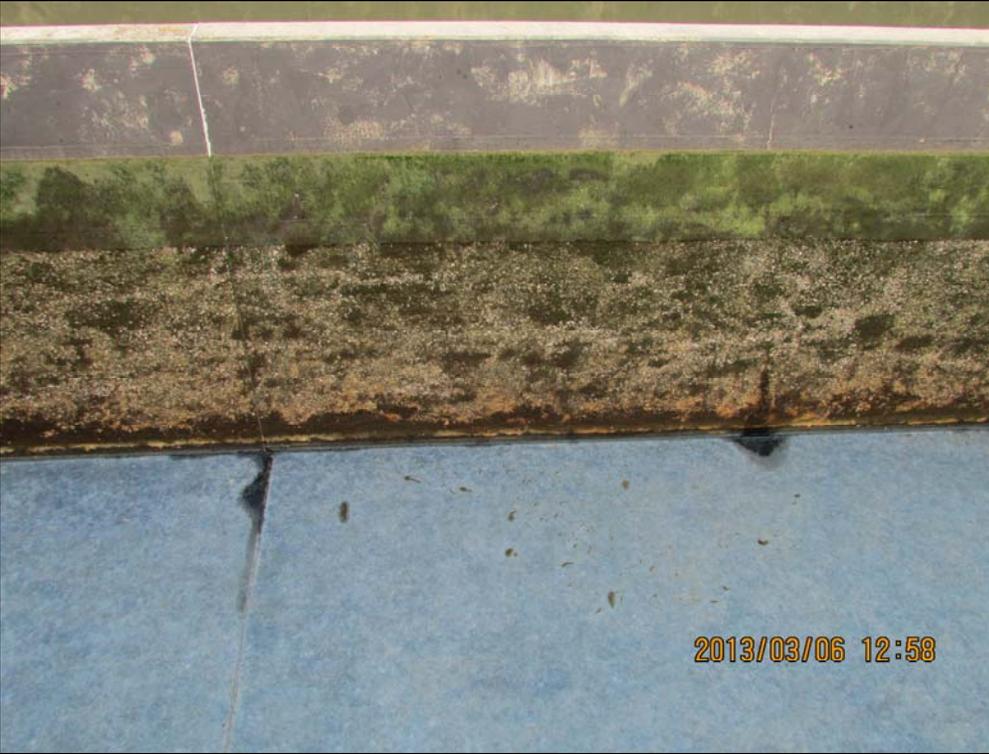
Location: Chlorine Contact Tank No. 1	Photo Name:	Photo #:
South wall, looking south	CCT1_015.jpg	5
<p>Description(s):</p> <p>Active leakage at floor/wall expansion joint.</p> <p>Vertical crack with active leakage located to the west of the expansion joint.</p>

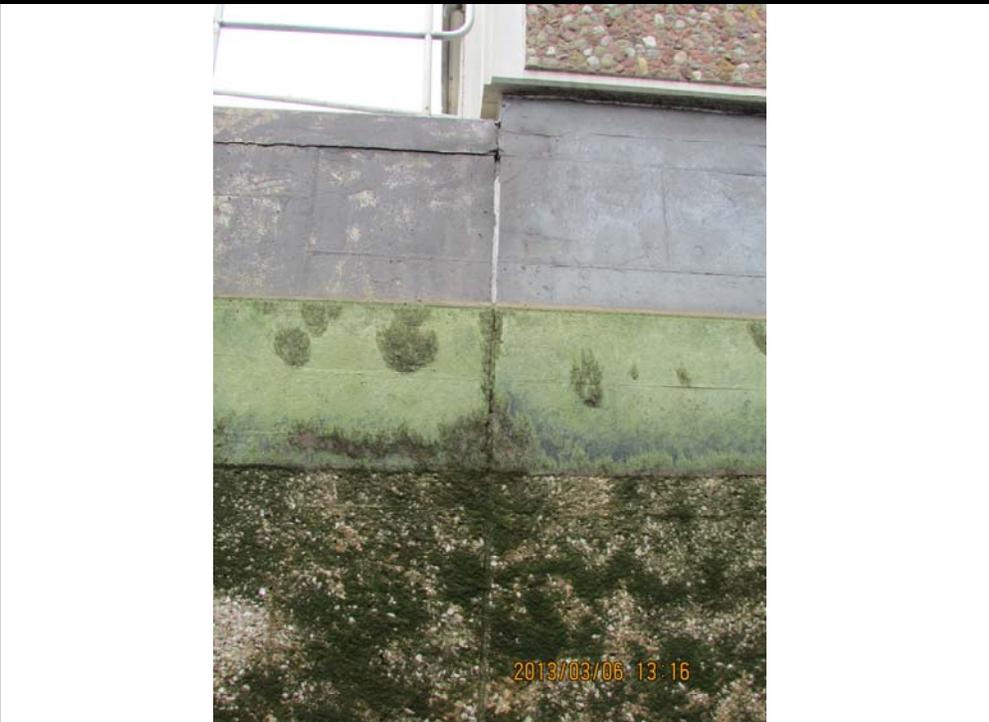
Location: Chlorine Contact Tank No. 1	Photo Name:	Photo #:
North wall, looking north	CCT1_031.jpg	6
<p>Description(s):</p> <p>At expansion joint.</p> <p>Top slab/wall joint is deteriorated along the full length of the wall with small spalls areas.</p>

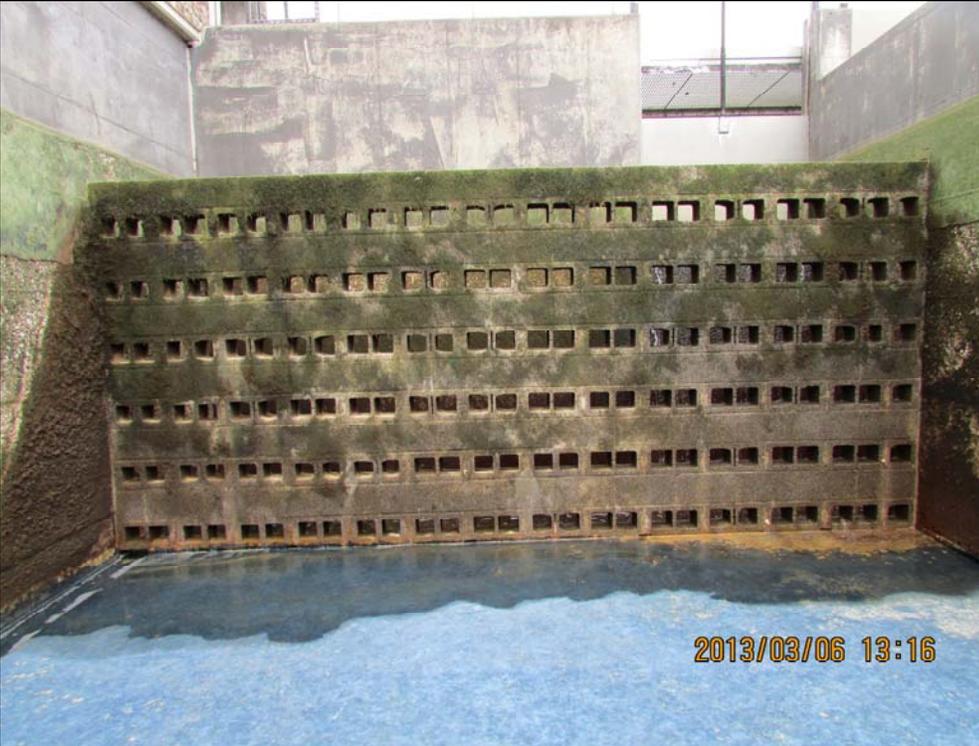
Location: Chlorine Contact Tank No. 1	Photo Name:	Photo #:
West elevation, looking east	CCT1_033.jpg	7
<p>Description(s):</p> <p>Concrete baffle wall is in good conditions, no structural damage.</p>

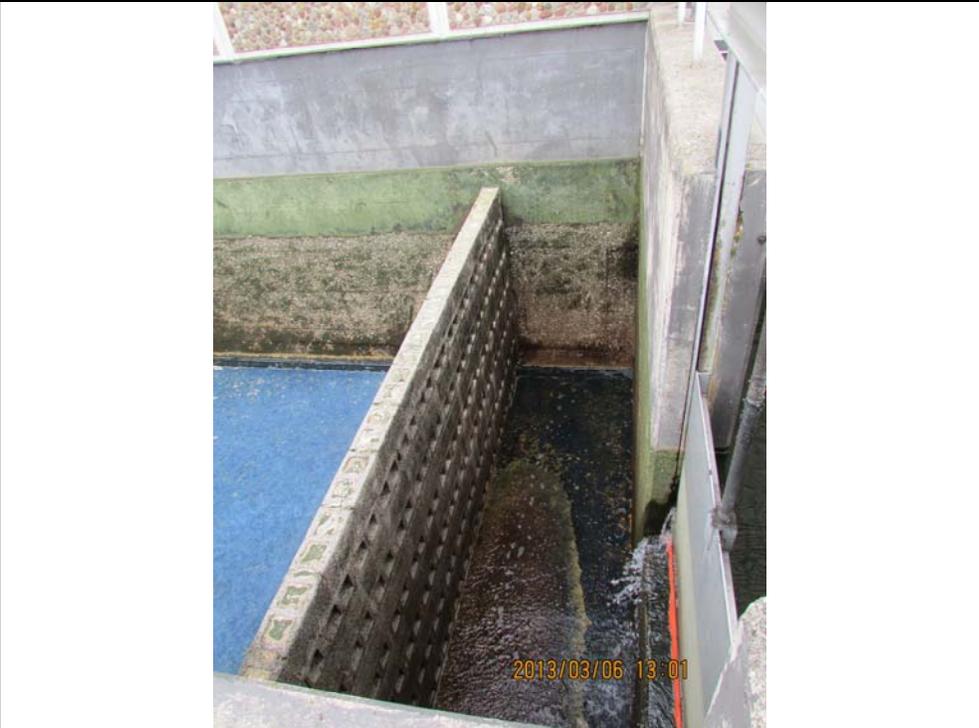
Location: Chlorine Contact Tank No. 1	Photo Name:	Photo #:
Looking north	CCT1_020.jpg	8
<p>Description(s):</p> <p>Concrete baffle wall and area behind is in good conditions, no structural damage.</p> <p>On the north wall there is an existing vertical crack repair that starts approximately 1.0' off the floor and continues up the wall for 4.0' to 5.0'±.</p>

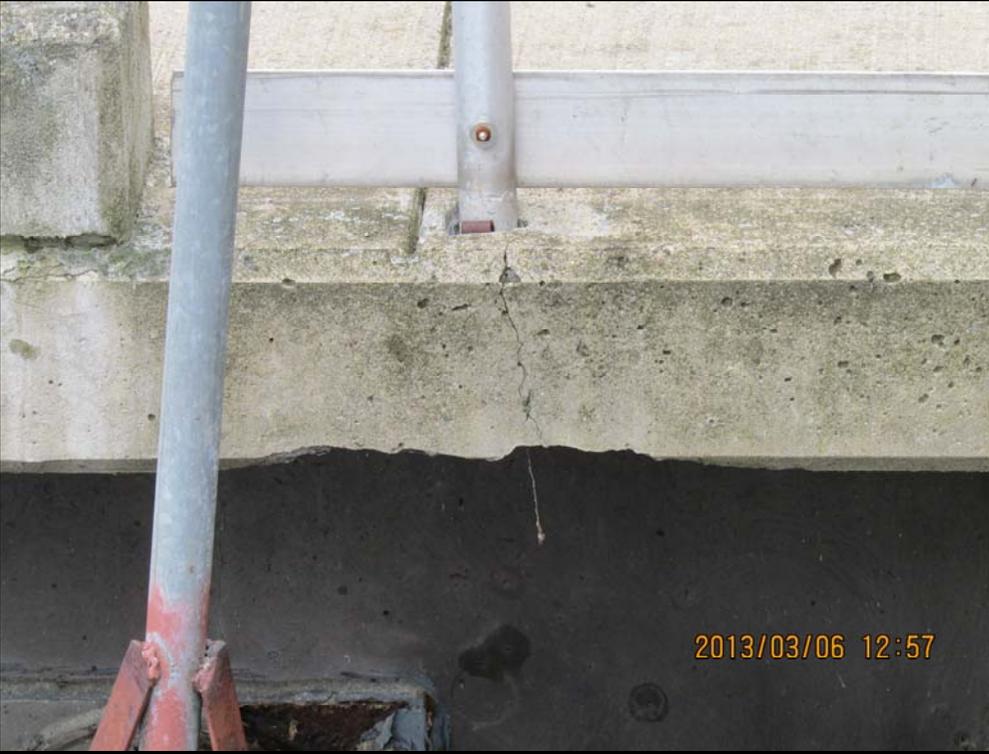
Location: Chlorine Contact Tank No. 1	Photo Name:	Photo #:
North fascia, looking south	CCT1_012.jpg	9
<p>Description(s):</p> <p>At the fascia of the concrete walkway, cracking as occurred at the base of each railing post.</p> <p>A large chunk of concrete has fallen off the underside at the 2<sup>nd</sup> post from the west end.</p>

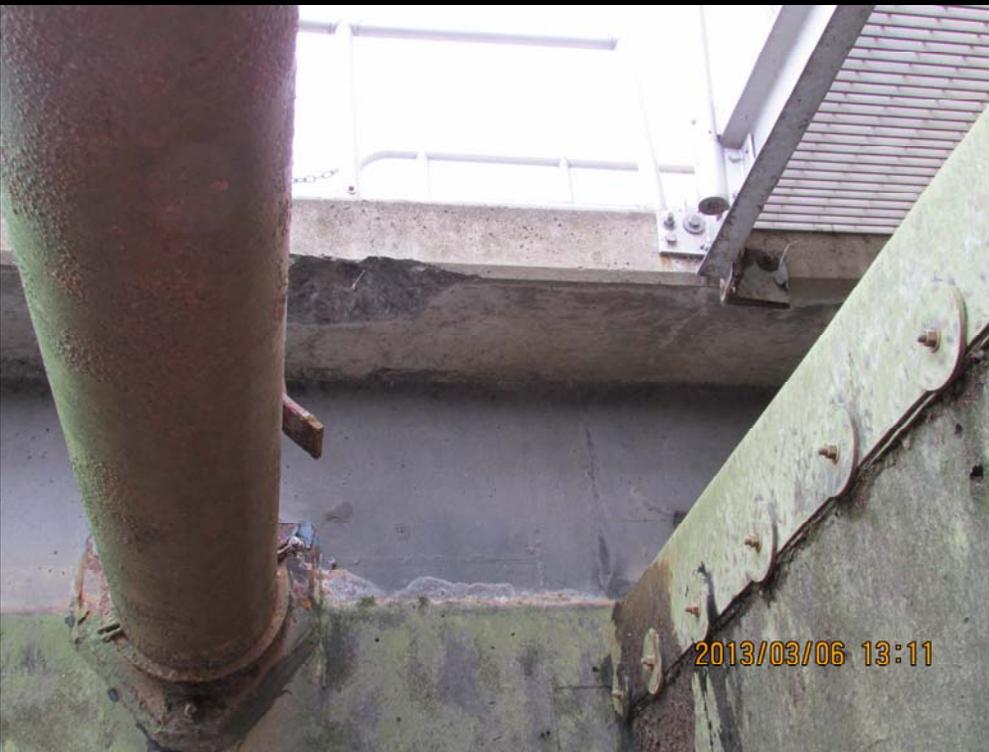
Location: Chlorine Contact Tank No. 1	Photo Name:	Photo #:
	CCT1_025.jpg	10
<p>Description(s):</p> <p>A large chunk of concrete has fallen off the underside at the 2<sup>nd</sup> post from the west end.</p> <p>See photo # 9.</p>

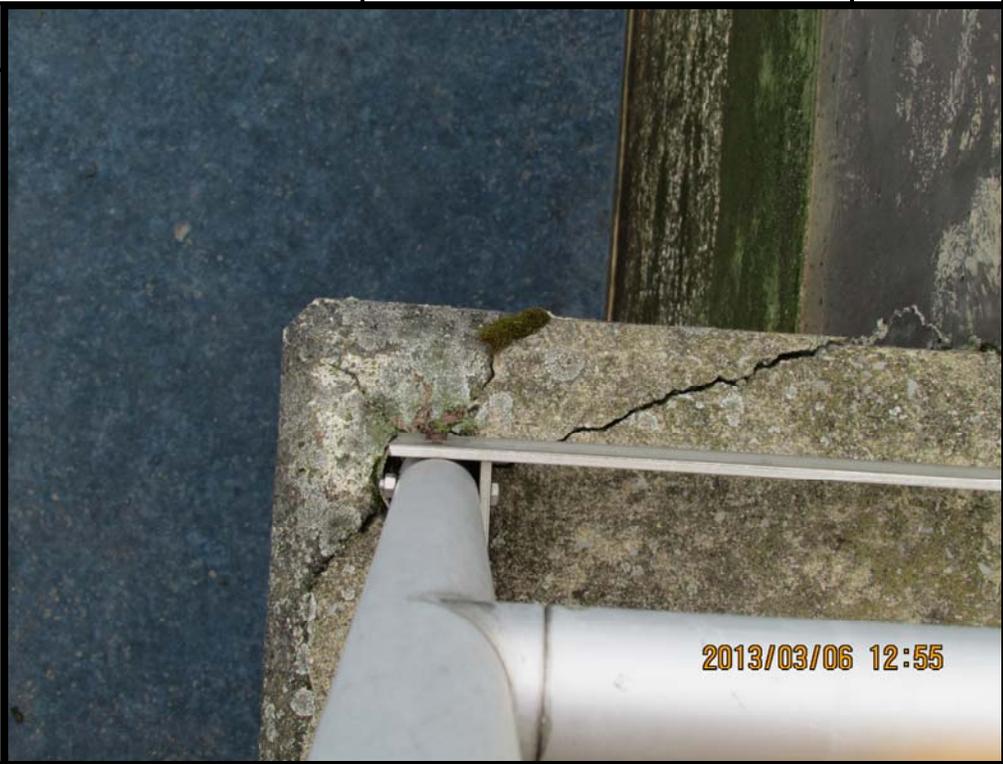
Location: Chlorine Contact Tank No. 1	Photo Name:	Photo #:
	CCT1_010.jpg	11
Description(s):

At the fascia of the concrete walkway, cracking as occurred at the base of each railing post.

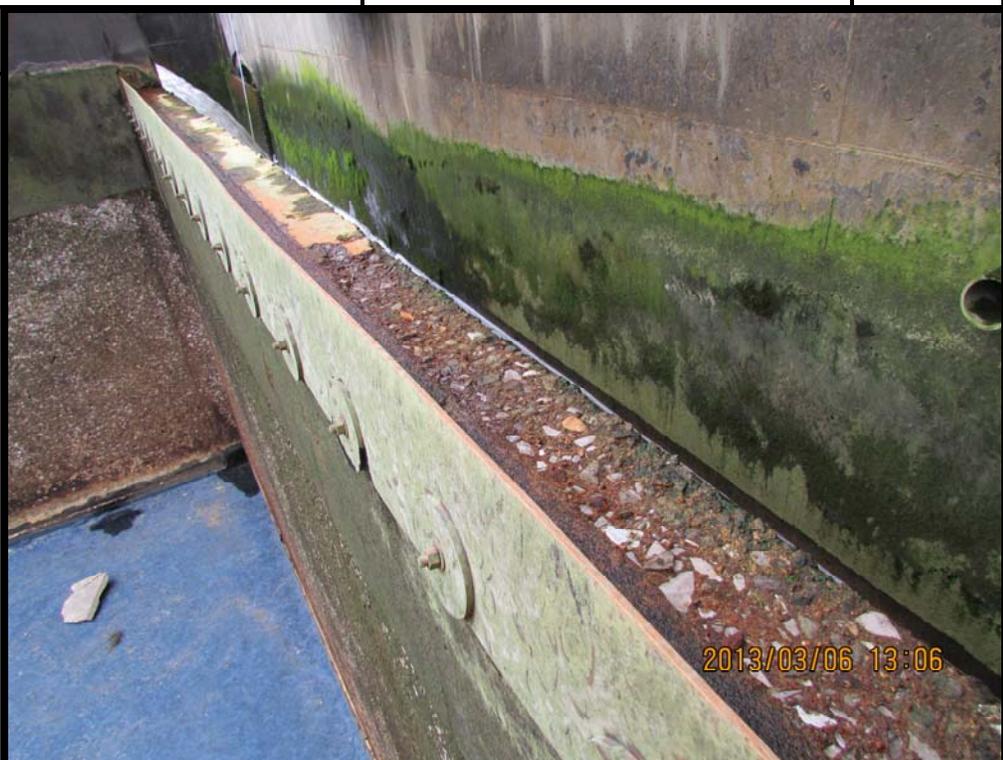
Location: Chlorine Contact Tank No. 1	Photo Name:	Photo #:
	CCT1_022.jpg	12
Description(s):

Top of fill chamber east wall has approximately a 1/4" of wear below the top aluminum plates.

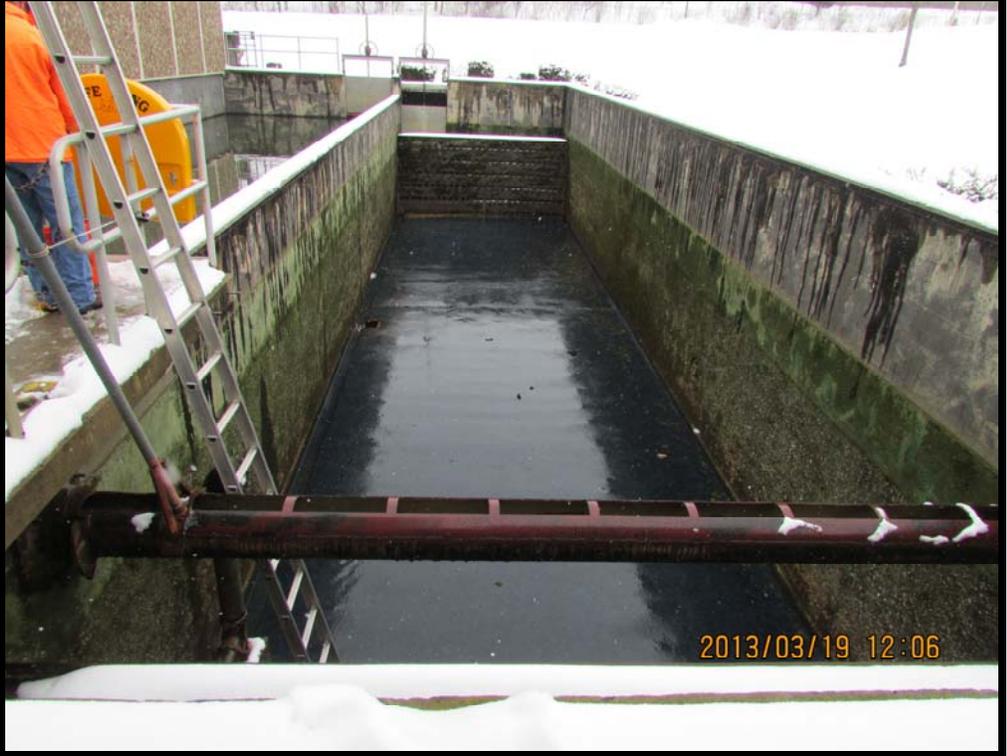
Location: Chlorine Contact Tank No. 2	Photo Name:	Photo #:
West elevation, looking east	CCT2_001.jpg	1
<p>Description(s):</p> <p>All wall surfaces below black/green protective coating are worn down to exposed aggregate. There is a 1/8" difference between the wall and coating and small popouts up to 3/8" deep. When chiseled the wall is very spongy and disintegrates to a powdery consistency.</p> <p>The blue colored residue on the floor is an unknown material; it appears not to be a protective coating. It disintegrates to a powdery consistency under the lightest pressure.</p>

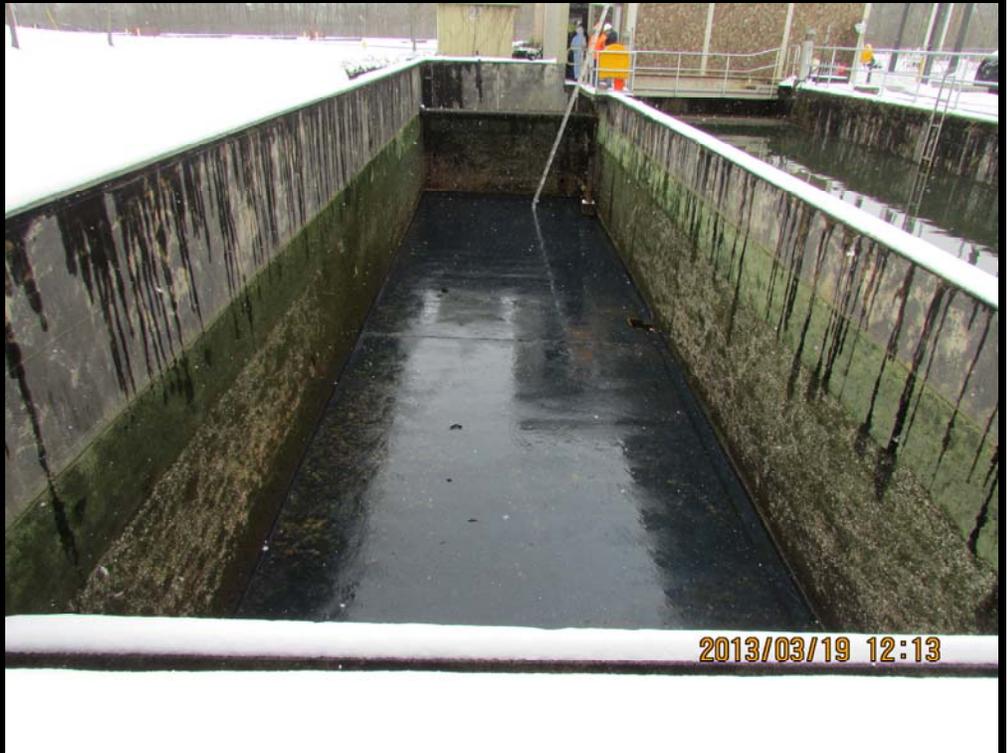
Location: Chlorine Contact Tank No. 2	Photo Name:	Photo #:
East elevation, looking West	CCT2_017.jpg	2
<p>Description(s):</p> <p>Refer to Photo # 1.</p>

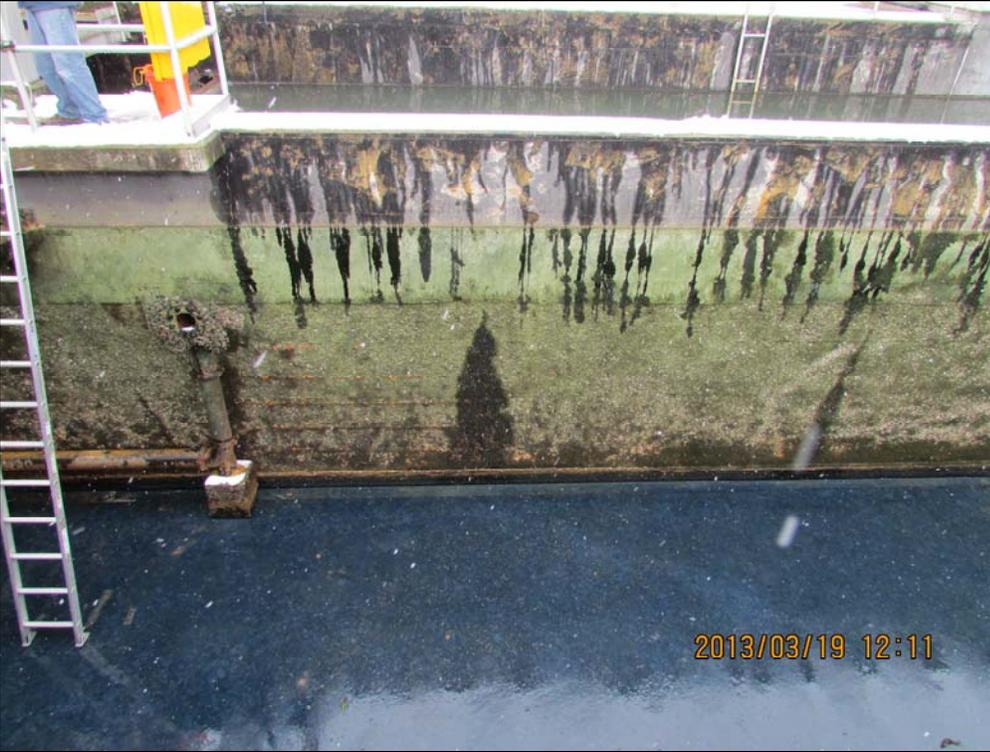
Location: Chlorine Contact Tank No. 2	Photo Name:	Photo #:
North wall, looking north	CCT2_010.jpg	5
<p>Description(s):</p> <p>Vertical crack with active leakage located to the west of the expansion joint.</p>

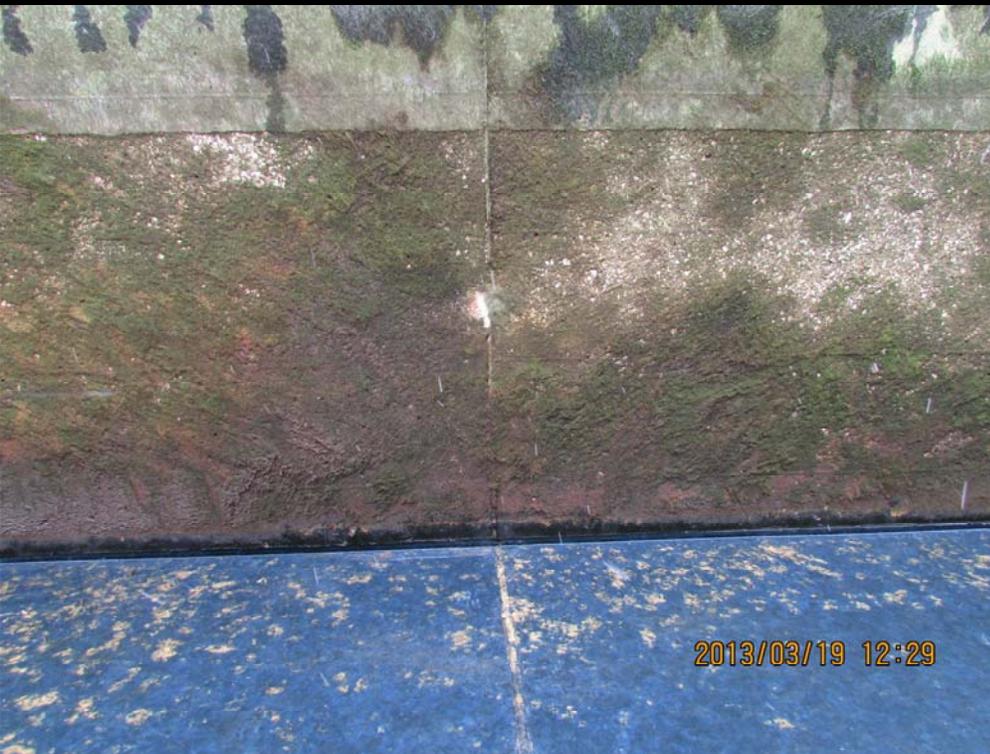
Location: Chlorine Contact Tank No. 2	Photo Name:	Photo #:
North wall, looking north	CCT2_027.jpg	6
<p>Description(s):</p> <p>At expansion joint. A small spall area with existing patch material that is failing is approximately 4.0' above the floor.</p>

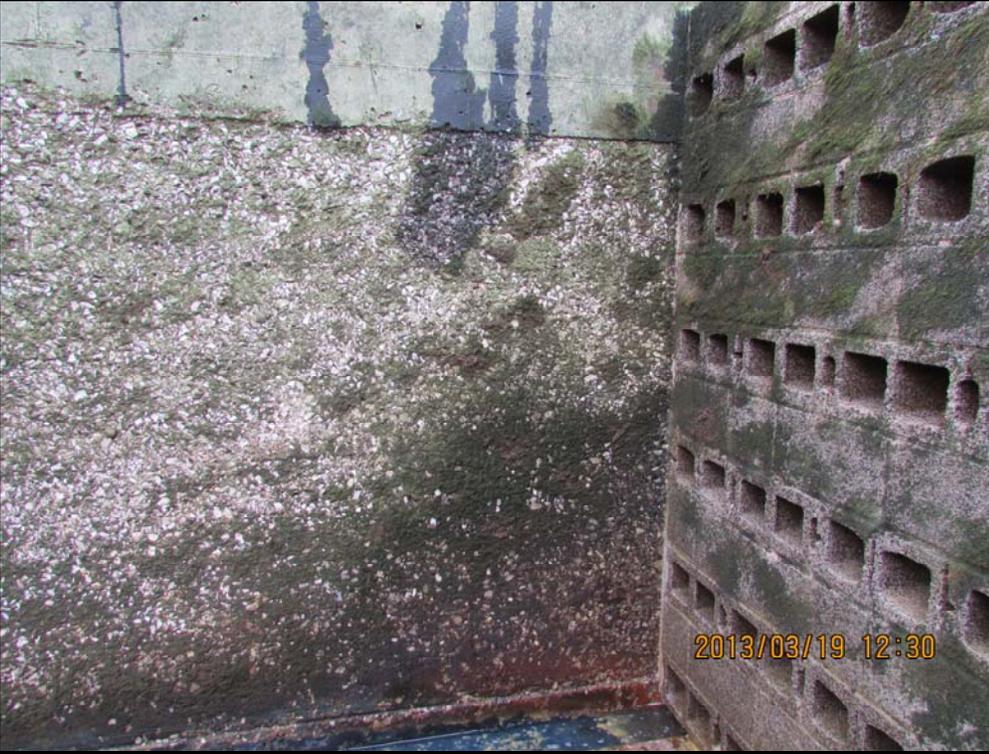
Location: Chlorine Contact Tank No. 2	Photo Name:	Photo #:
Northwest elevation, looking east	CCT2_030.jpg	7
<p>Description(s):</p> <p>Concrete baffle wall is in good conditions, no structural damage.</p>

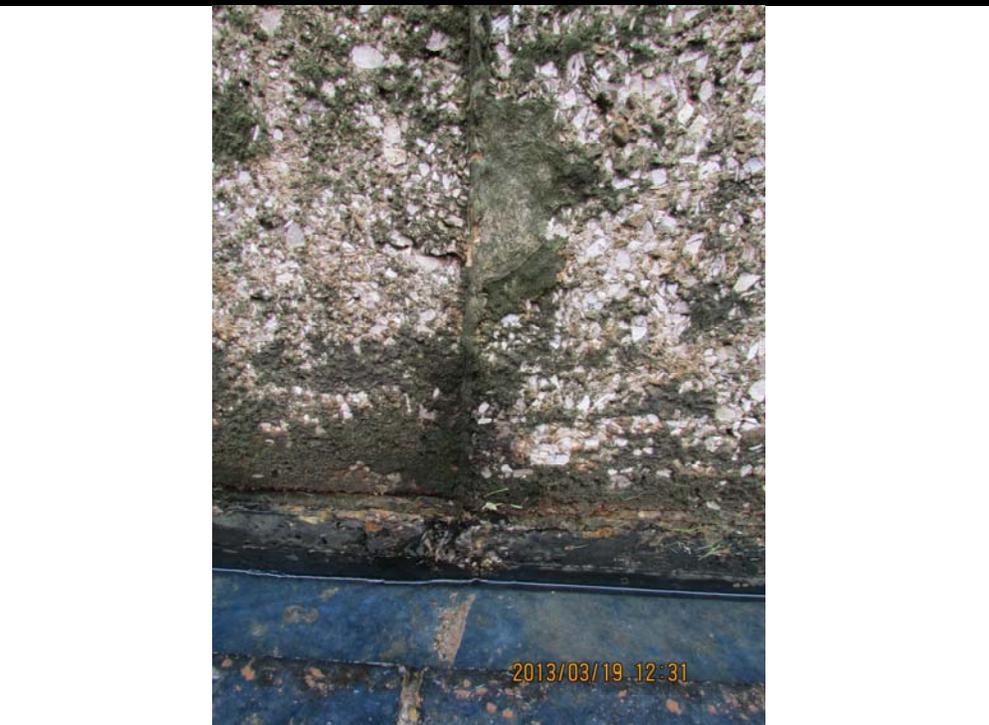
Location: Chlorine Contact Tank No. 2	Photo Name:	Photo #:
North wall, Looking north	CCT2_032.jpg	8
<p>Description(s):</p> <p>Small spall area, actively leaking at the base of the expansion joint.</p>

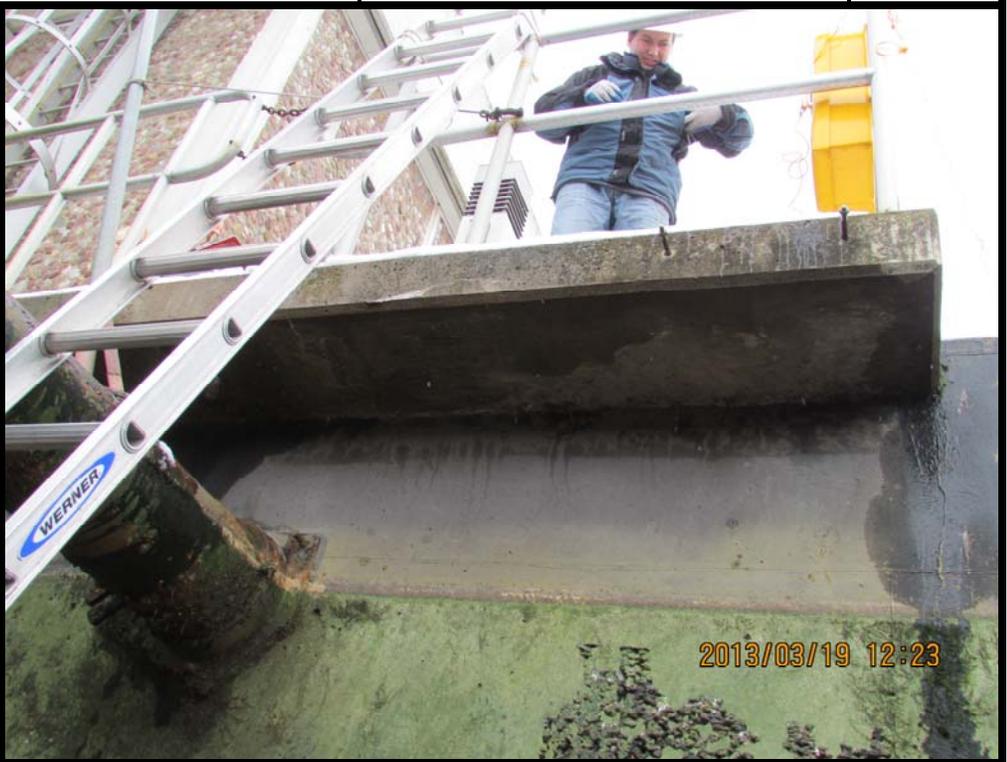
Location: Chlorine Contact Tank No. 2	Photo Name:	Photo #:
Underside of walkway.	CCT2_022.jpg	9
<p>Description(s):</p> <p>Map cracking with efflorescence is evident on the underside of the walkway.</p>

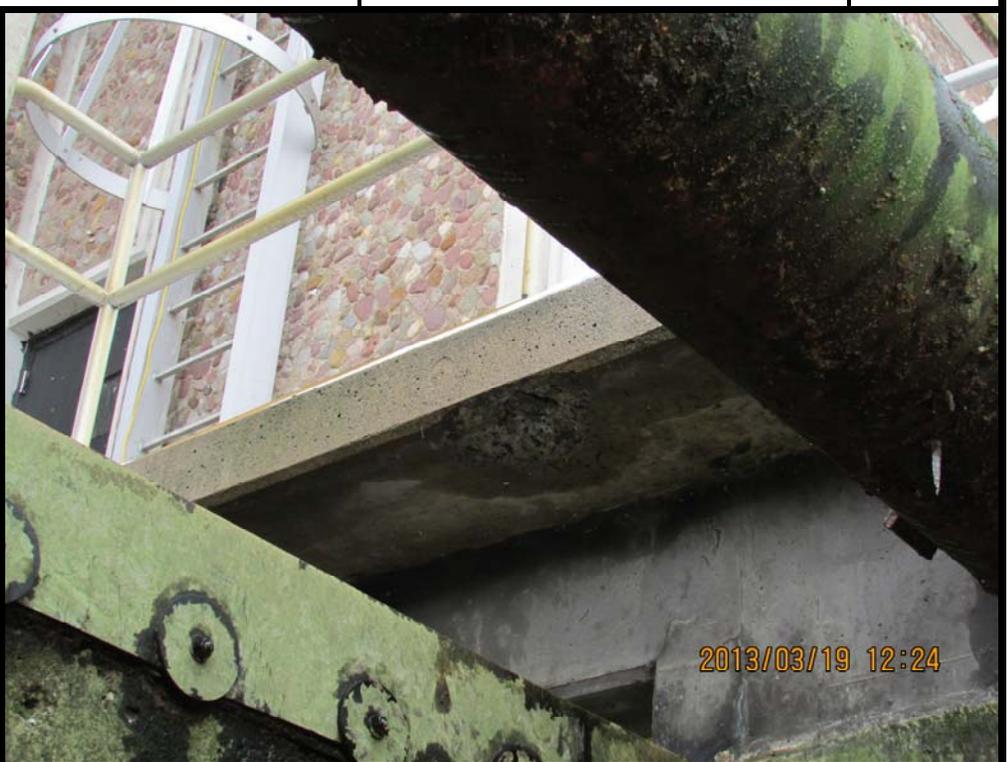
Location: Chlorine Contact Tank No. 2	Photo Name:	Photo #:
Underside of walkway.	CCT2_023.jpg	10
<p>Description(s):</p> <p>A 2.0' x 2.0' x 1½" deep spall area has developed on the underside of the walkway.</p>

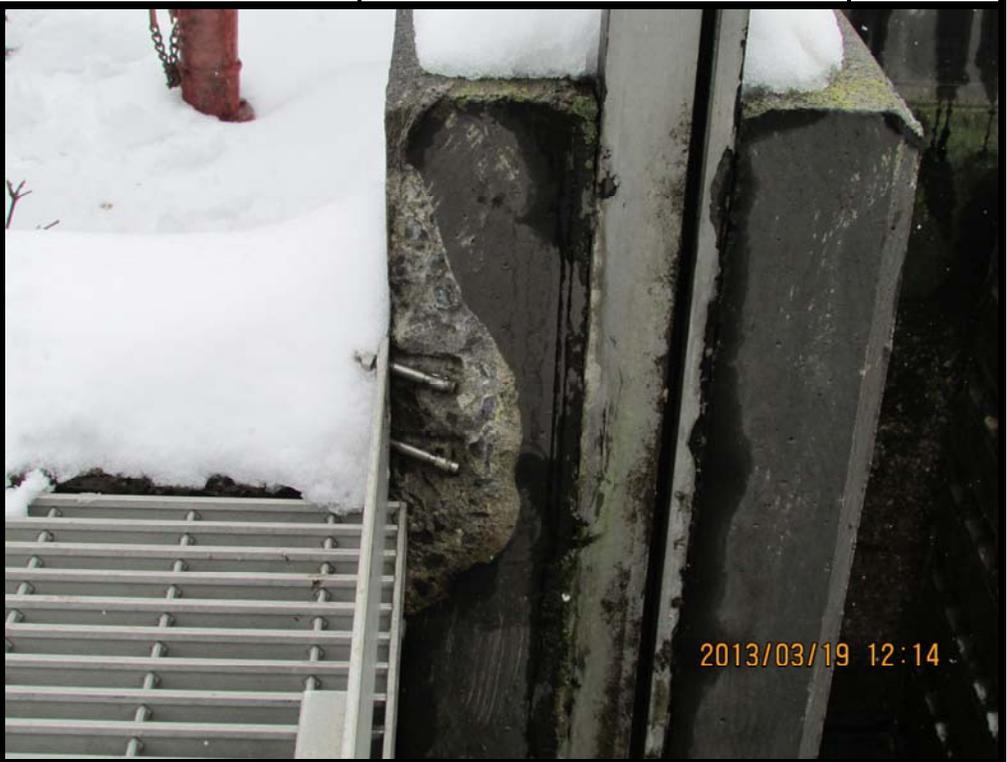
Location: Chlorine Contact Tank No. 2	Photo Name:	Photo #:
East end of tank, opening for effluent channel gate.	CCT2_019.jpg	11
<p>Description(s):</p> <p>The concrete has spalled at the location for the anchorage to the grating over the effluent channel</p>

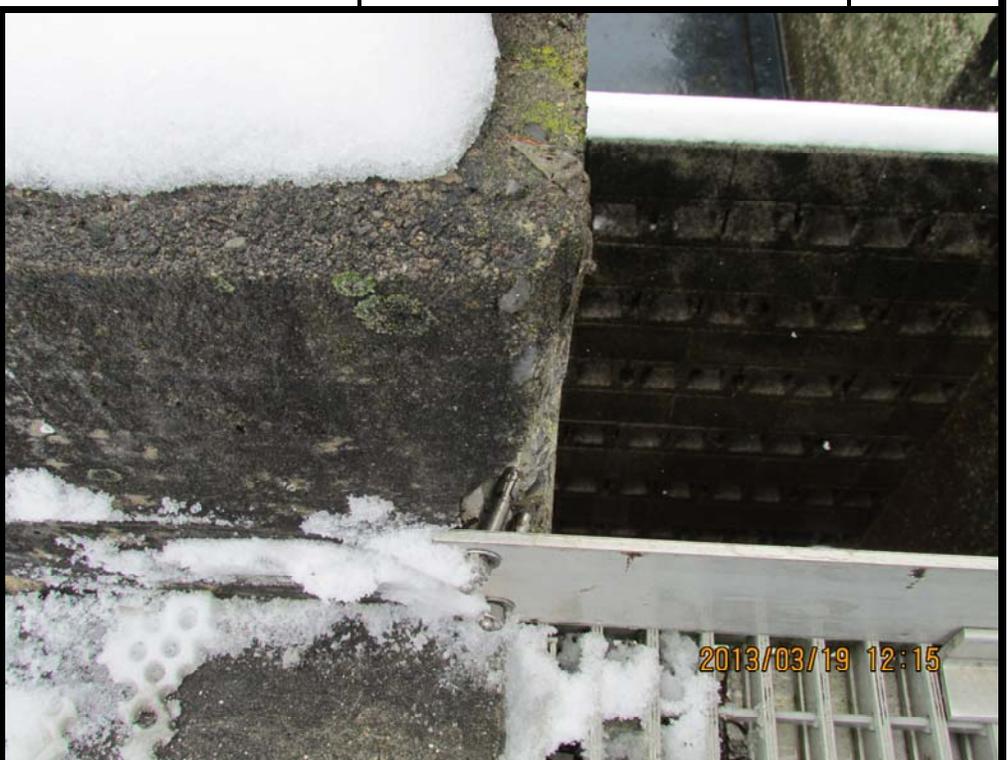
Location: Chlorine Contact Tank No. 2	Photo Name:	Photo #:
East end of tank, opening for effluent channel gate.	CCT2_021.jpg	12
<p>Description(s):</p> <p>The concrete has spalled at the location for the anchorage to the grating over the effluent channel</p>
