Onondaga County, NY  
Condition Assessment Report  
Baldwinsville-Seneca Knolls Wastewater Treatment Plant

January 2015

# 7. Disinfection Evaluation

## Appendix K - Condition Assessment Photos

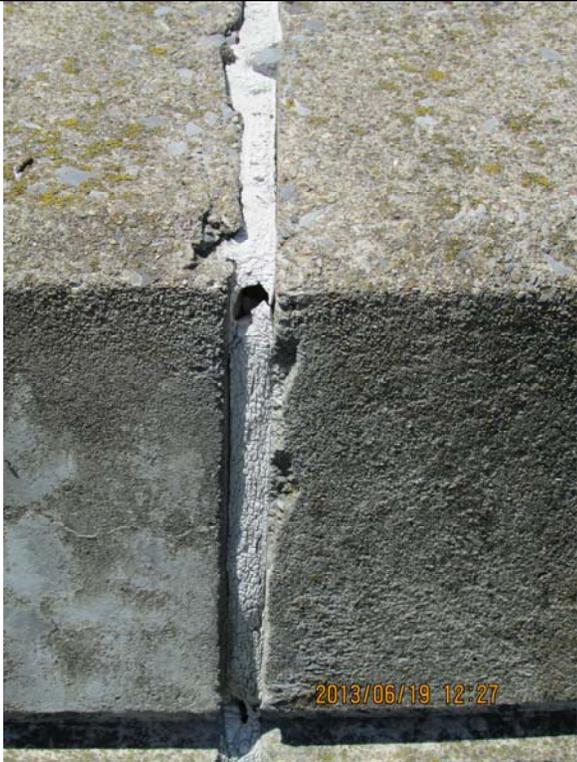
Location: Chlorine Contact Tanks		Photo Name:	Photo #:
		CCTe_005.jpg	13
Description(s):

Deteriorated joint on the exterior tank walls.

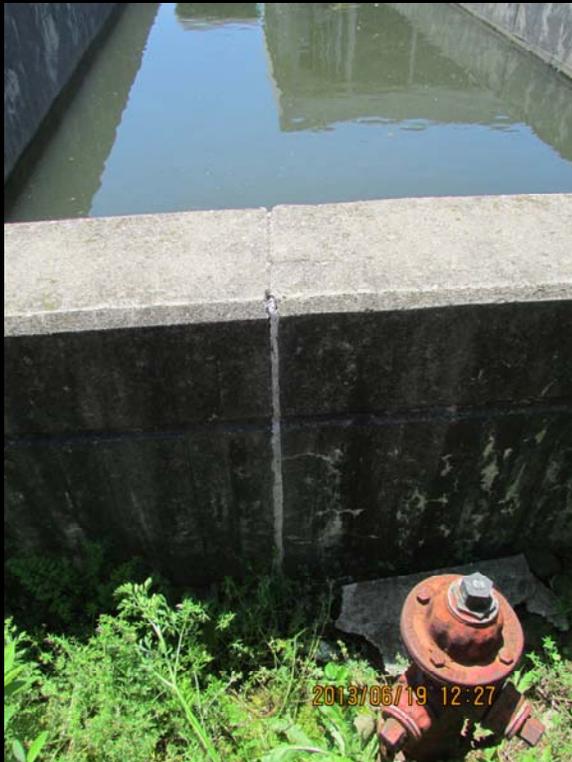
Location: Chlorine Contact Tanks		Photo Name:	Photo #:
		CCTe_006.jpg	14
Description(s):

Deteriorated joint on the exterior tank walls.

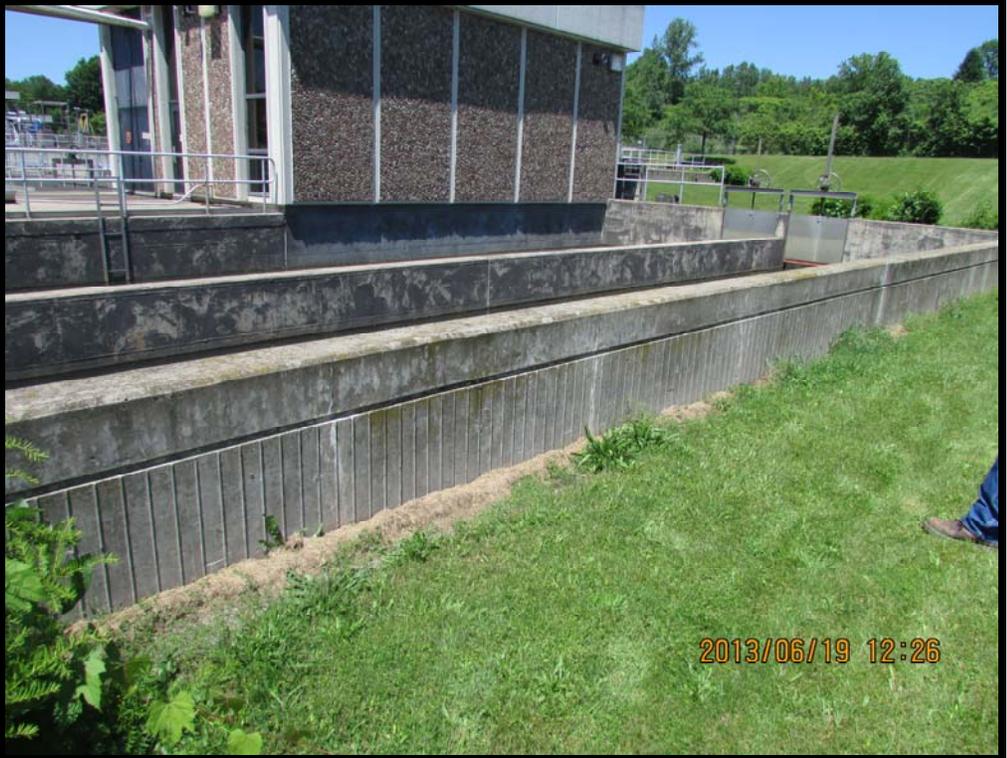
Location: Chlorine Contact Tanks	Photo Name:	Photo #:
South elevation, looking northeast	CCTe_004.jpg	15
<p>Description(s):</p> <p>Random vertical cracks some with efflorescence that extend from the ground to the top of the wall.</p>

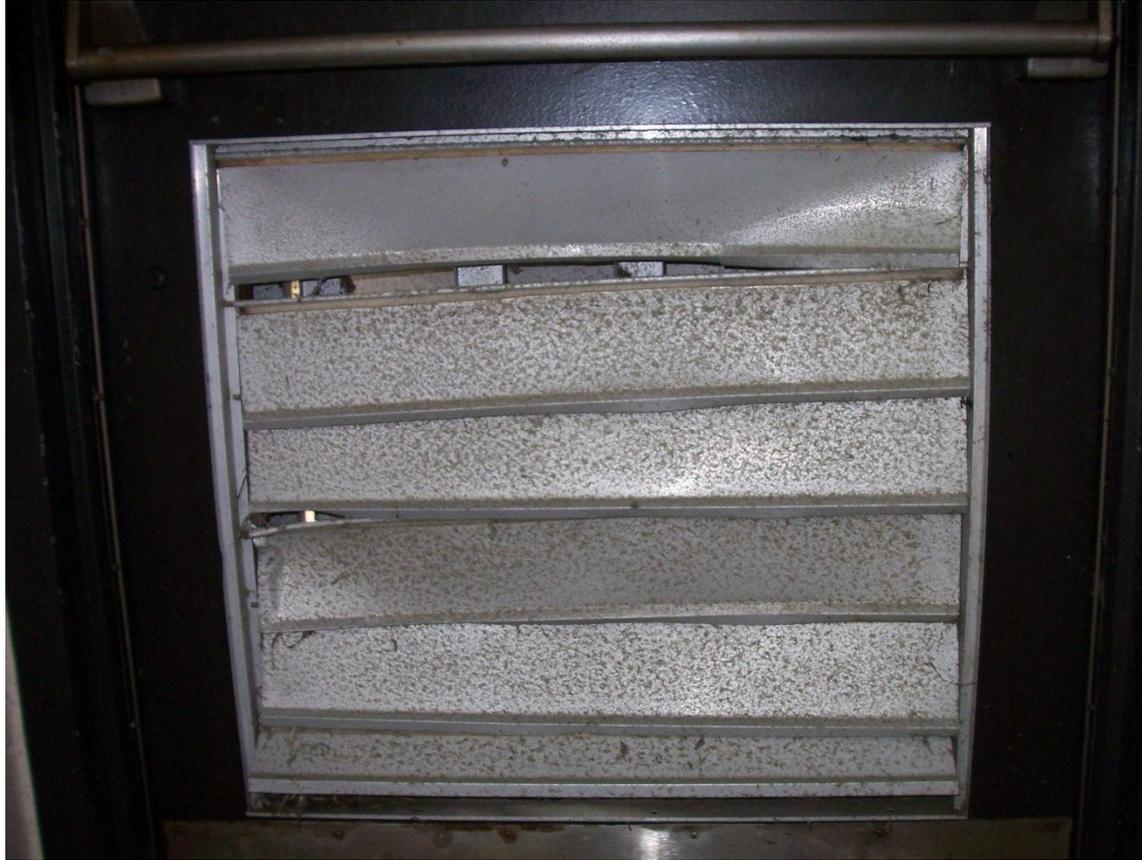
## Disinfection Building – Intake Damper

Gravity damper seized in closed position
