**CONESTOGA-ROVERS  
& ASSOCIATES**

## TECHNICAL MEMORANDUM

RE: Metro WWTP - Compliance Alternatives for Outfall 002 and Tertiary Treatment Bypass

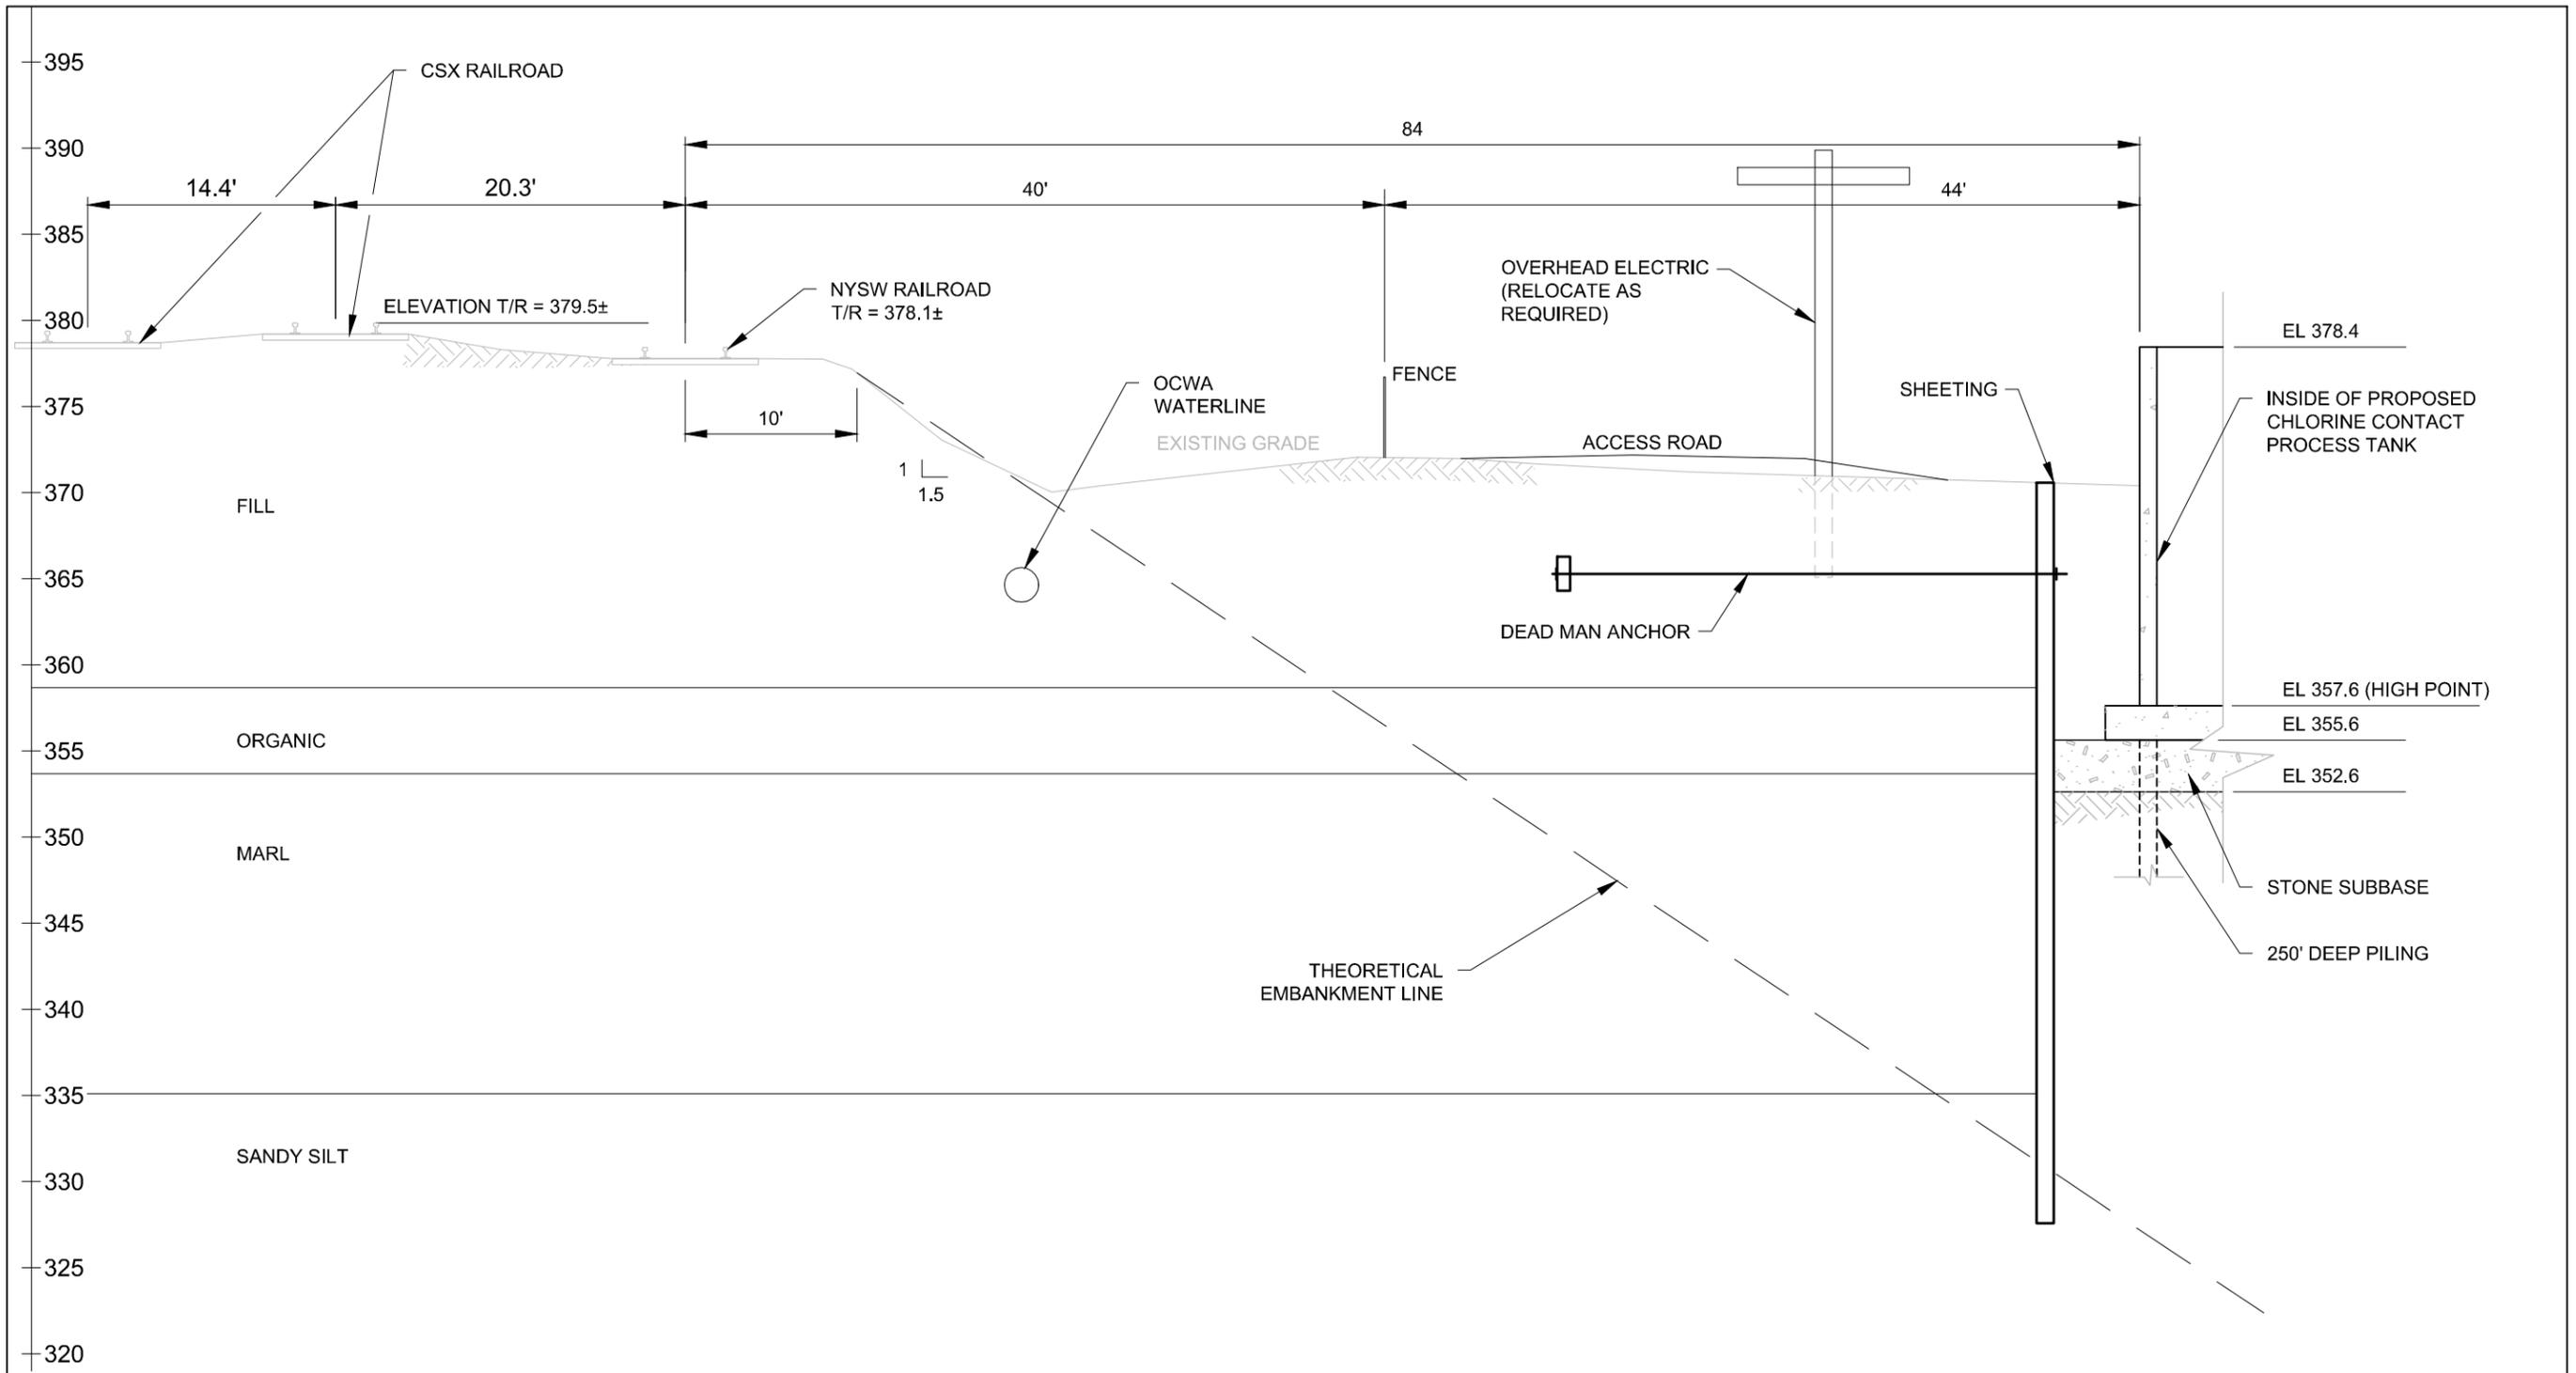
SECTION A  
 1" = 10' figure 2

Assuming the maximum volume is detained during a peak hydraulic grade condition, a tank with two 35-foot wide by 185-foot long chambers would provide approximately 2.0 MG of capacity. This tank would be located just north of the existing BCCT and to the west of Aeration Tanks F and G. Figure 2 illustrates the preliminary layout for Alternative A.

A detailed analysis of the size and layout of the new tankage is recommended after the secondary bypass testing program discussed above is completed. The analysis should present layout options with associated costs and consider items such as the unique geotechnical design requirements for tank construction, impacts to the railroad and the Onondaga County Water Authority (OWCA) transmission main to the north of the tank, impacts to WEP's ongoing treatment operations, chemical deliveries and vehicular access around the tank, and the future operation and maintenance of the existing aeration tanks and expanded BCCT process.

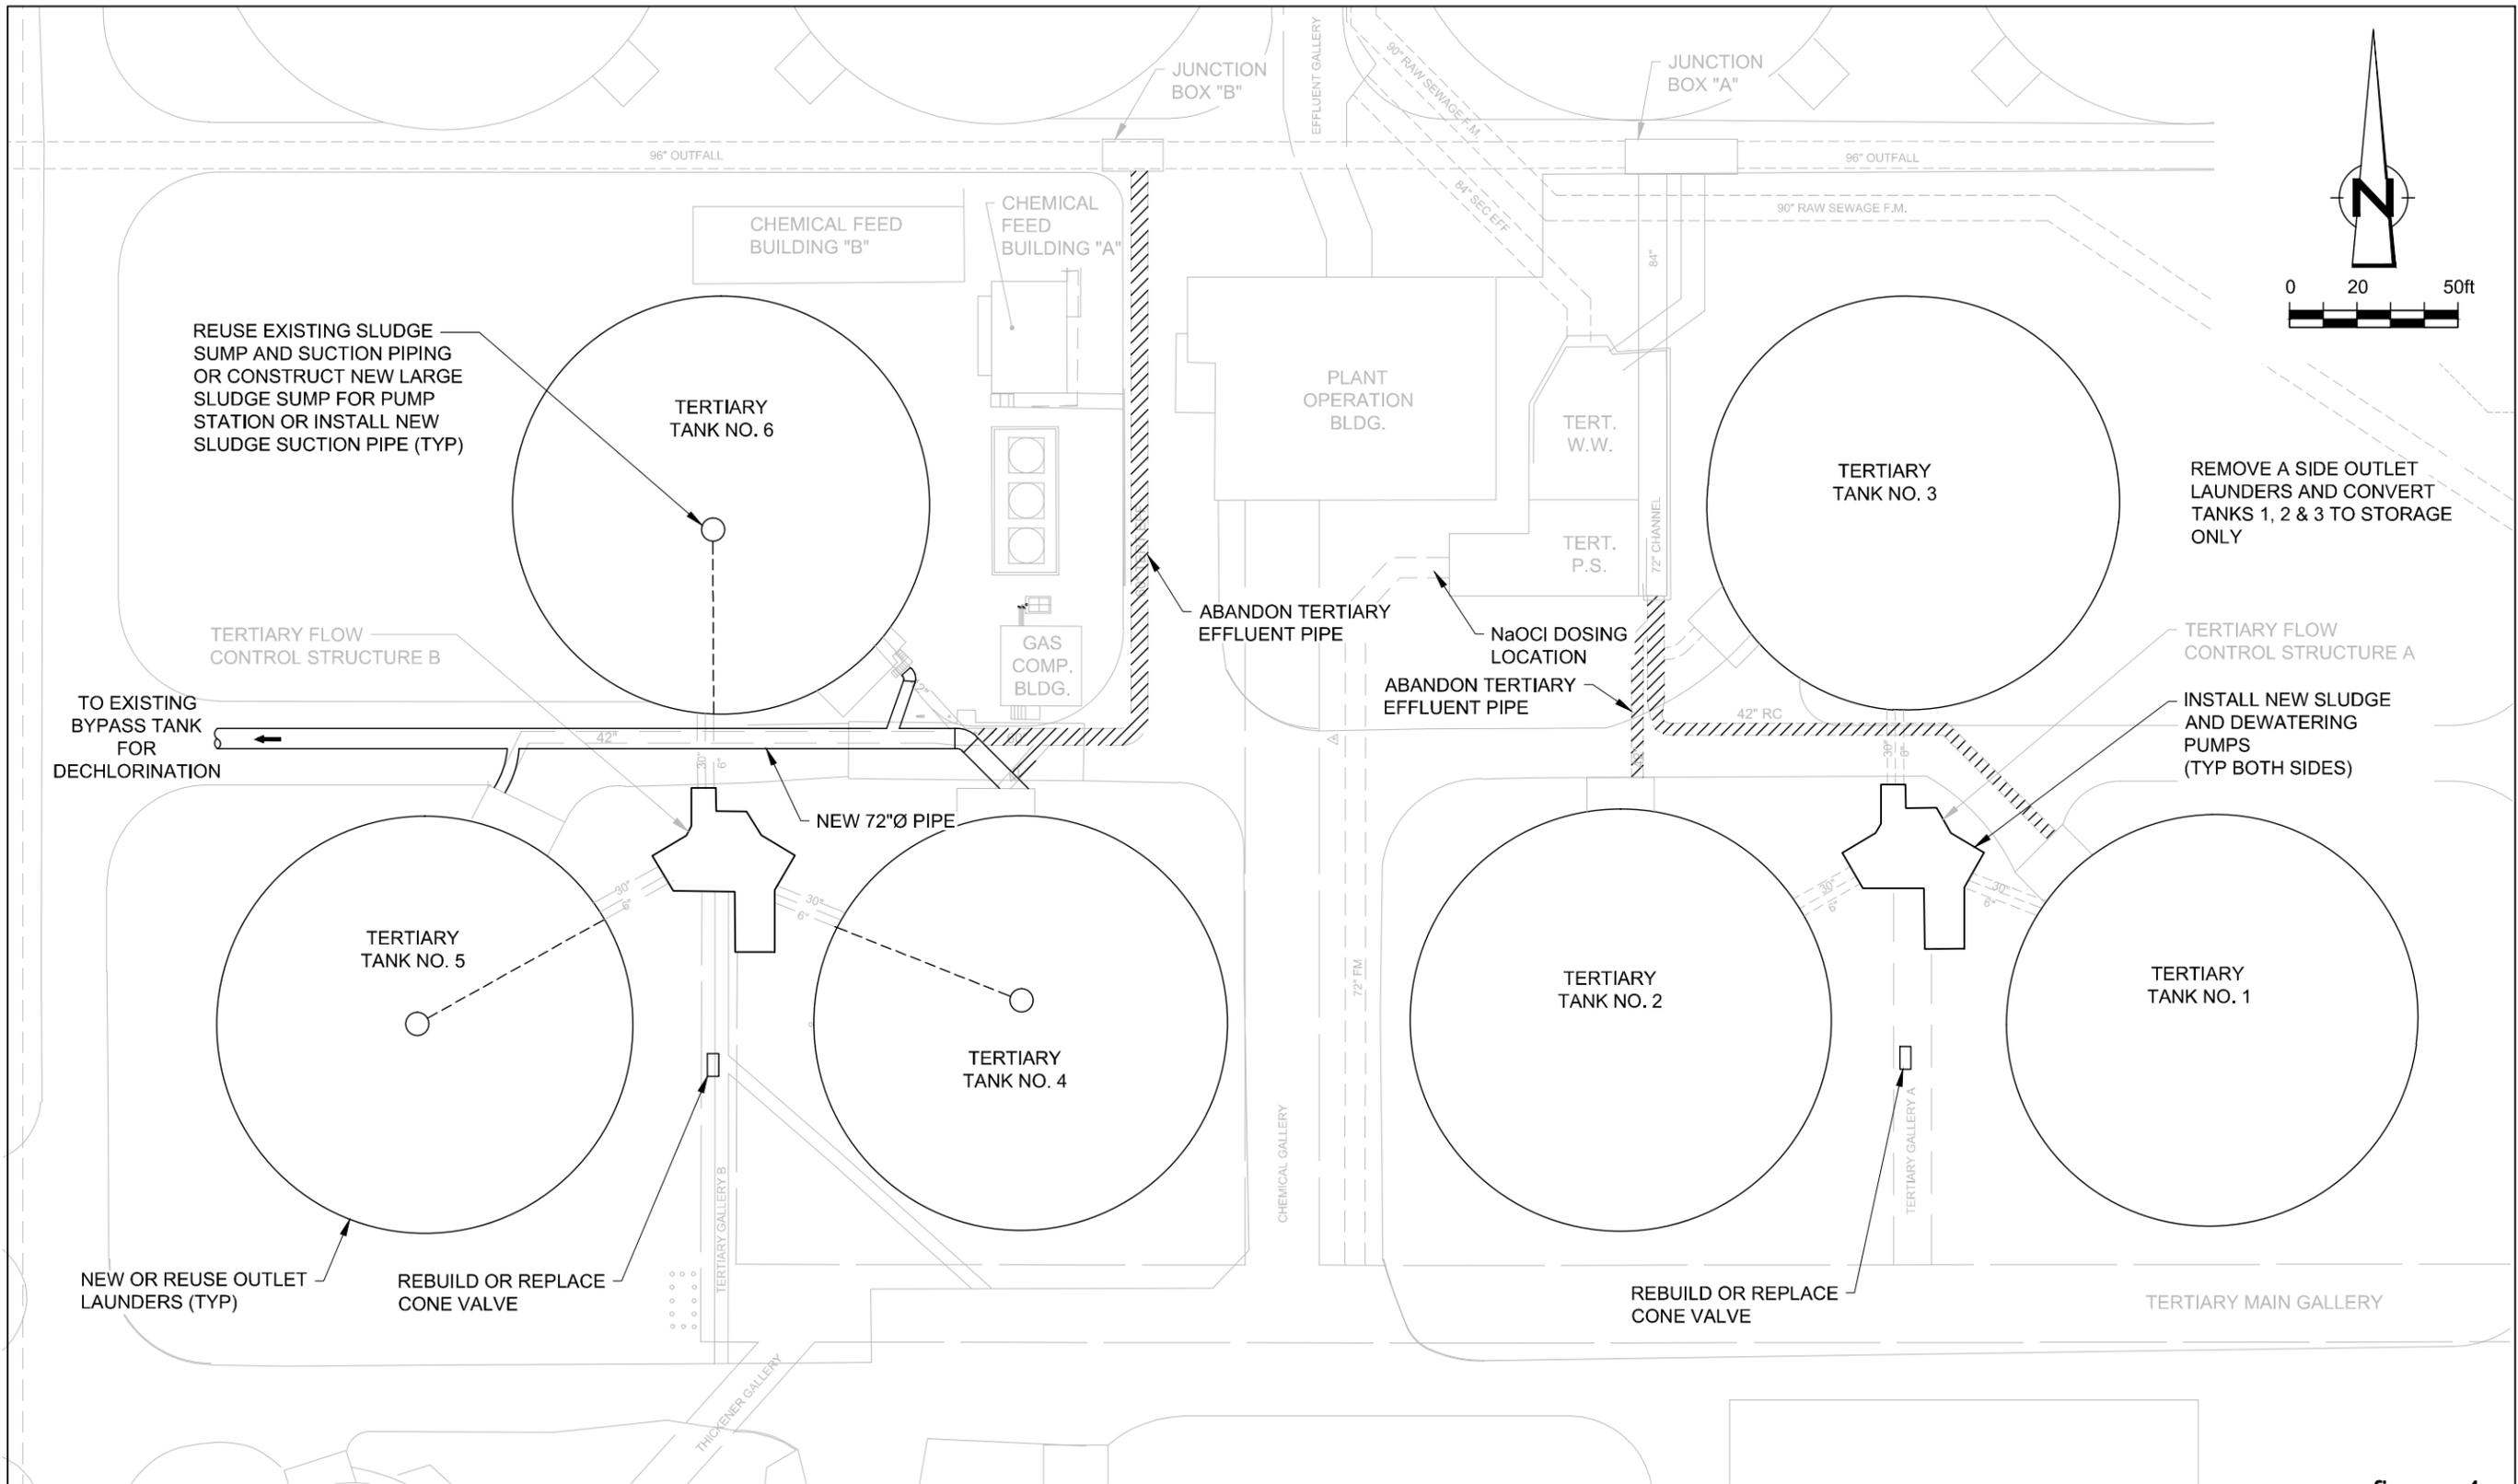
figure 4

The A tanks, once cleaned and refurbished, would provide approximately 3 MG of storage volume for bypass flow. Reuse of these tanks would require refurbishment or replacement of an existing control valve within the main pipe gallery to close off flow to the A side once the tanks are filled to capacity, at which time the B side would begin to receive flow. The A side outlet launders would be removed and the effluent piping abandoned.

Another significant concern with Option 1 involves the elevation of the existing tertiary tank effluent weirs, as the weir for Tank No. 5 (tank that has settled most) is at an elevation lower than the existing BCCT discharge weir elevation. Assuming even a marginal headloss within the effluent piping, the existing BCCT discharge weir elevation would need to be lowered to overcome the headloss. This could compromise the WWTP's protection from maximum lake level conditions.

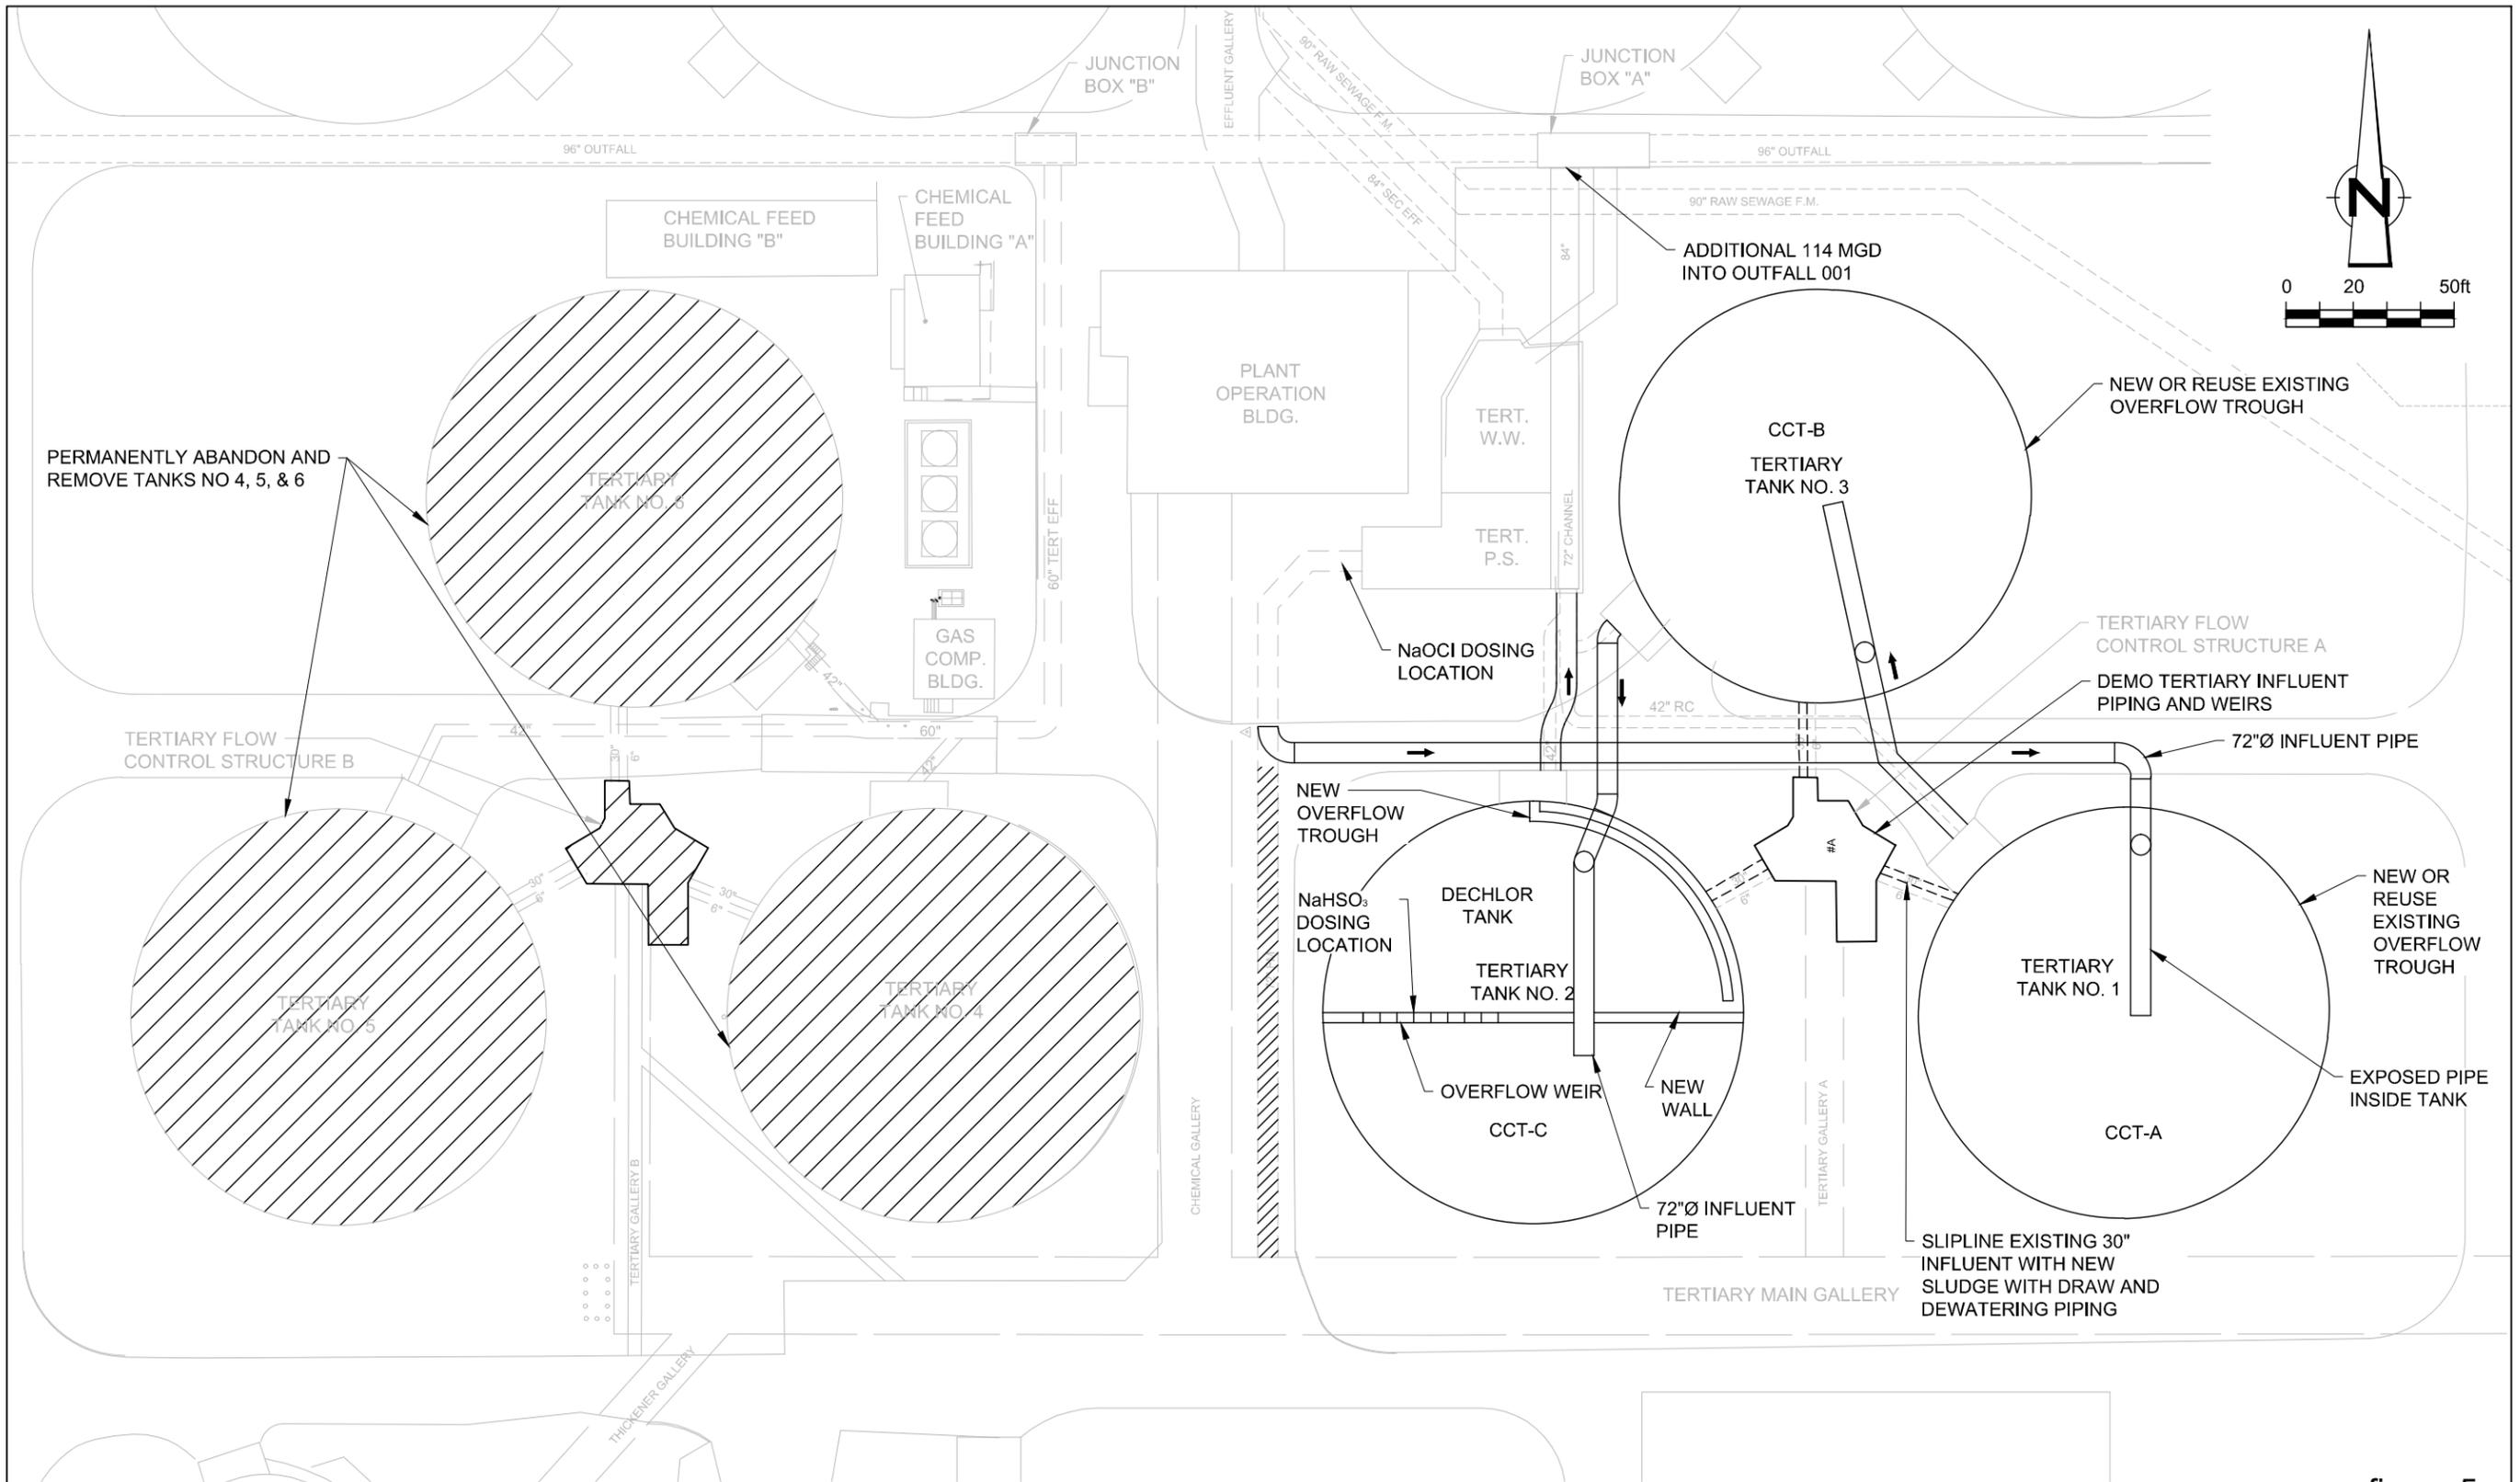
figure 5  
**TERTIARY TANK REUSE OPTION 2 - THREE TANKS IN SERIES**  
**METRO WWTB BYPASS DISINFECTION EVALUATION**  
*Onondaga County WEP*

A permanent cleaning system similar to Option 1 would be required in each of the three tanks. Sludge suction piping would need to be evaluated before reuse as there is a concern of pipe age and that tank settling may have damaged the pipe.

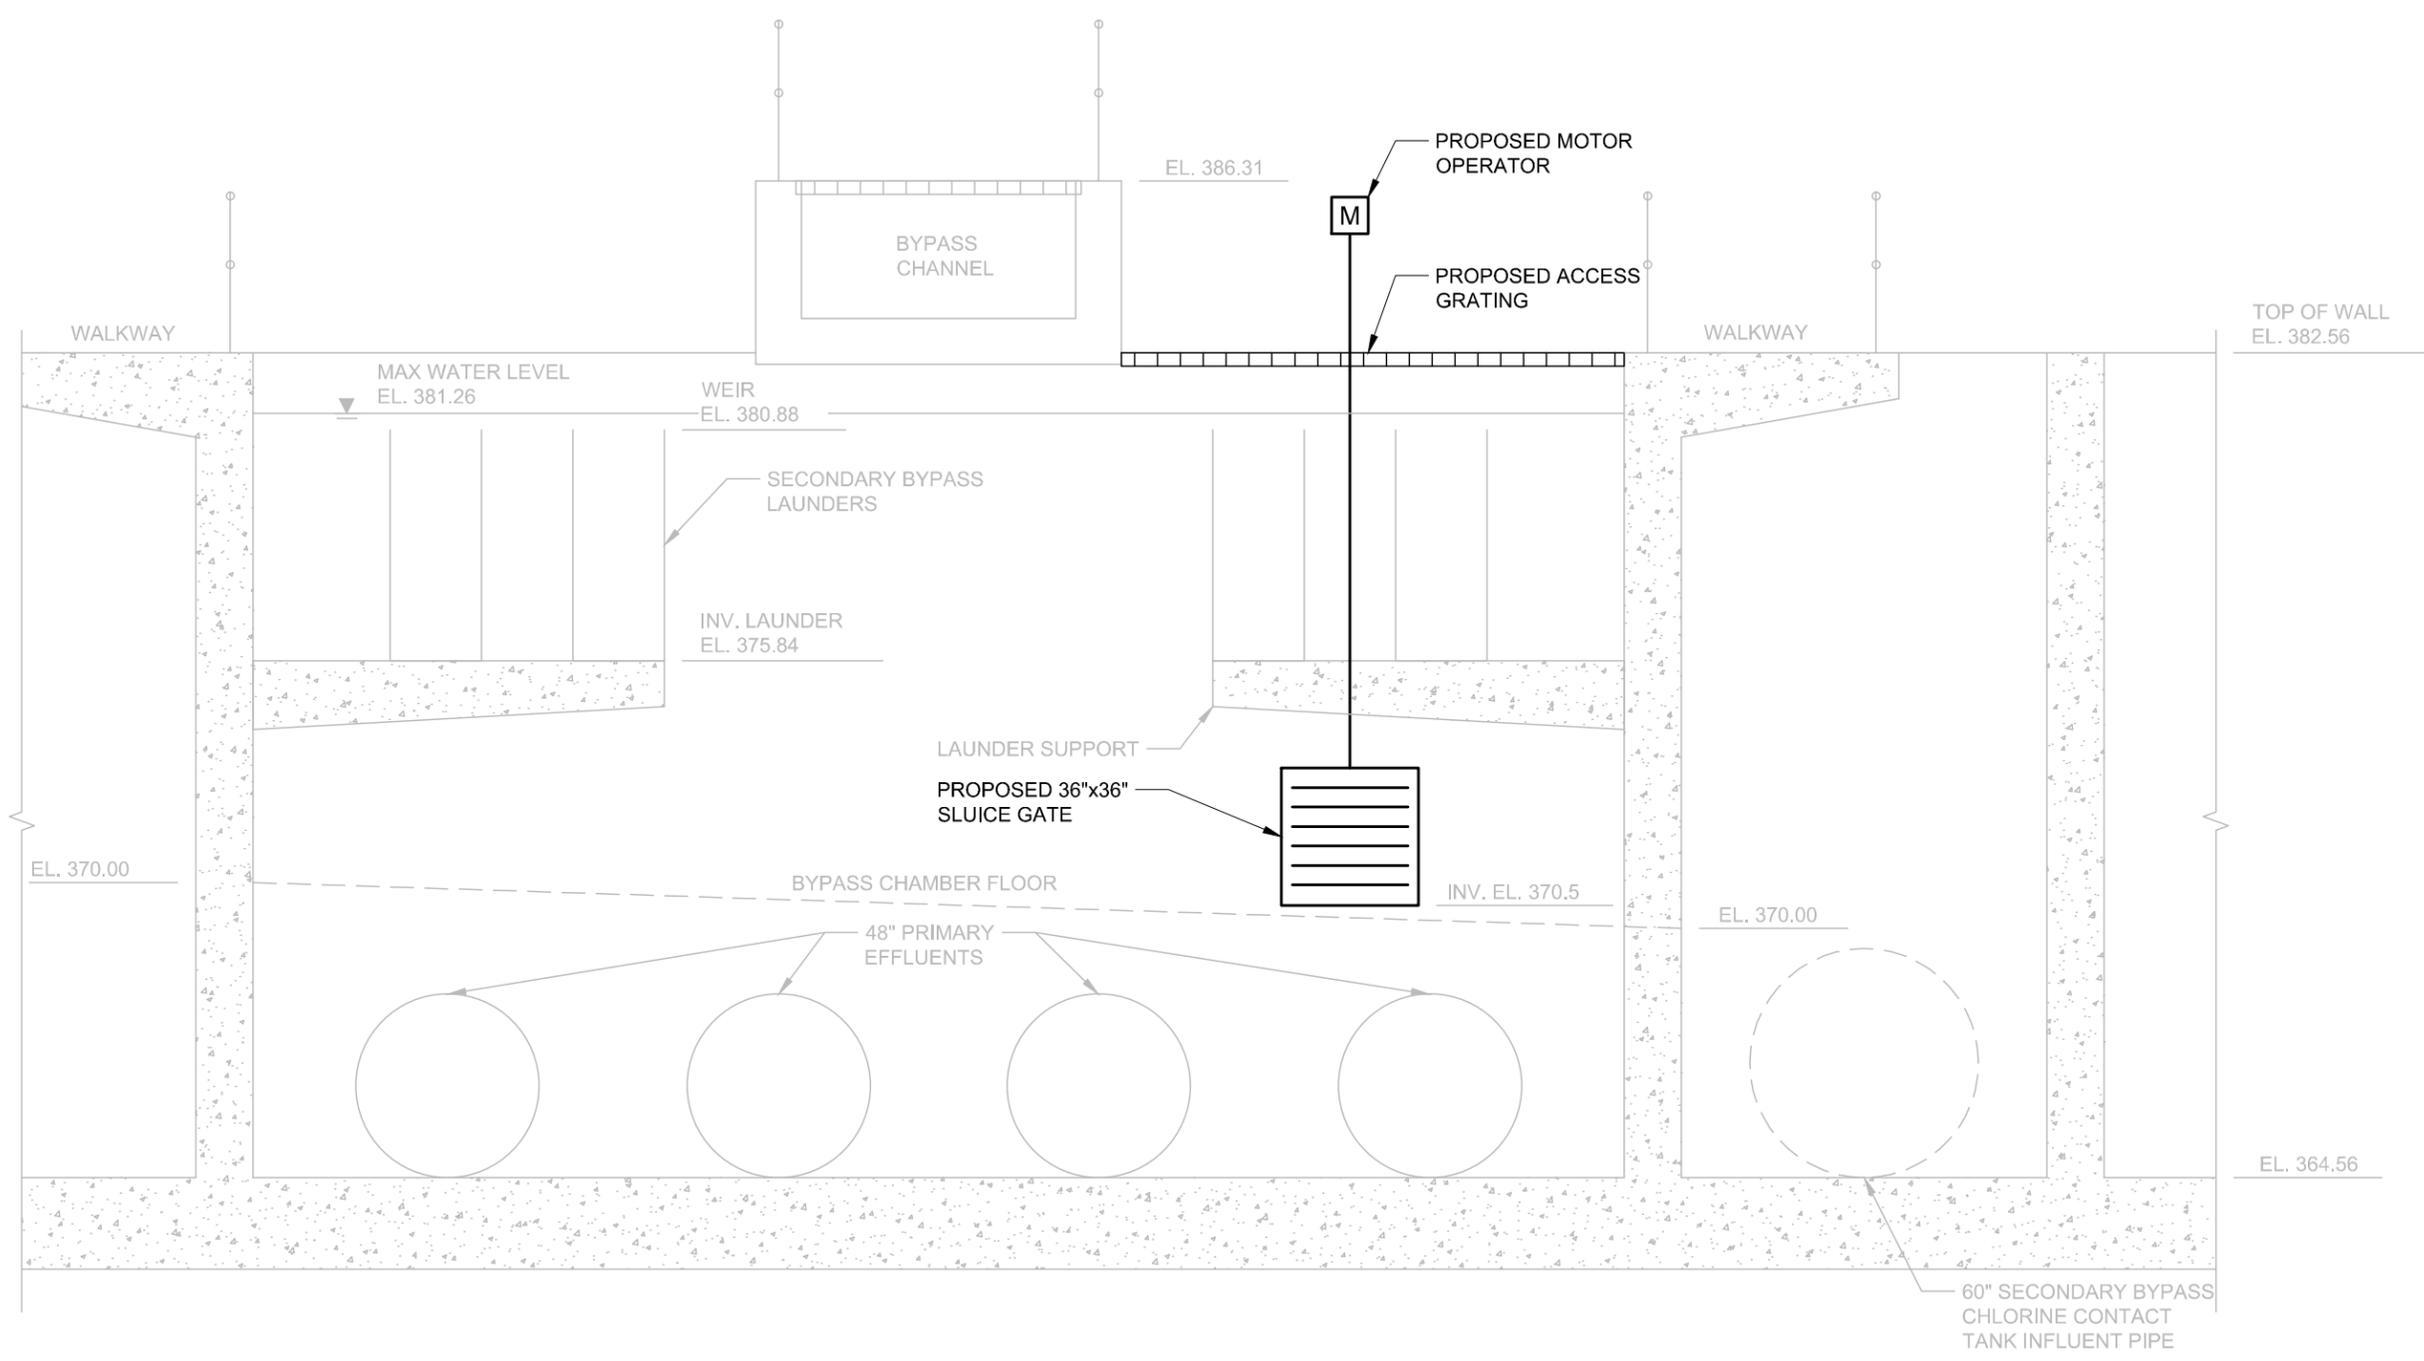
SECTION LOOKING SOUTH AT  
SECONDARY BYPASS LAUNDERS

NOTE:  
SLUICE GATE INSTALLED ON SOUTH SIDE OF  
BYPASS CHAMBER WALL.

Modifying the secondary bypass weirs such that unplanned tertiary bypasses no longer occur is the preferred method of mitigating the need for a new tertiary bypass disinfection system. The addition of a sluice gate at each of the secondary bypass locations could be used to reduce the hydraulic grade within the tertiary pump station wet well by diverting flow to the bypass tank during times of reduced tertiary hydraulic capacity, thereby eliminating tertiary bypasses. A 36-inch by 36-inch gate would have the capacity to divert about 50 mgd (per train) during peak hydraulic grade conditions with the new bypass tank. Figure 6 shows how the gates would be installed within the secondary bypass overflow chamber at the aeration tanks. The gates would be normally closed and opened incrementally in relation to the desired water level in the tertiary pump station wet well.

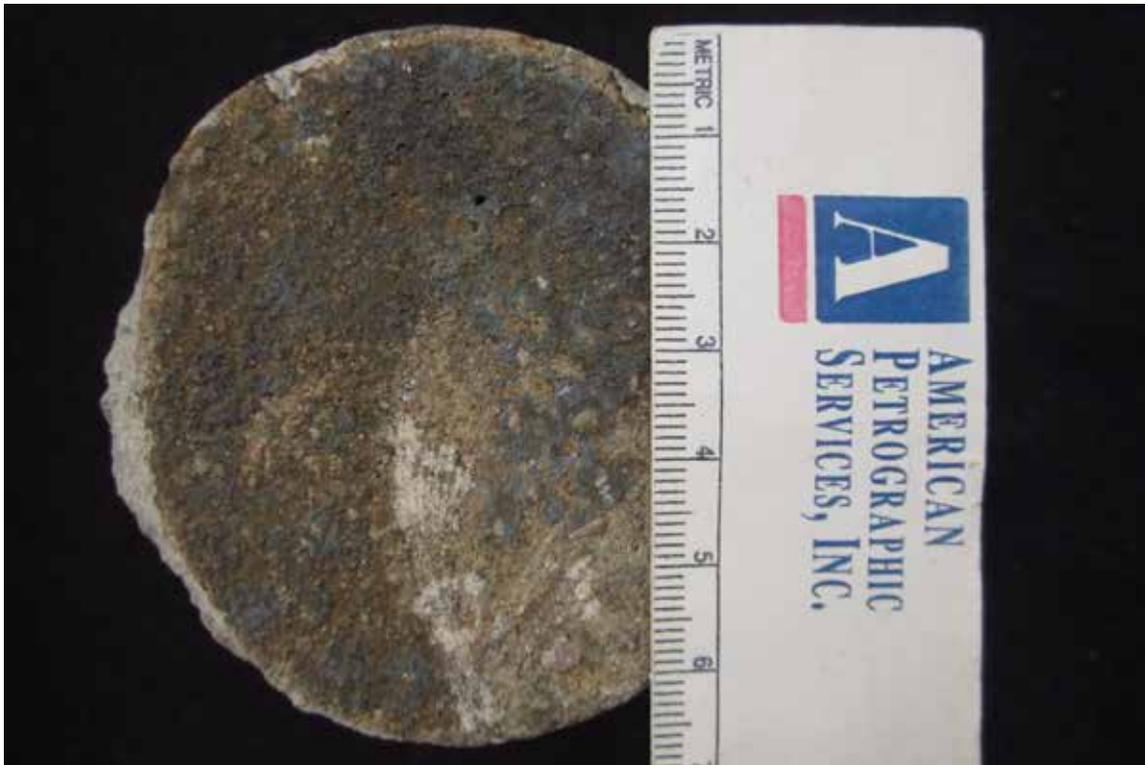
2. **Surface Conditions:**  
Outer: Fairly rough, chemical attacked? medium light brown stained surface  
Inner: Rough, irregular, fractured surface
3. **Reinforcement:** None observed

SAMPLE ID: 5 DESCRIPTION: Overall view of the outer surface of the sample.

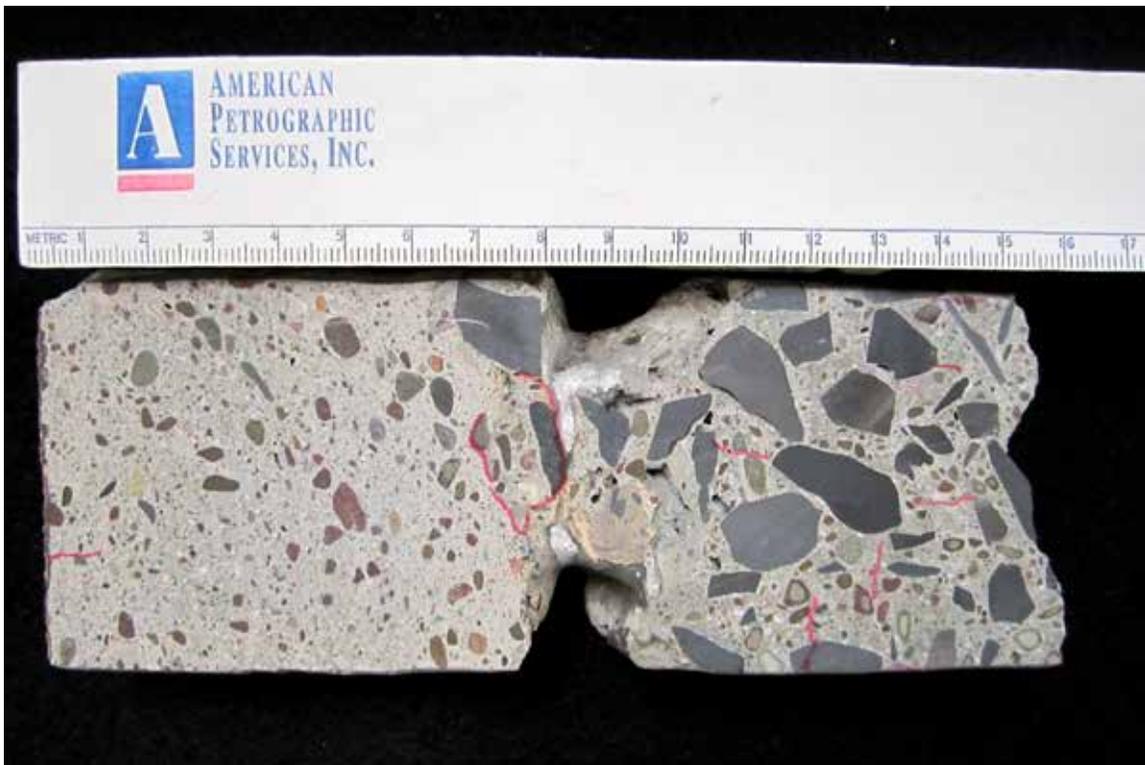
SAMPLE ID: 5 DESCRIPTION: Overall view of a cut and polished cross section of the sample. The outer concrete is on the left side and inner concrete is on the right side of the photo. Microcracking was mapped in red ink.

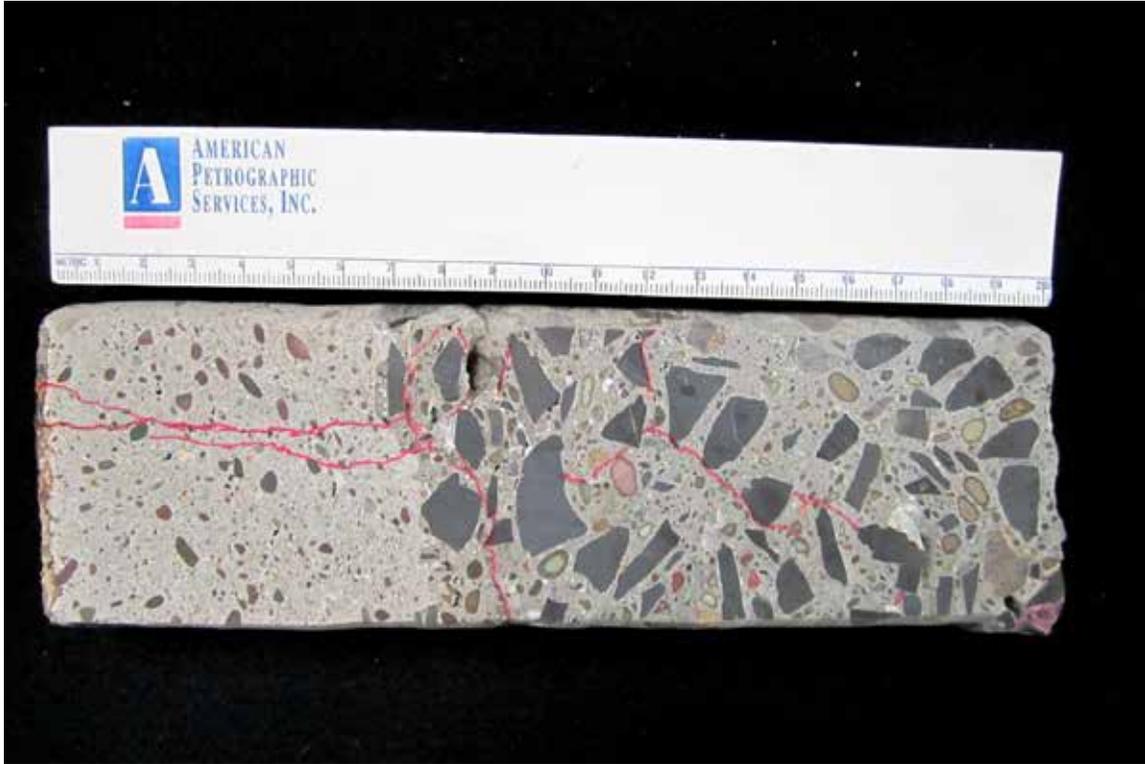
**SAMPLE ID:** 6      **DESCRIPTION:** Overall view of a cut and polished cross section of the sample. The outer concrete is on the left side and inner concrete is on the right side of the photo. Microcracking was mapped in red ink.

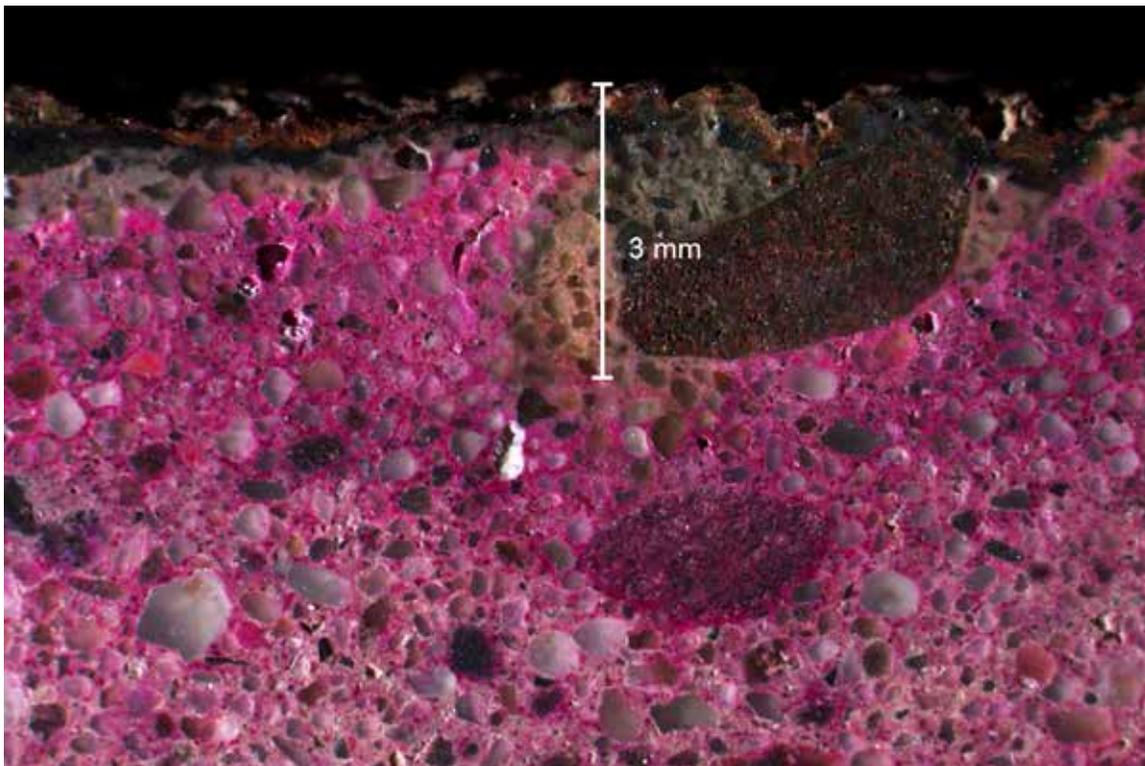
**SAMPLE ID:** 5      **DESCRIPTION:** Carbonation (unstained) proceeds from the outer surface of the outer  
**MAG:** 15x      concrete up to 3 mm (1/8") depth.

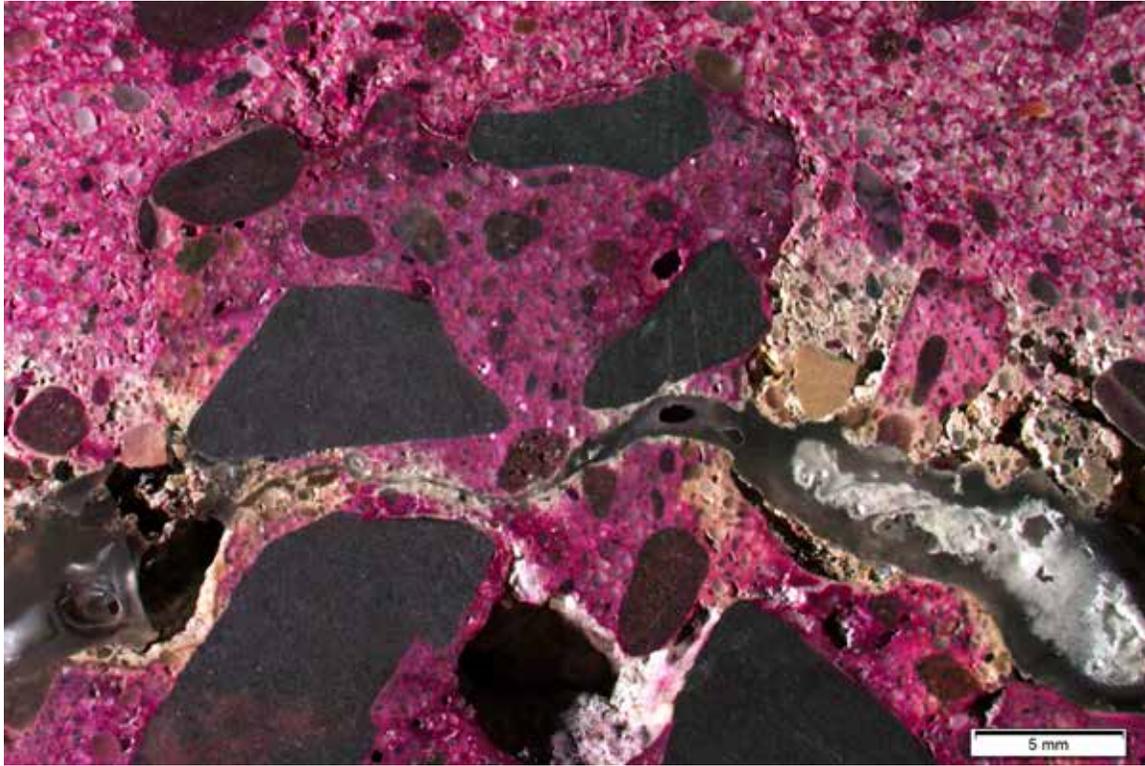
SAMPLE ID: 5      DESCRIPTION: Carbonation (unstained) was observed intermittently along and proximate  
MAG: 5x      to the fracture within the inner concrete.

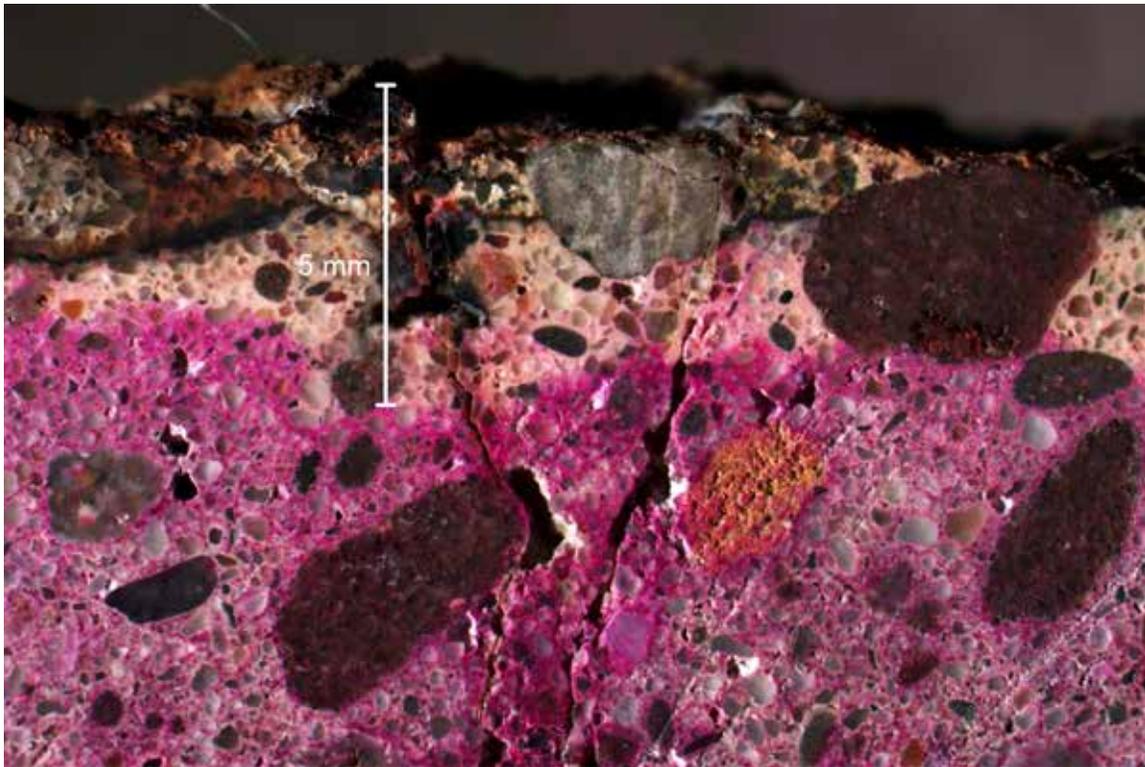
SAMPLE ID: 6      DESCRIPTION: Carbonation (unstained) proceeds from the outer surface of the outer  
MAG: 10x      concrete up to 5 mm (3/16") depth.

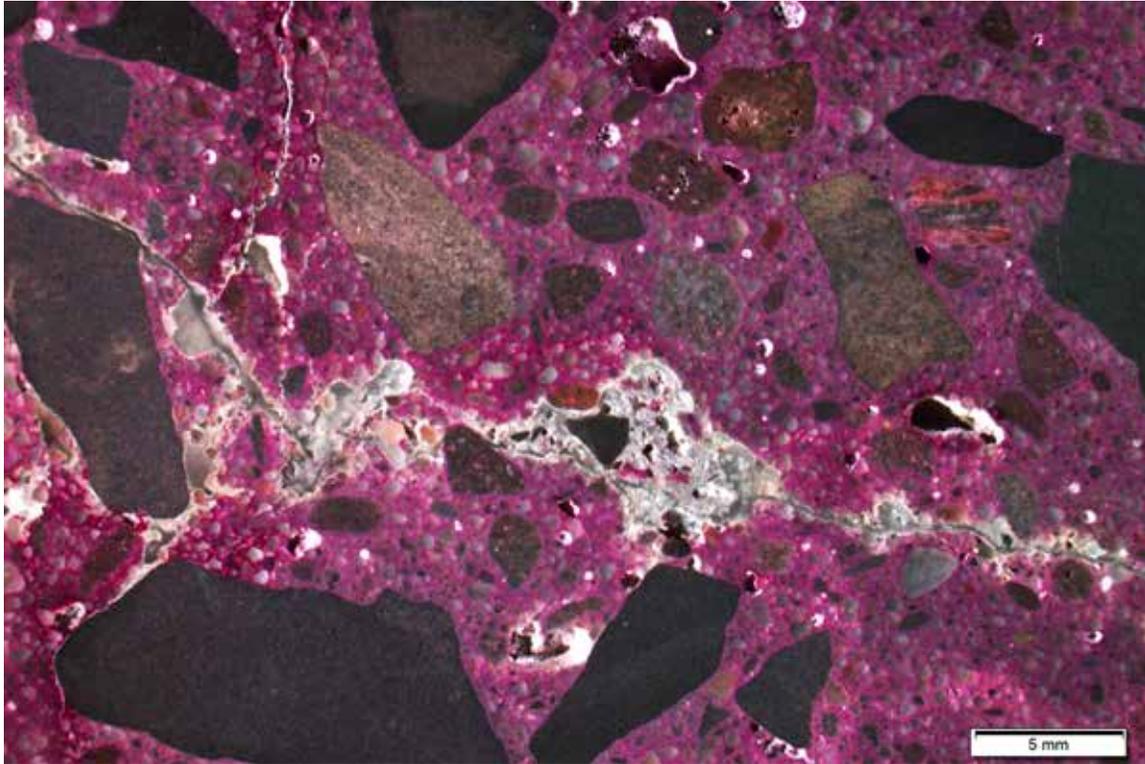
SAMPLE ID: 6 DESCRIPTION: Carbonation (unstained) was observed intermittently along and proximate  
MAG: 5x to the fracture within the inner concrete.

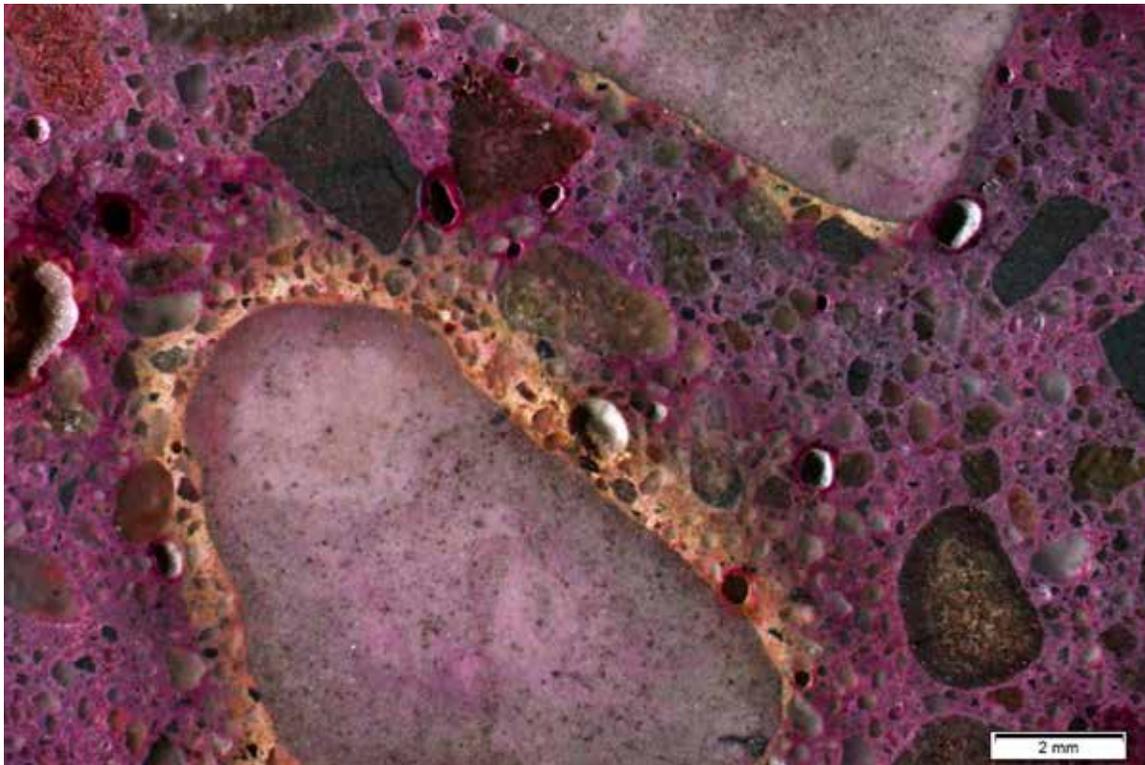
SAMPLE ID: 6 DESCRIPTION: Carbonation (unstained) was observed along the perimeter of few coarse  
MAG: 10x aggregate particles within the inner concrete in a cut and polished cross section of concrete core.
