**CONESTOGA-ROVERS  
& ASSOCIATES**

## TECHNICAL MEMORANDUM

RE: Metro WWTP - Compliance Alternatives for Outfall 002 and Tertiary Treatment Bypass

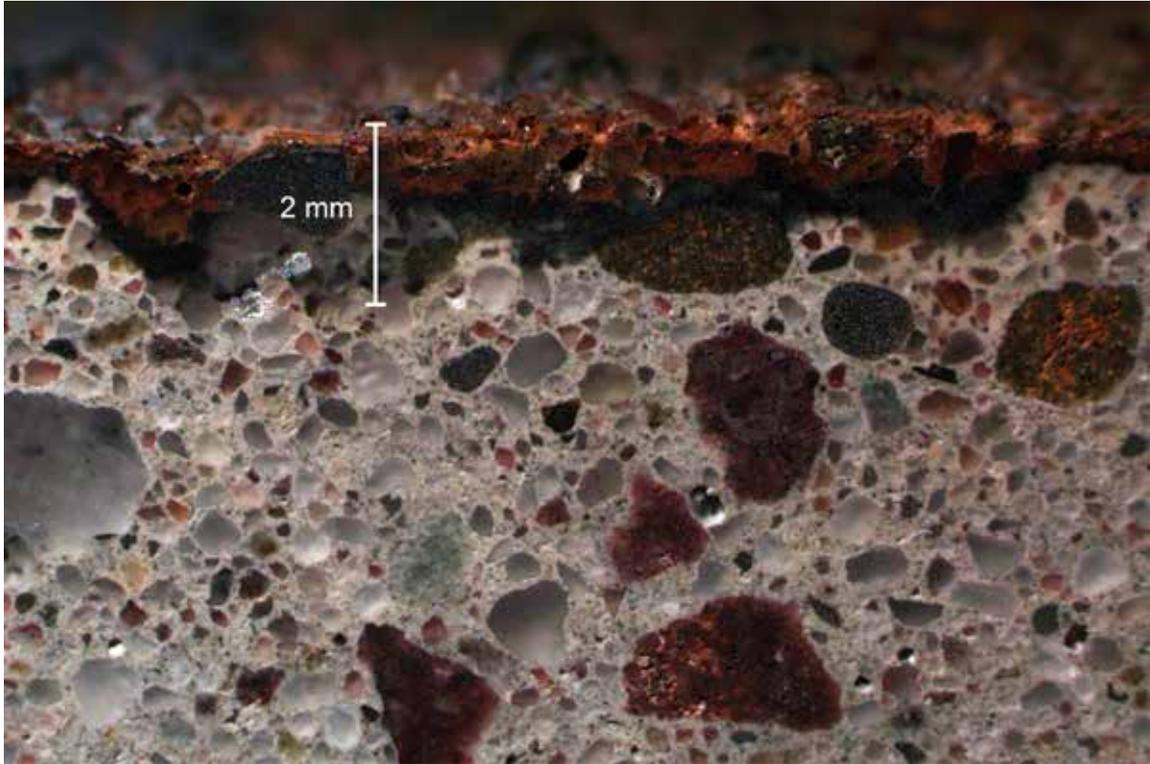
**SAMPLE ID:** 5      **DESCRIPTION:** Approximately 2 mm (1/16") of the outer surface of the outer concrete was stained medium dark gray and light brown due to a possible chemical attack in a cut and polished cross section of concrete core.  
**MAG:** 15x

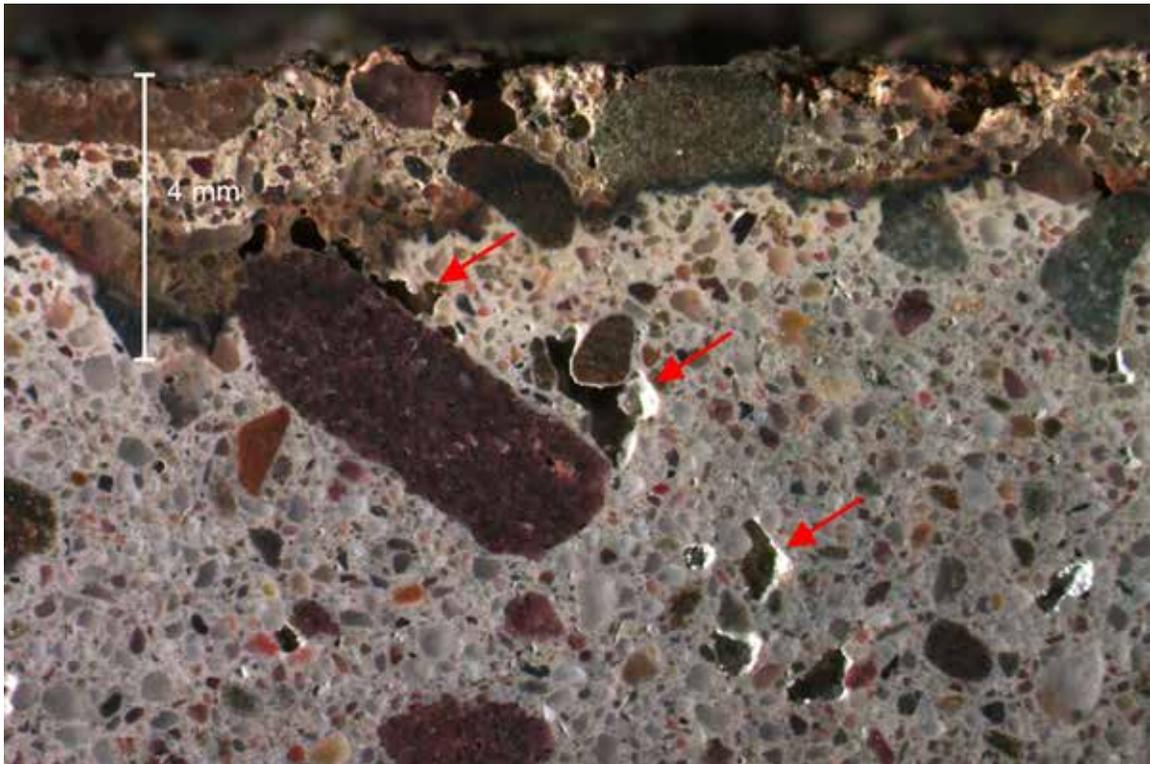
**SAMPLE ID:** 6      **DESCRIPTION:** Approximately 4 mm (5/32") of the outer surface of the outer concrete was stained medium dark gray and light brown due to a possible chemical attack. Few irregular shaped voids (red arrows) were observed in the cut and polished cross section of concrete core.  
**MAG:** 10x

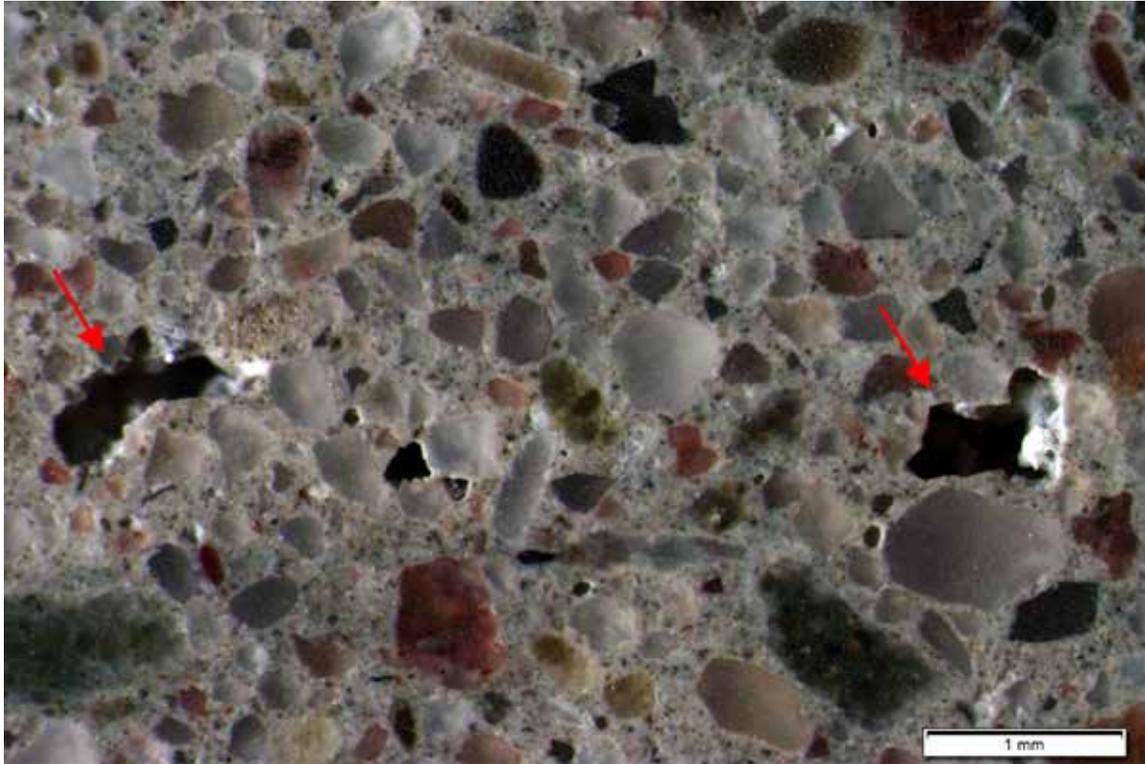
SAMPLE ID: 5 DESCRIPTION: Few irregular shaped voids (red arrows) were observed within the outer  
MAG: 30x concrete in a cut and polished cross section of concrete core.

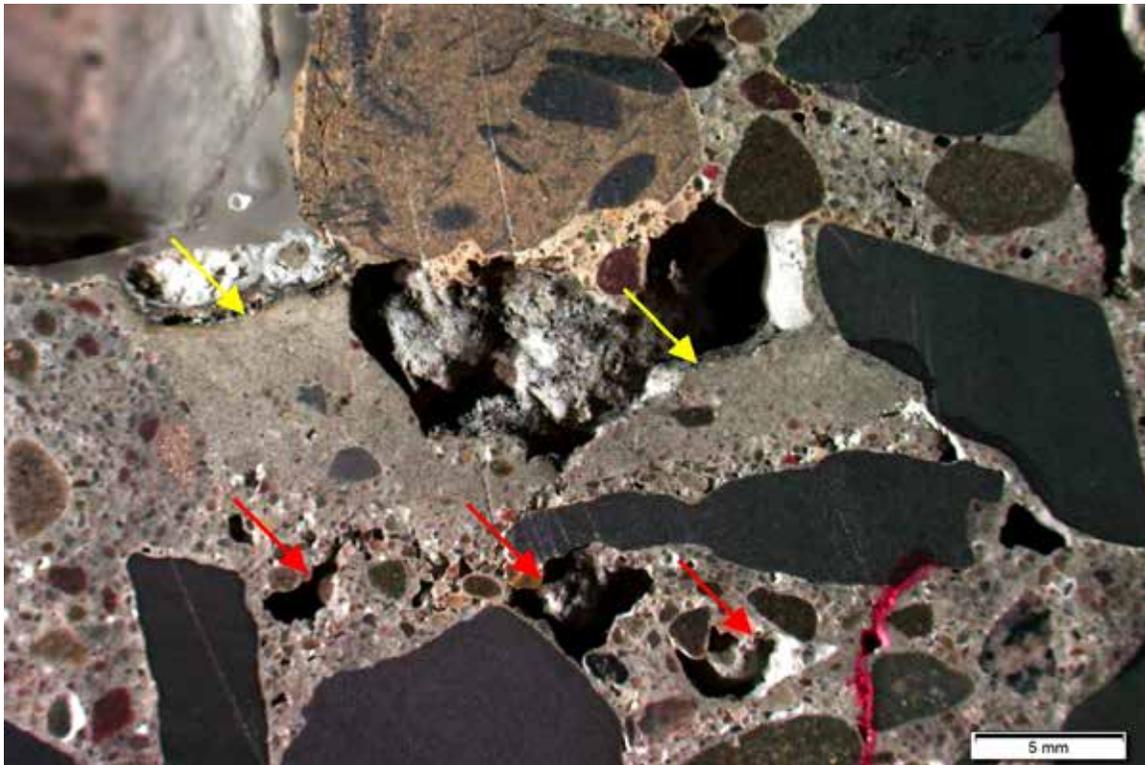
SAMPLE ID: 5 DESCRIPTION: Few irregular shaped voids (red arrows) were observed within the inner  
MAG: 5x concrete in a cut and polished cross section of concrete core. Note the poorly distributed sand  
(yellow) in the paste.

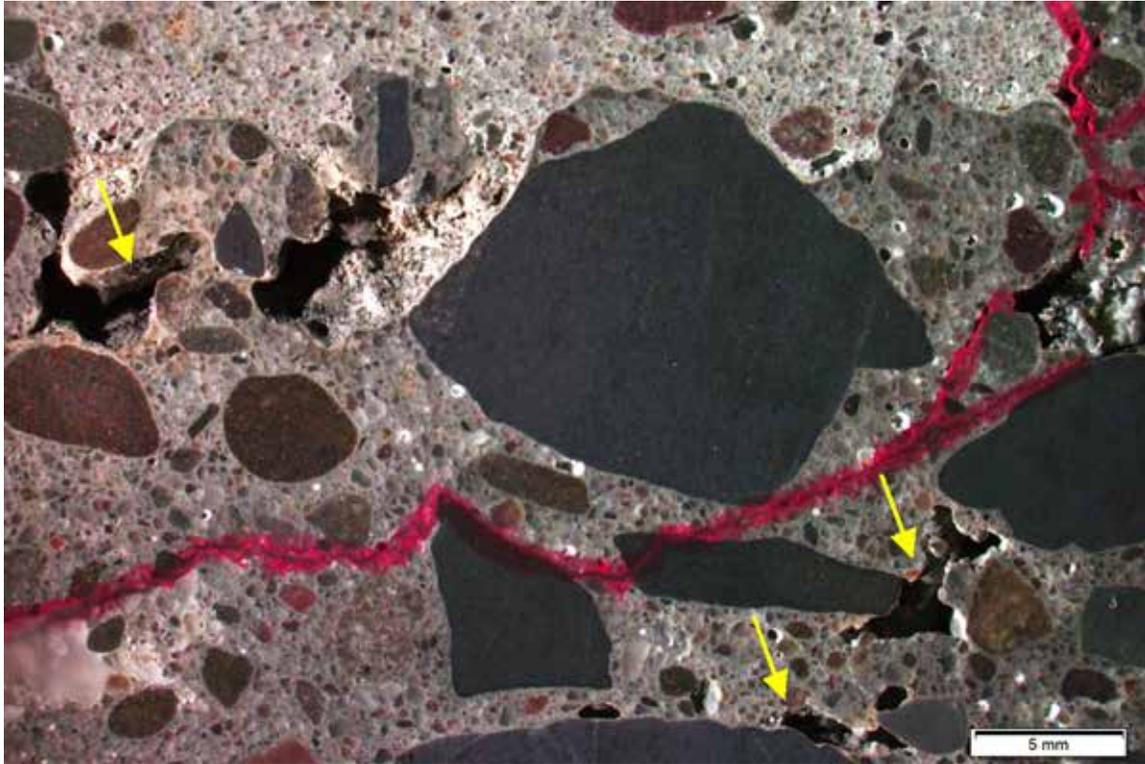
SAMPLE ID: 6 DESCRIPTION: Few irregular shaped voids (yellow arrows) were observed within the inner  
MAG: 5x concrete in a cut and polished cross section of concrete core.

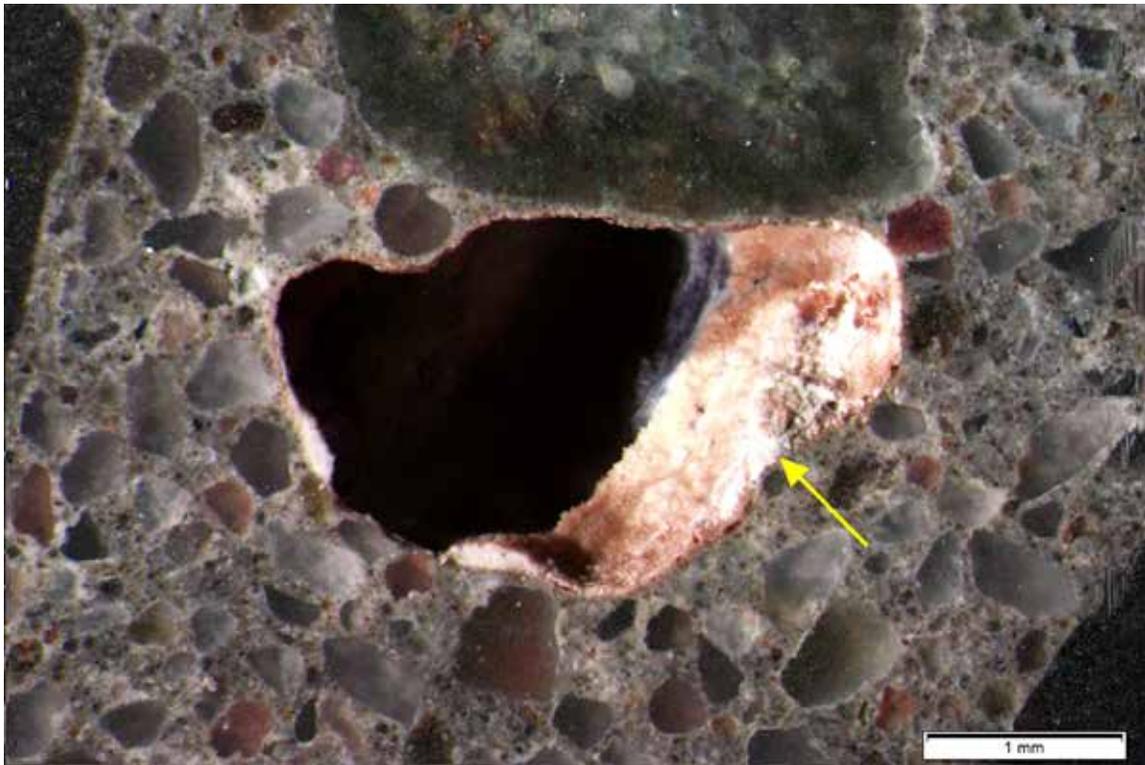
SAMPLE ID: 6 DESCRIPTION: White to dark yellowish orange calcite (yellow arrow) was observed lining  
MAG: 30x an entrapped sized void in the inner concrete in a cut and polished cross section of concrete core.

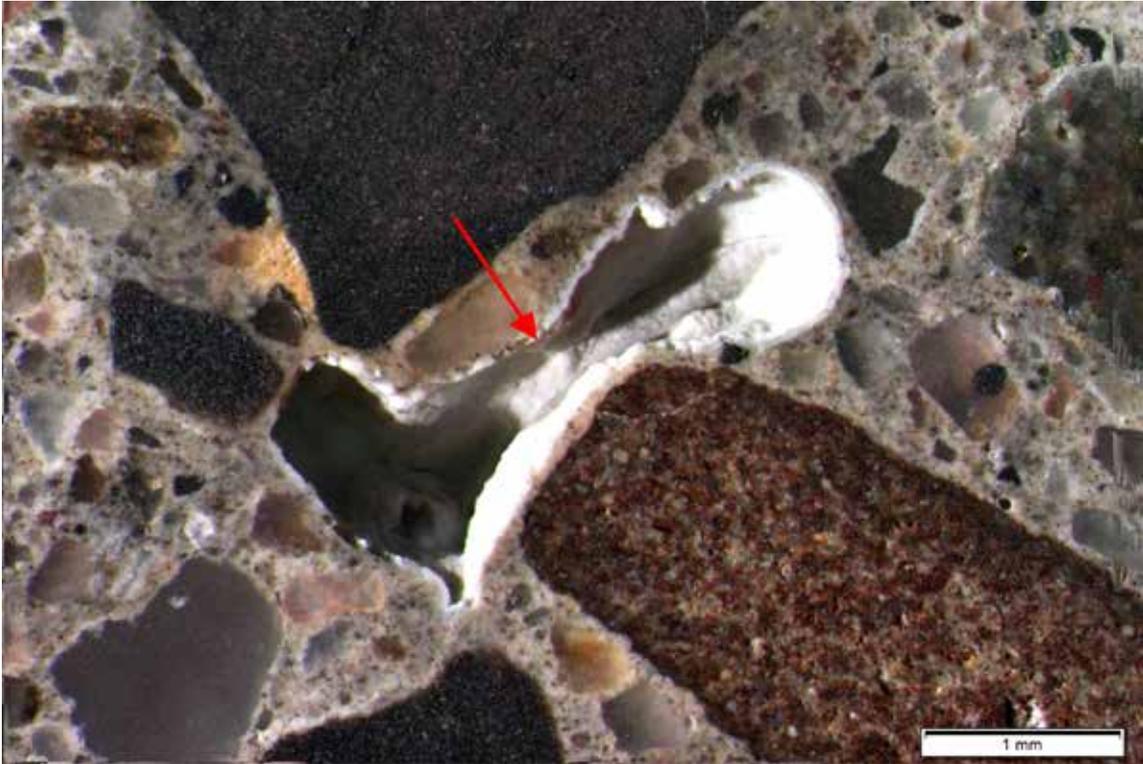
**SAMPLE ID:** 6      **DESCRIPTION:** White alkali silica gel (red arrow) was observed lining a void space in a cut  
**MAG:** 30x      and polished cross section of concrete core.

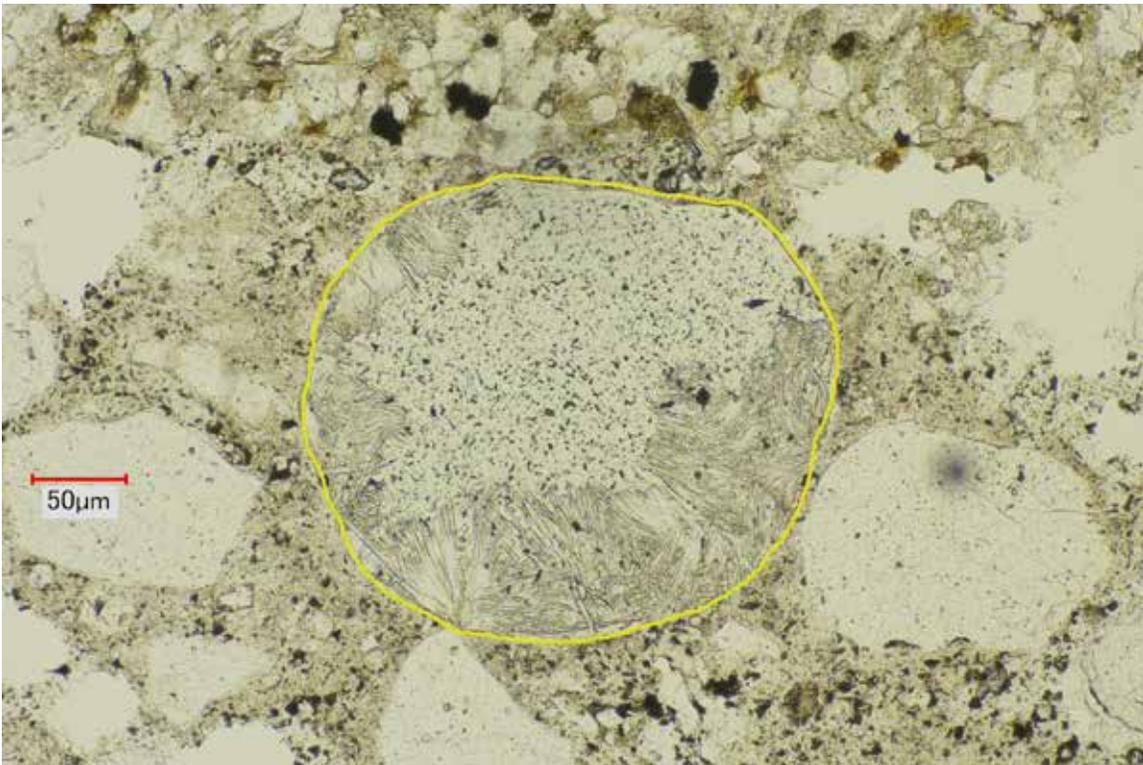
**SAMPLE ID:** 5      **DESCRIPTION:** Acicular ettringite partially filling an air void (yellow outline) in thin  
**MAG:** 200x      section of concrete under plane polarized light.

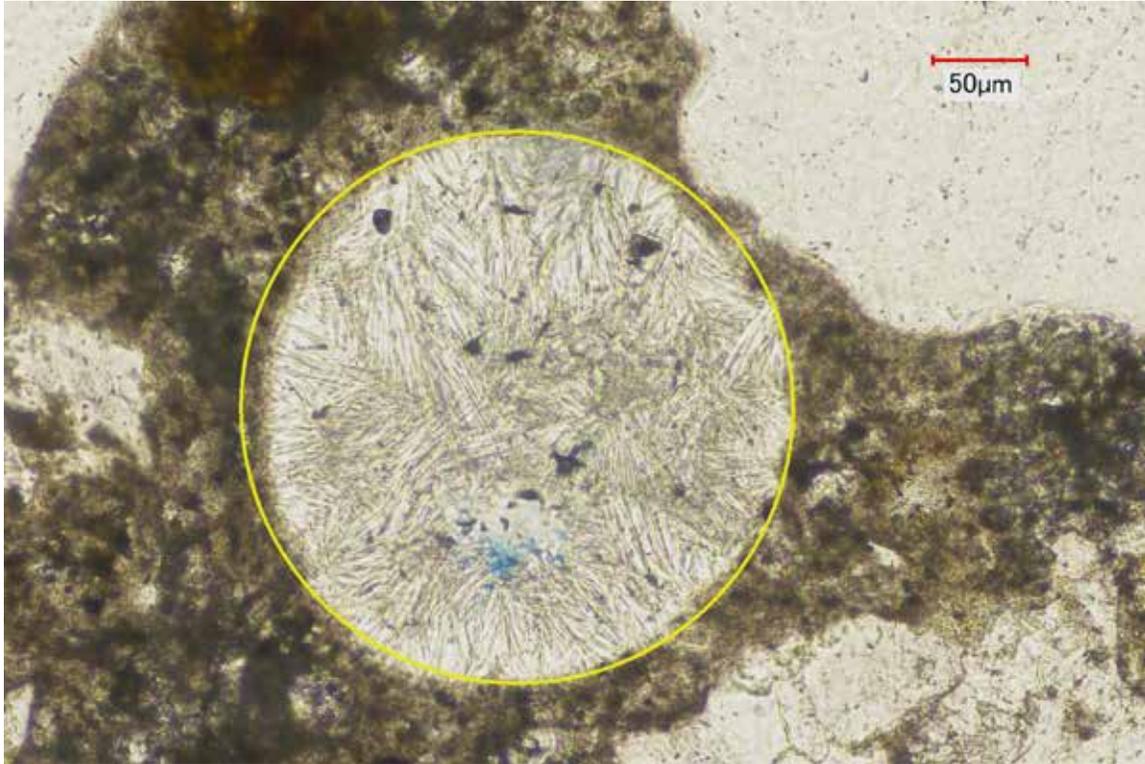
SAMPLE ID: 6 DESCRIPTION: Acicular ettringite filling an air void (yellow circle) in thin section of  
MAG: 200x concrete under plane polarized light.
