Onondaga County Department of
Water Environment Protection
Syracuse Metropolitan WWTP Digester
Cleaning and Miscellaneous Repairs Project
Technical Report

TECHNICAL REPORT
SYRACUSE METROPOLITAN WWTP DIGESTER CLEANING
AND MISCELLANEOUS REPAIRS PROJECT

GHD CONSULTING ENGINEERS, LLC
One Remington Park Drive
Cazenovia, NY 13035

Project No. 8614054

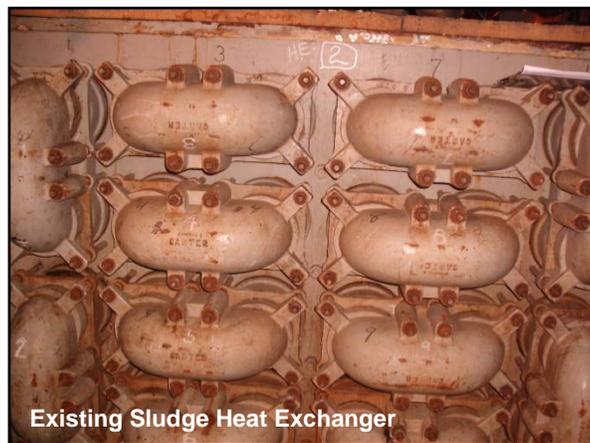
Existing Sludge Heat Exchanger

There are three “tube and shell-type” sludge heat exchangers in the basement manufactured by the Ralph B. Carter Co. The design heating capacity is 1 million BTU/hour, the design sludge flow is 700 gpm at a pressure of 30 psig, and the design heated water flow is 300 gpm. The heat exchangers have been in service in excess of 35 years and are obsolete because the manufacturer is no longer in business and replacement parts are not readily available. The work order history reviewed on the CMMS documents that these heat exchangers experience approximately two corrective maintenance issues per year. Due to the age of the equipment and unavailability of parts, it is recommended that the three sludge heat exchangers be replaced as part of Phase 2.

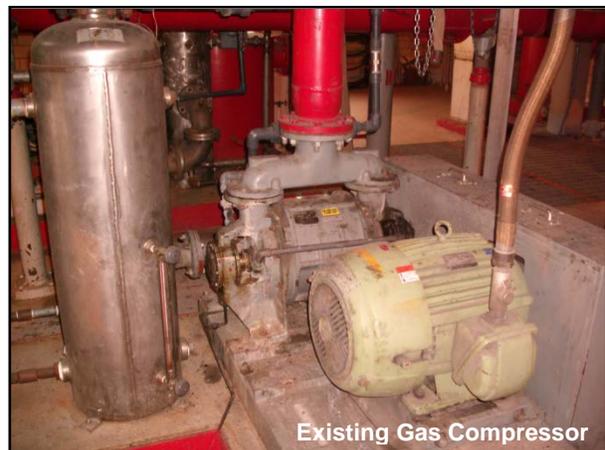
Existing Gas Compressor

There are five gas compressors (three active, two spare) on the first floor. They are liquid ring pumps, manufactured by Nash Engineering Co. and are approximately 17 years old. The compressor capacity is 370 SCFM at 14.2 psig. The 40 HP motors are manufactured by Emerson Electric. The compressors compress the digester gas before feeding it to the bubble generators on the gas mixing guns. The work order history on CMMS documents that these compressors experience an average of five

to six corrective maintenance issues per year, the majority of which involve seal water ball valve cleaning, water leaking, repacking, difficult valve operation, seal water system issues, and belt replacements. It was observed that the compressors appear to be operating at less than their design flow and experienced difficulty providing enough pressure to purge water out of the gas

lines after flushing them with water. Due to this, the maintenance issues, and the fact that the compressors are nearing the end of their useful life, it is recommended these units be replaced as soon as possible, before Phase 2.

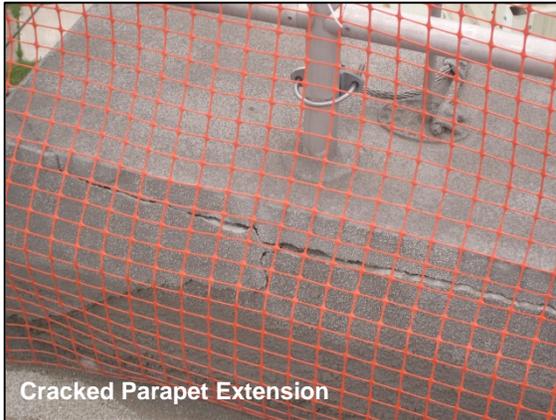
Cracked Parapet Extension

The exposed pilasters appears to have a stucco finish which needs to be repaired in several different areas. There is a significant horizontal crack near the top of every pilaster below the parapet extensions, with the exception of Digester 3, which does not have parapet extensions. Some of the parapet extensions are spalled where the guardrail posts are embedded. In these areas, the concrete has broken away from the face of the concrete wall, leaving inadequate support for the guardrail. In these areas, we recommended that the embedded posts be replaced with surface mounts and the spalls repaired during Phase 1 of the project. This work was not completed in Phase 1 but will be done so by the County in the near future. We recommended repairing the remaining cracks and spalls and recoating the pilasters in Phase 2. We recommended replacing the remaining embedded guardrail posts with surface mounts in Phase 2.

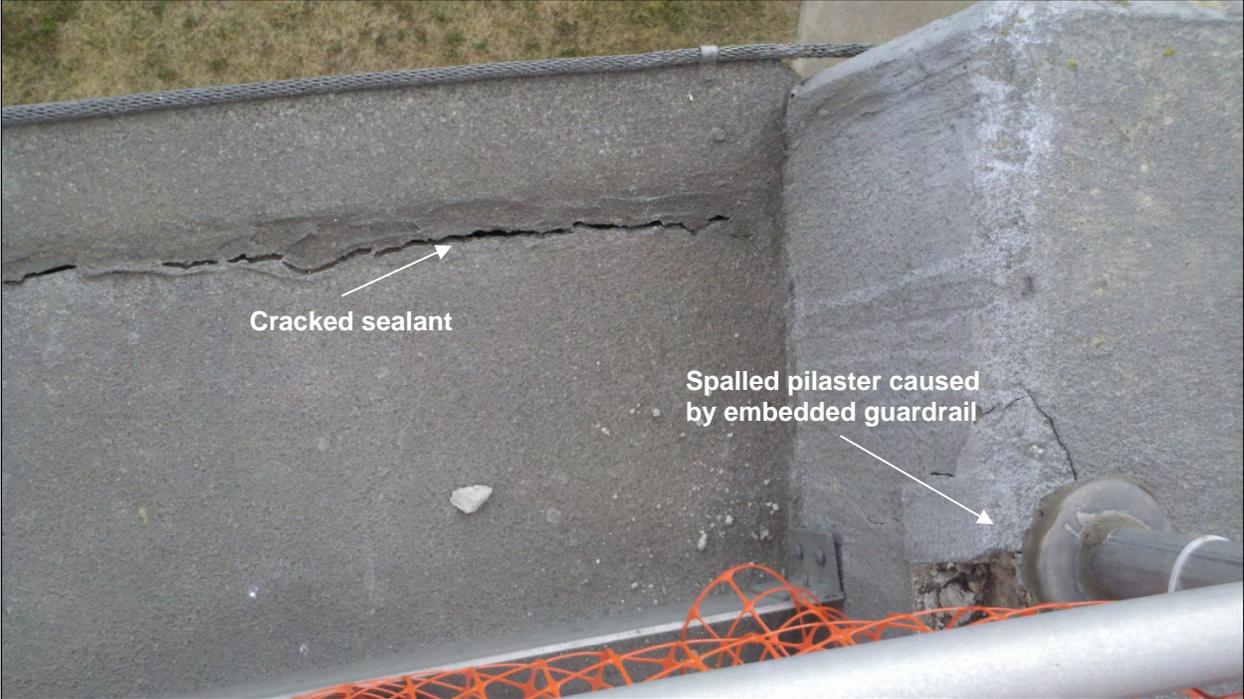
Photo 1: Top of Digester No. 1 exterior wall, looking down on parapet extension and sealant along metal siding flashing cap.

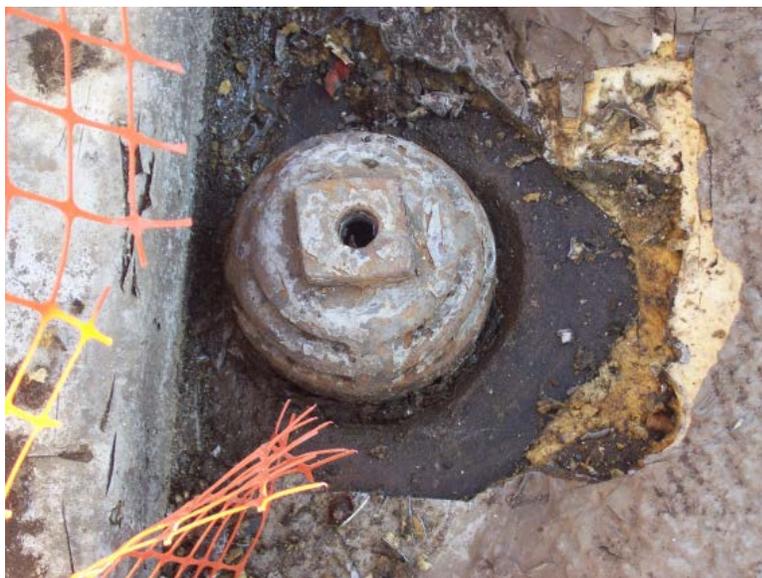
Roof Drain Strainer

There are three roof drains for each primary digester. The roof drains are 4-inch diameter cast iron pipe original to the digester. Much of the pipe was still coated with sludge residue making it difficult to observe its original condition. The pipe appears to be in poor condition. The pipe showed signs of pitting and corrosion. Also, one of the roof drains was observed to be leaking during a previous inspection. We inspected the roof drains again on May 6, 2011 to try and determine the point of leakage. We added water to the drain to examine for leaks. During the addition of water, it was evident that the mechanical link seal was leaking. However, there was no leakage observed around the sleeve or pipe joints. Below are photos of the roof drain from May 6, 2011.

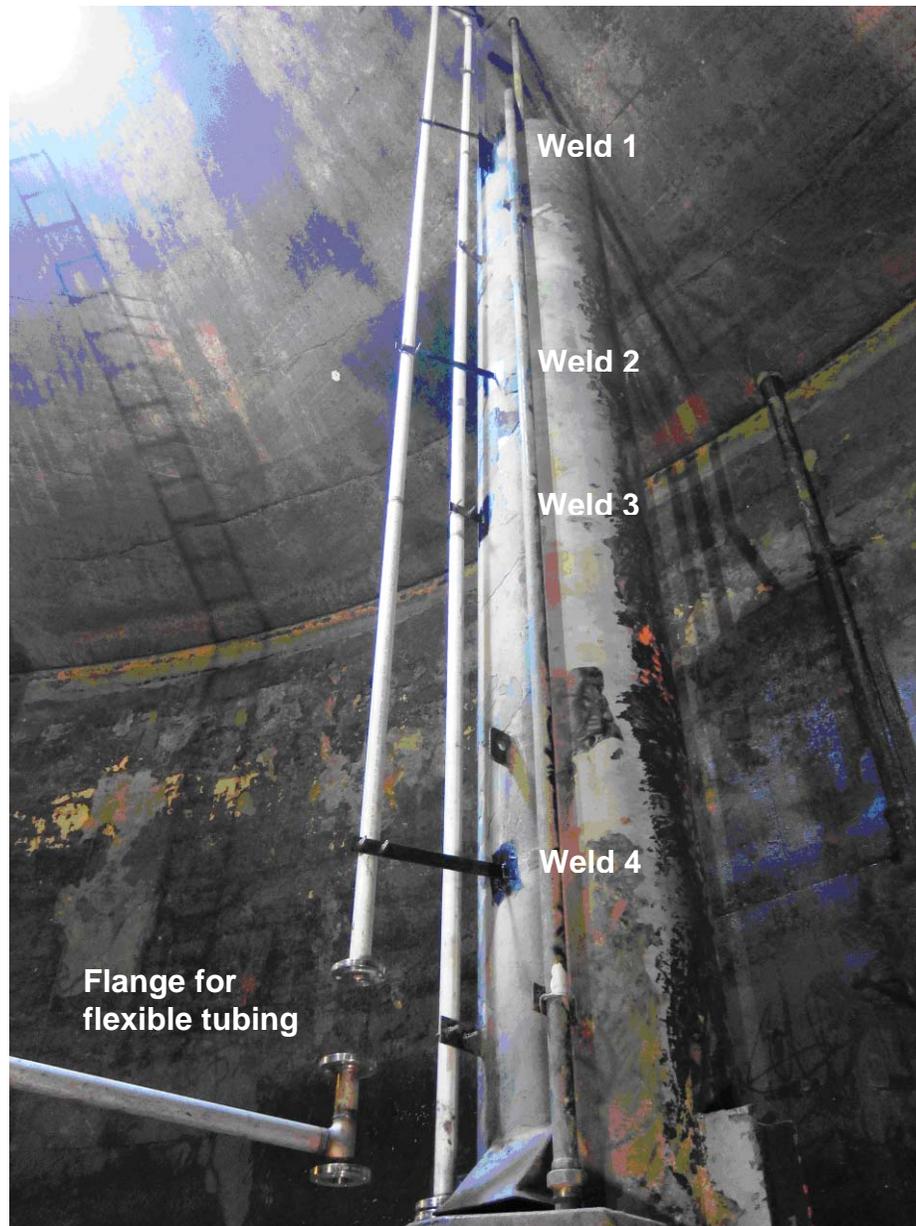
The above picture shows the newly welded Hartford Loop on the existing Cannon Mixer. The end of the Hartford loop includes a steel braided flexible tube connection, see picture below.

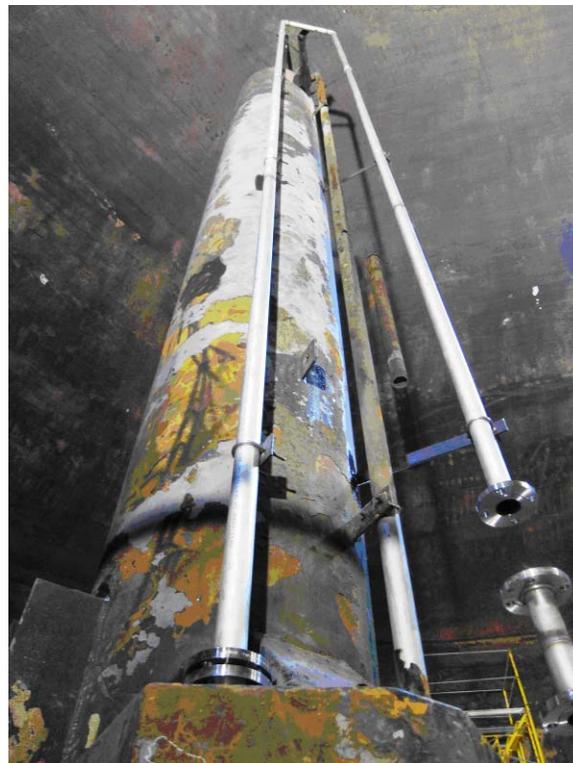
Although the surface of the mixer appears (see picture above) to have some rust, the discoloration due to oxidation was superficial and did not appear to pose any physical or structural issue.

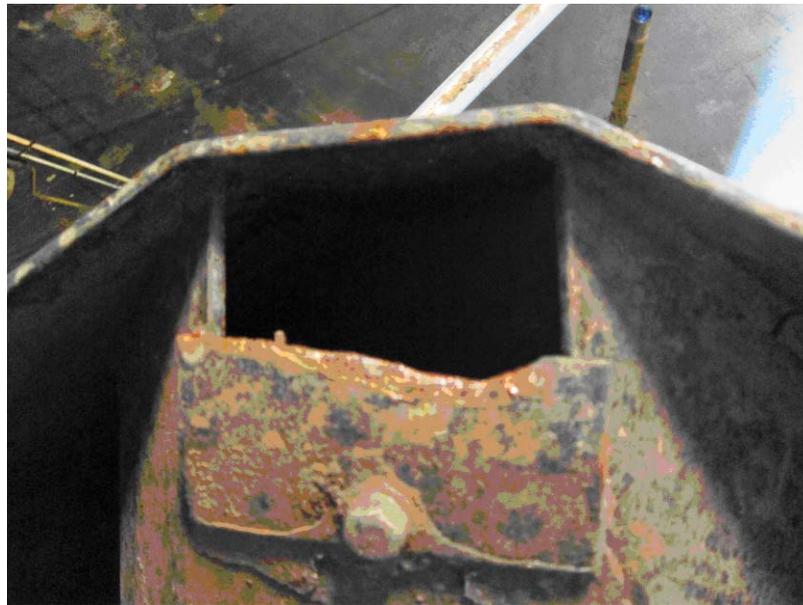
The most significant surface rust was noticed in mixer #8 throttle plate (see picture above), however on measuring the opening it was determined that the throttle plate is still within specification to operate properly without the need to be replaced.

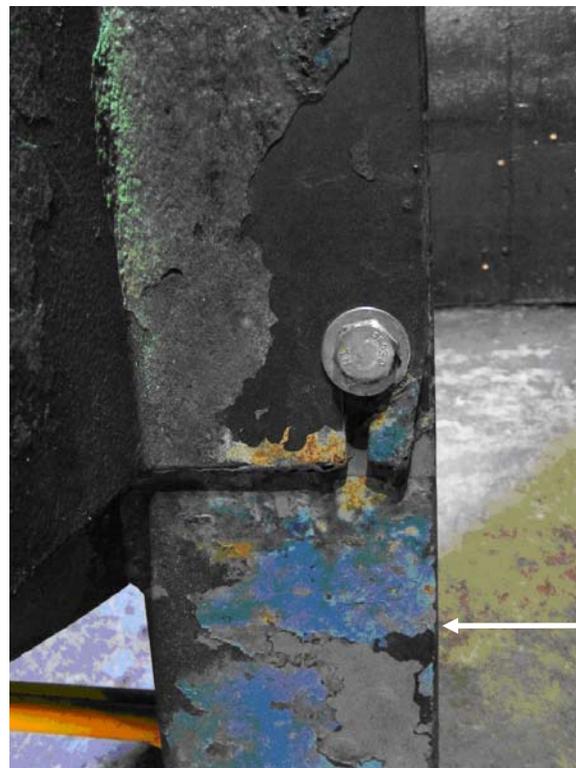
Mixer #10 bubble generator bolt hole was bent, but does not pose any physical or structural issues. No changes required.

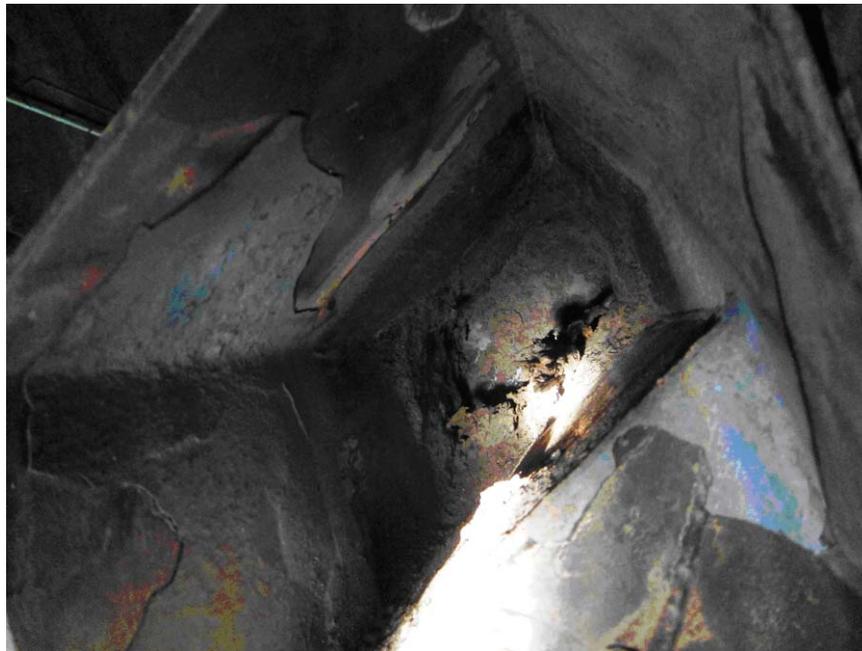
Mixer #12 bubble generator insides were not fully cleaned, rags were visible (see picture above) within the right section of the bubble generator that must be cleaned prior to placing the digester into service.

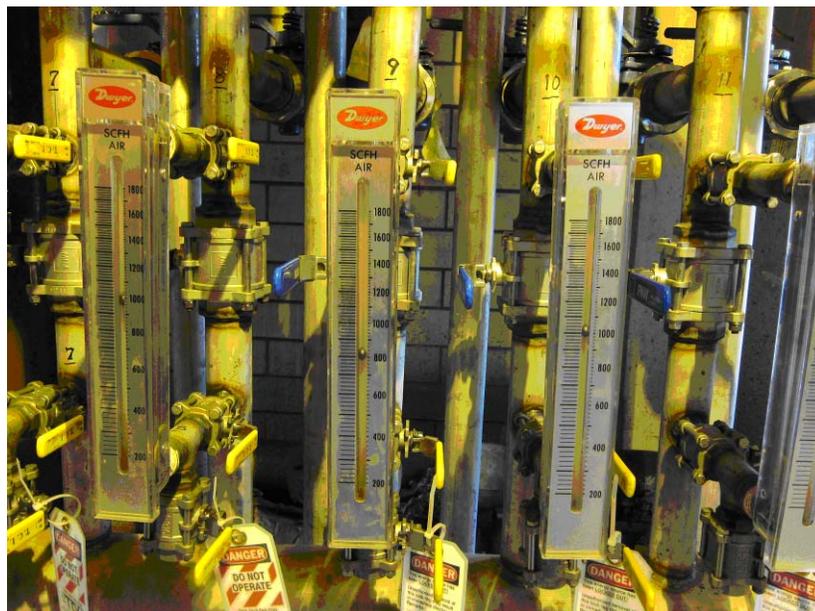
The gas balancing system for digester #1 (which is in operation) was checked to ensure all mixers were receiving the required gas flow. Gas flow meter for mixer #9 was the only flow meter that consistently showed less flow (by 100 scfm) as opposed to the rest of the mixers. Even when we tried to balance the gas flow by throttling the gas flow to the other mixers, the #9 flow meter would continue to read less than the other flow meters; however by measuring the pressure, the gas flow to the mixer #9 appears to be operational.

IDI also recommends that each of the digester gas balancing system be used at least once a month to check the flow to each of the mixers and adjusted or cleaned as required. Initial cleaning shall be done using just biogas pressure by throttling gas to other mixers within the same digester. Secondary cleaning shall utilize water from the roof directed directly to the bubble generator via the rodding line. Tertiary cleaning shall be done only in the even the mixer is significantly clogged (no noticeable blip in the pressure gauge on the mixer gas feed line) using flushing valve located above the throttling valve in the gas balancing system.

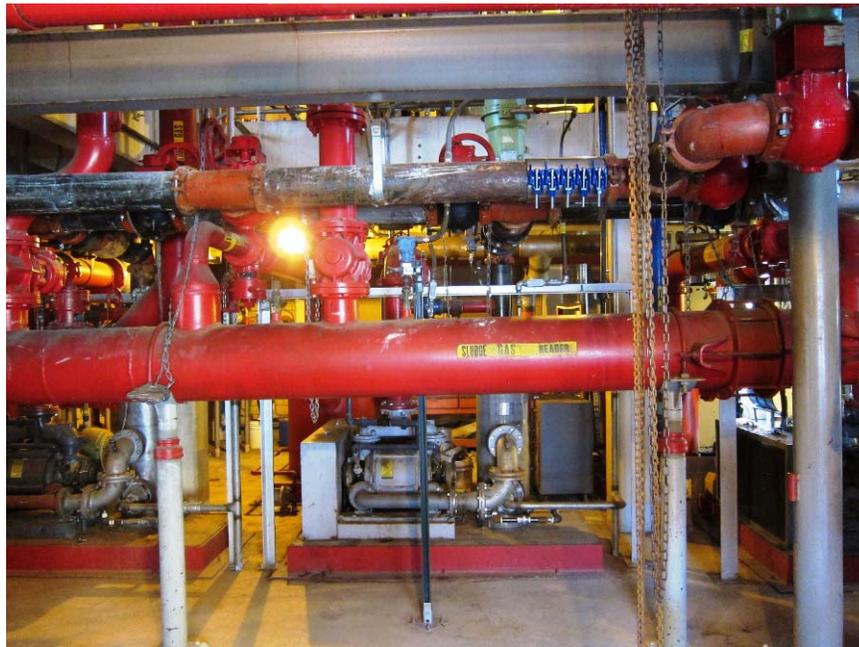
The biogas lines/connection in the compressor room were made of mild (or carbon steel), while the current piping configuration and material does not impact the digestion process, for the sake of longevity of digester operation it is recommended that the piping at some point in time be changed to stainless steel (304 or 316).

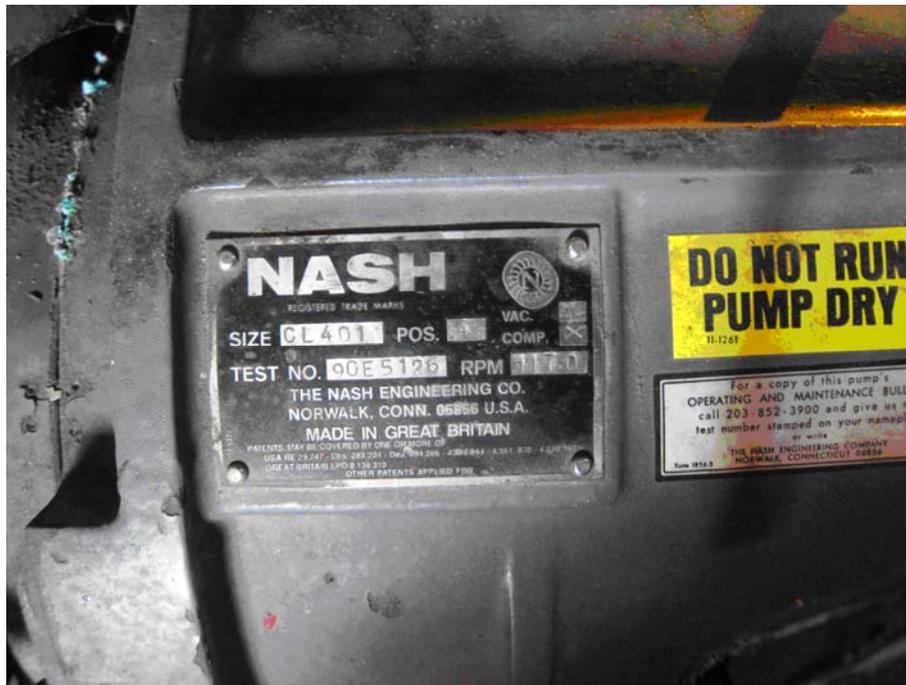
The addition of the Hartford loop while not significantly increasing the compress headloss during normal operation, it might be significantly undersized in the event when the biogas lines are filled with clean water used to remove obstruction during maintenance or service. Since the compressors are almost 20 years old, it is recommended that at some point in time these be replaced with newer, more efficient and economical compressor.

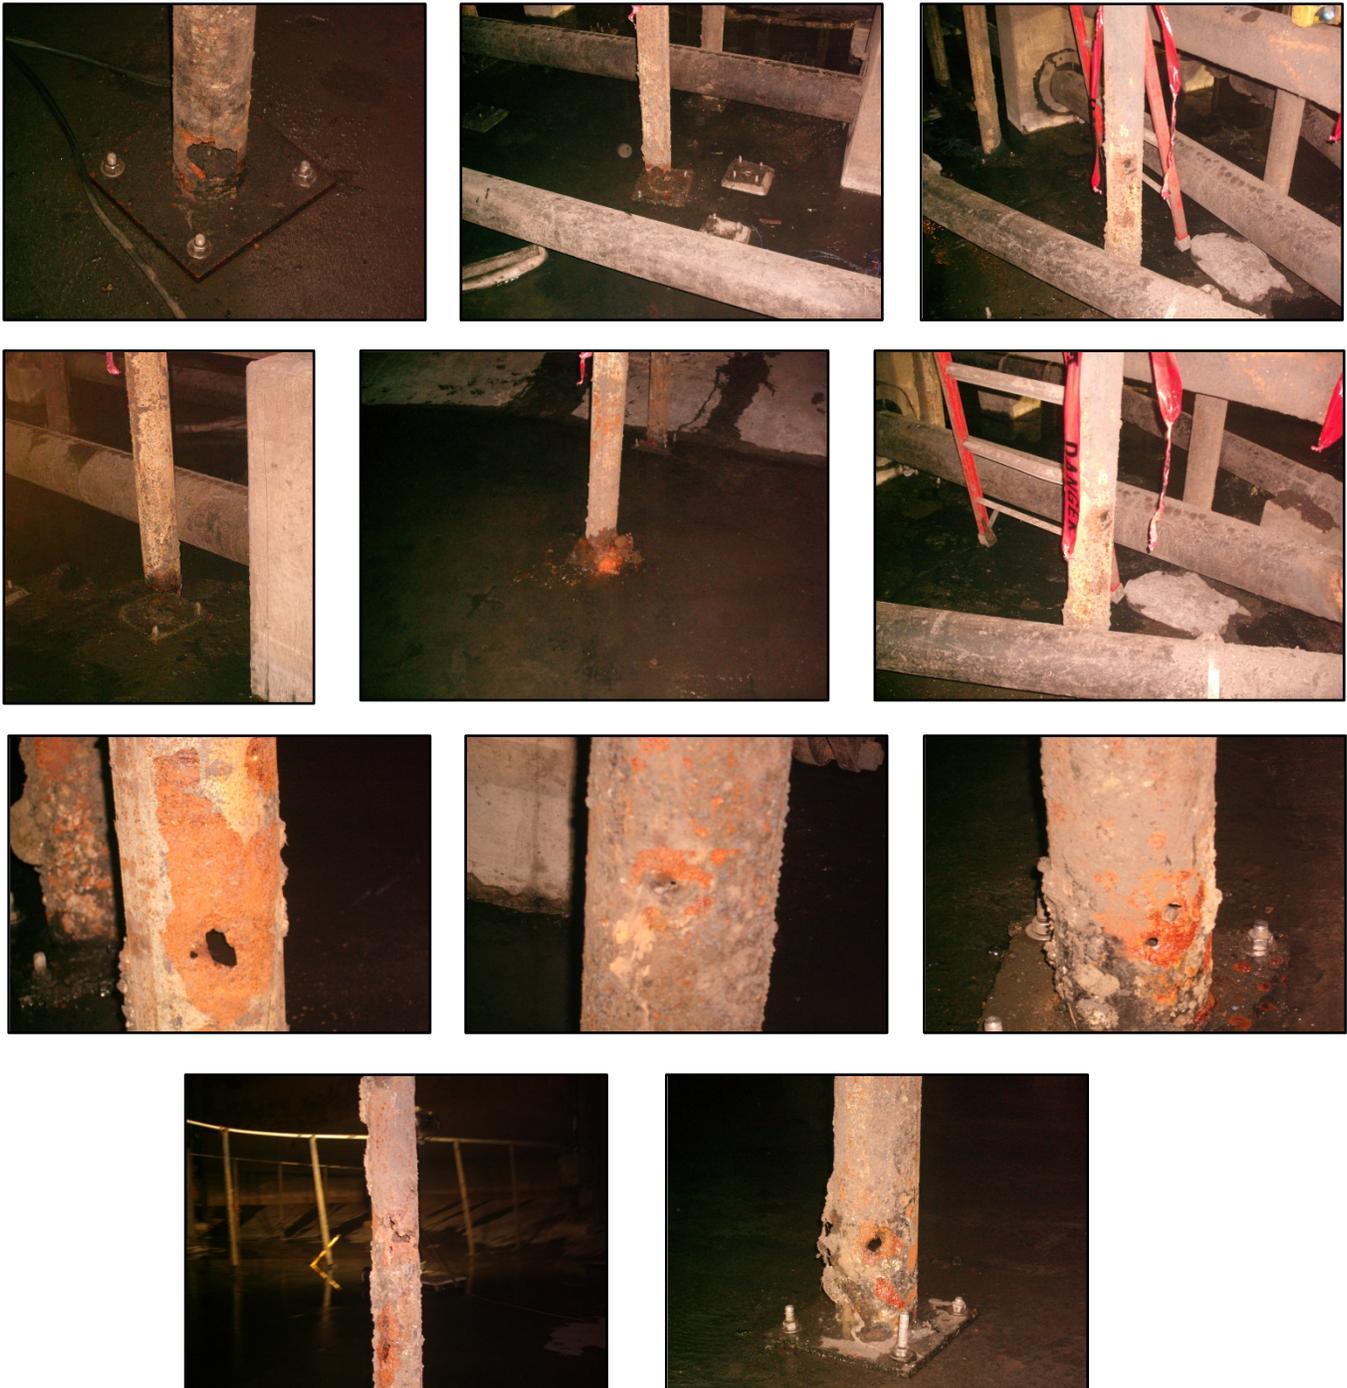
The photos which follow show the corrosion on the pipe supports.

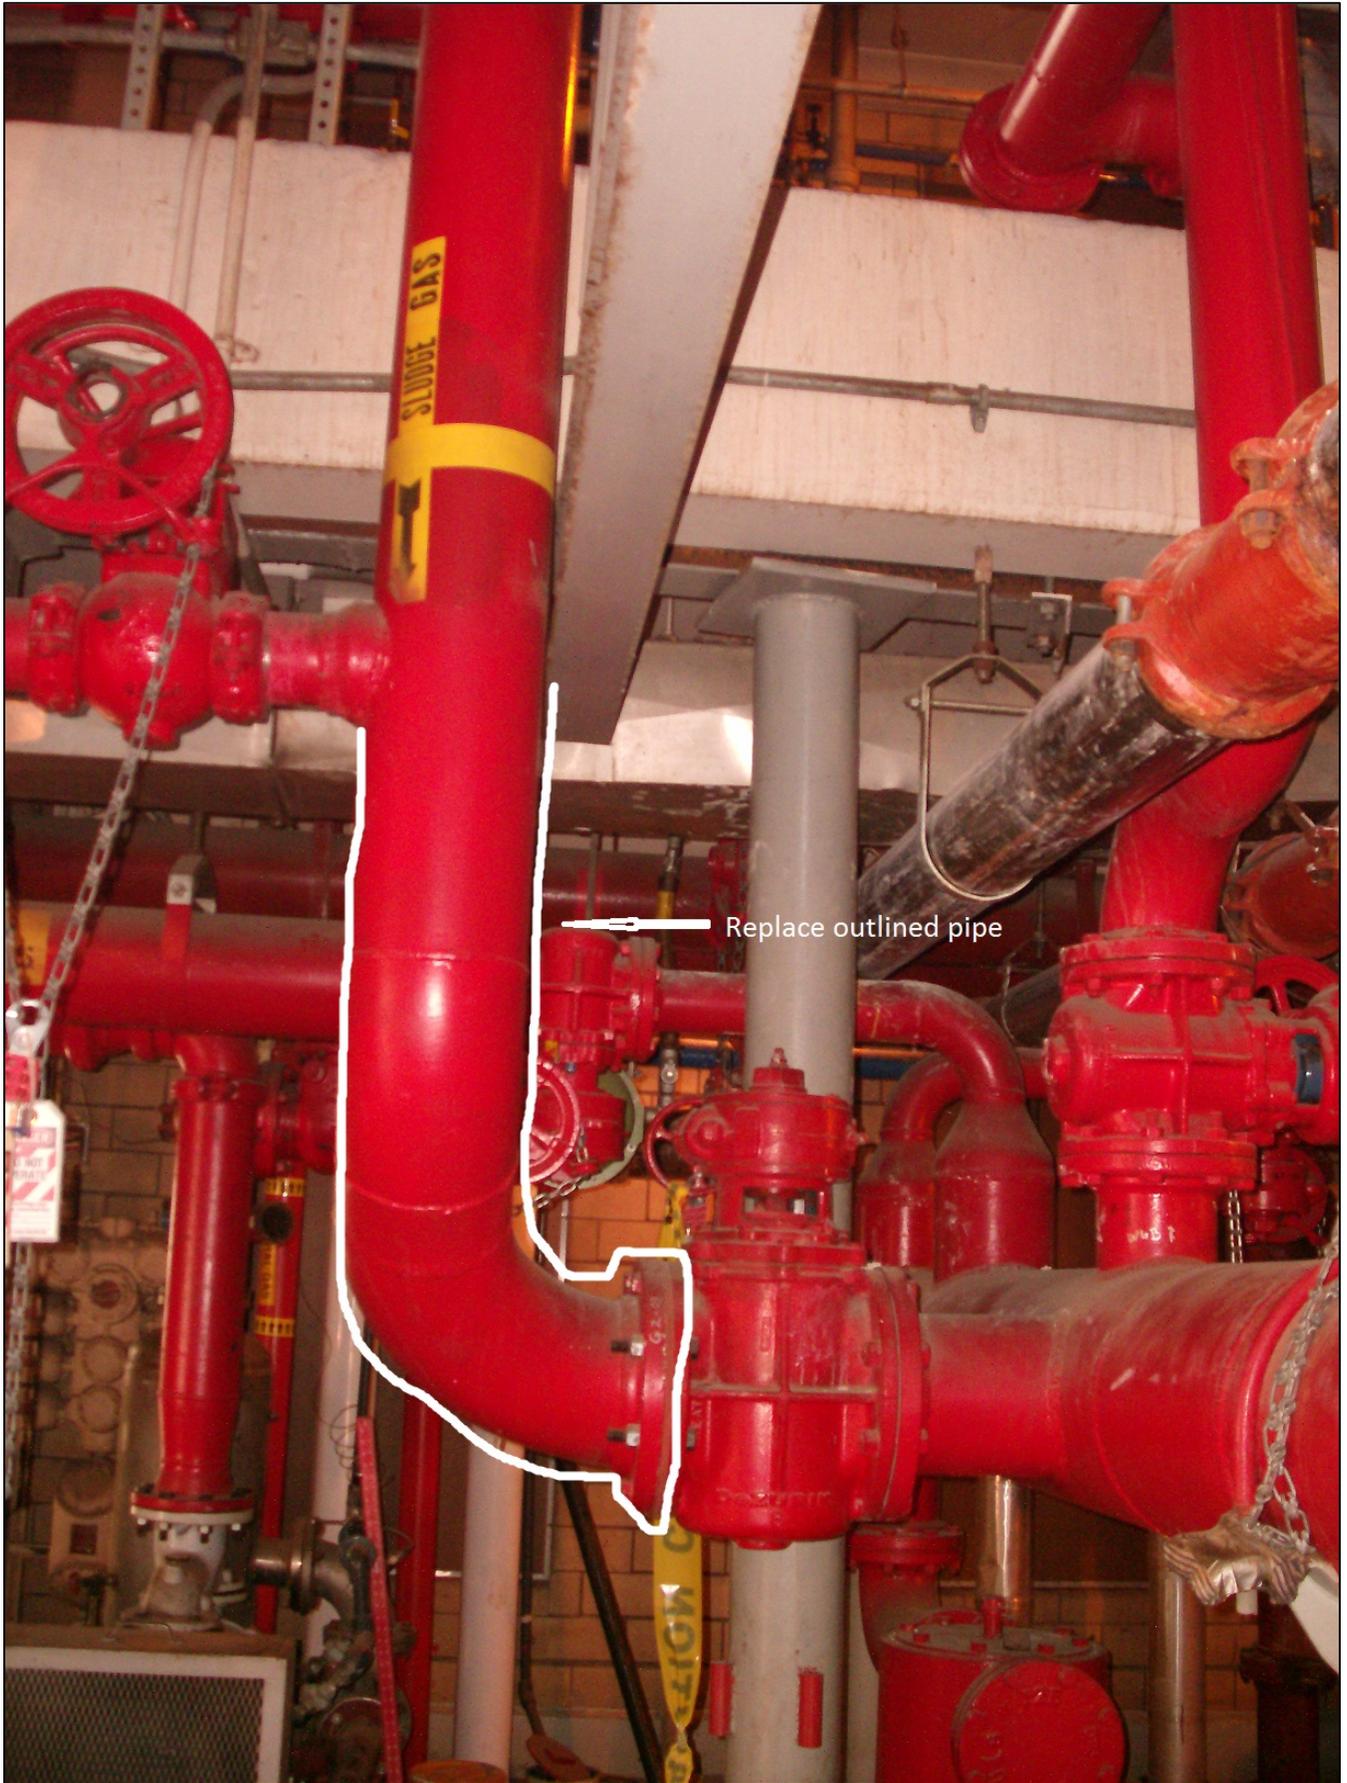
Replace outlined pipe

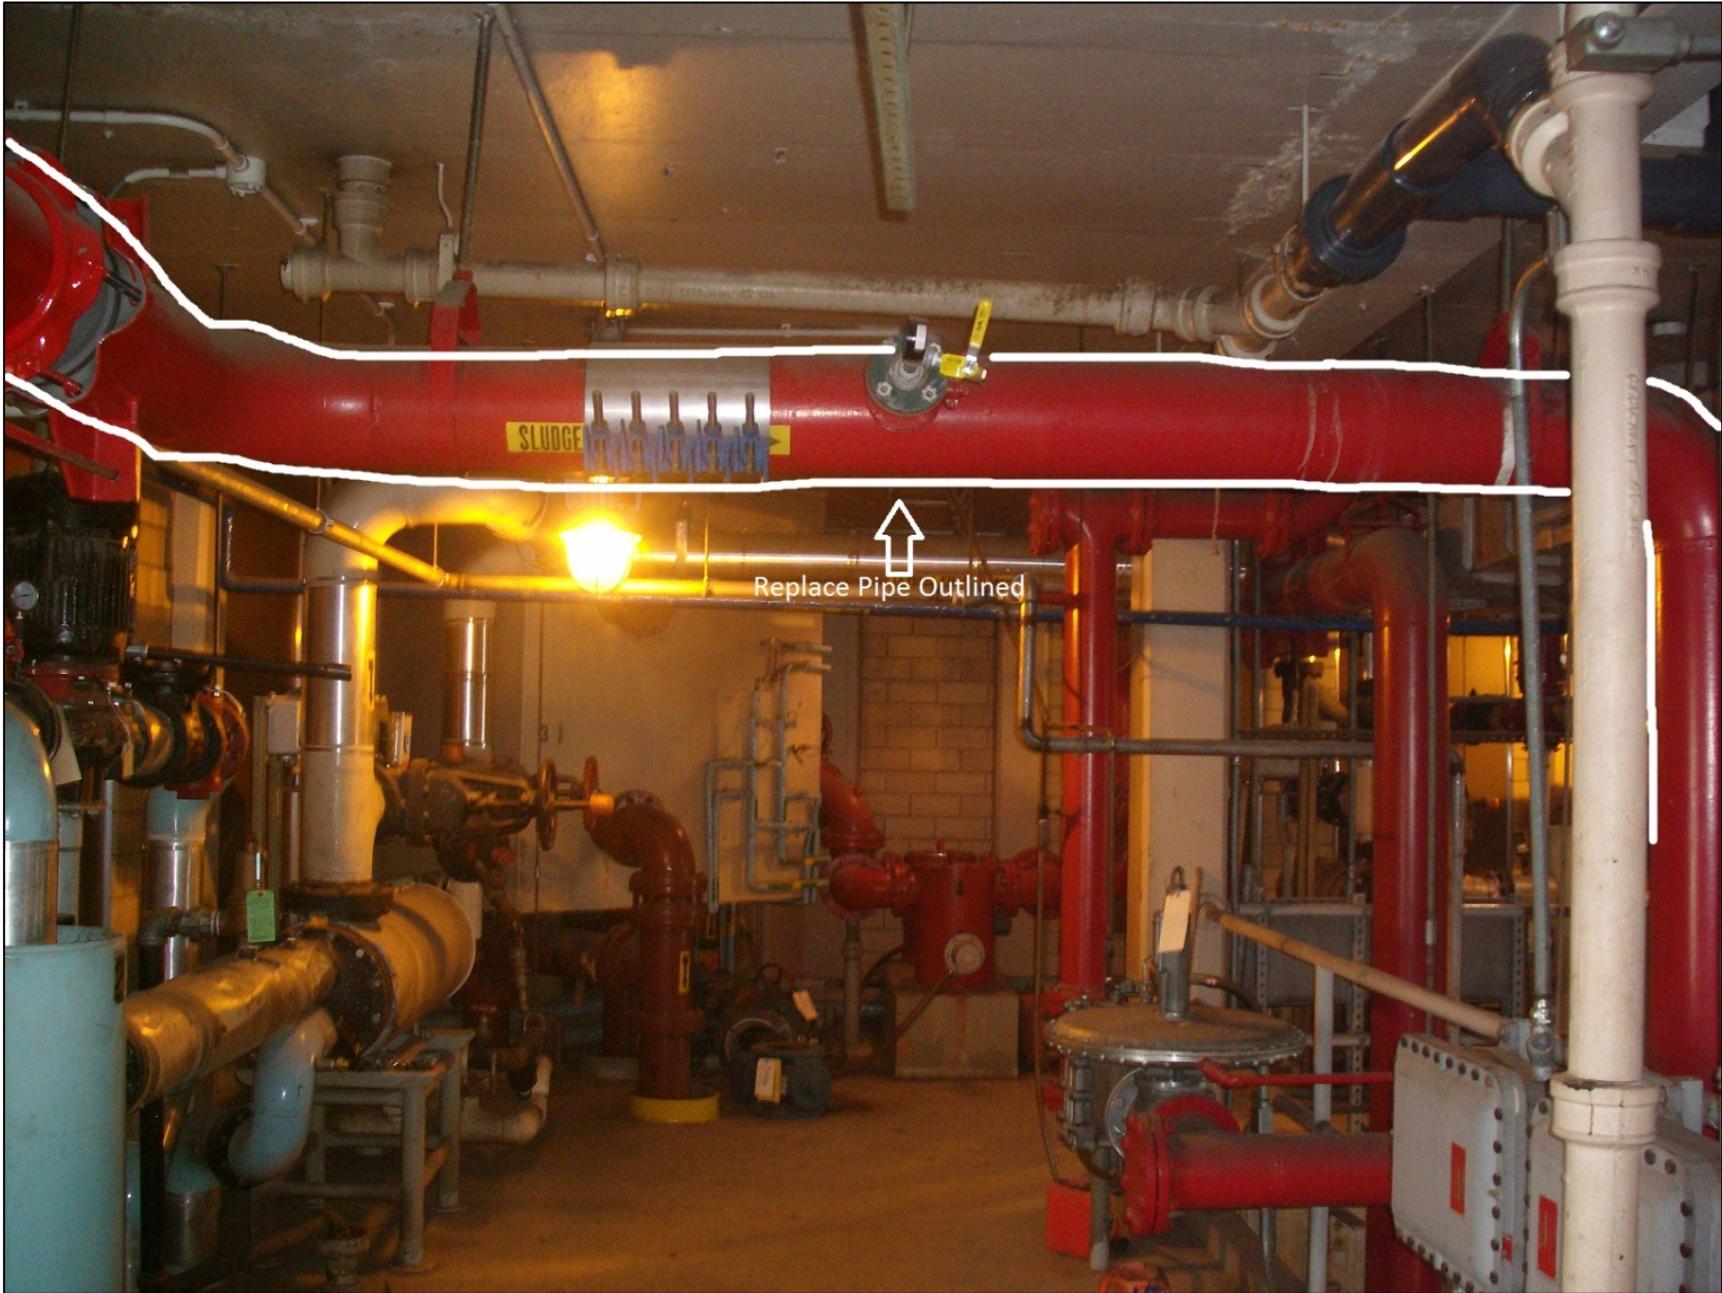
Replace Pipe Outlined
