Identification of the Primary Sources of Bacteria Loading in Selected Tributaries of Onondaga Lake: Phase 3 Microbial Trackdown Study

Final Report

April 11, 2019

Submitted to:
NYS Department of Environmental Conservation

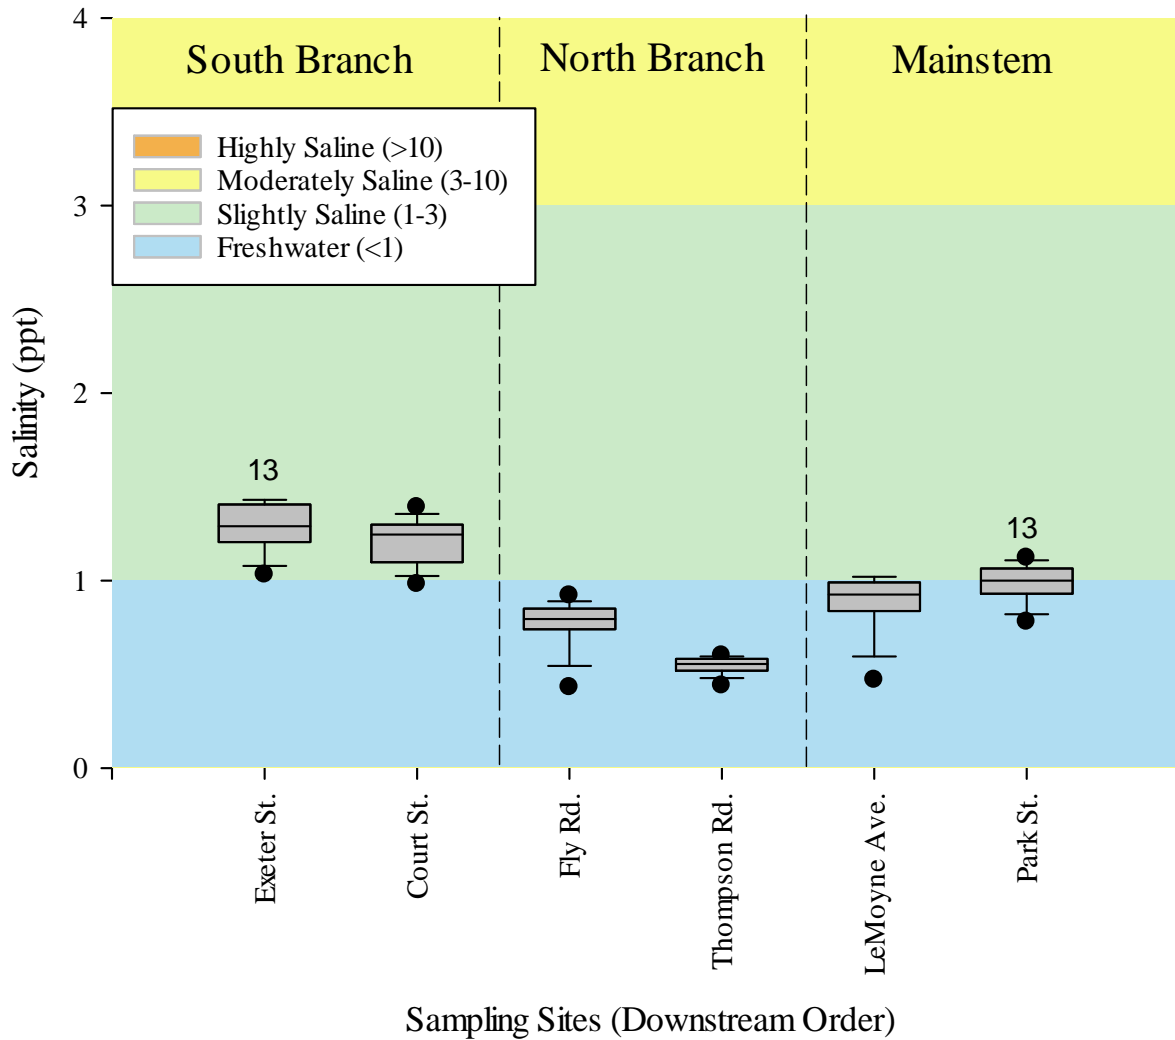
Figure 27. Salinity levels for Phase 3 Ley Creek routine sampling locations (2014-2015). Unless specified, the number of samples used to generate box plots is N=13.

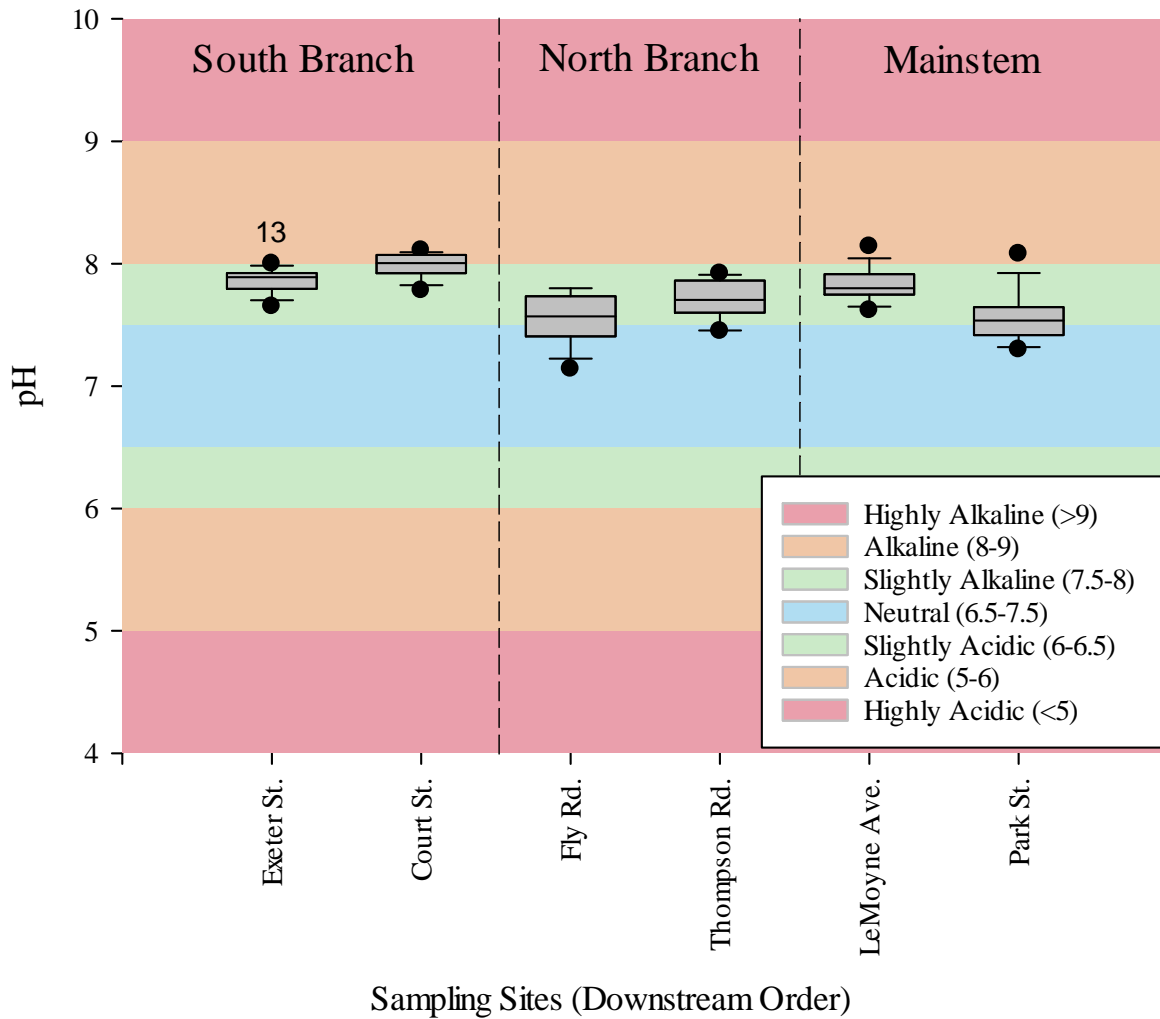
Figure 29. pH levels for Phase 3 Ley Creek routine sampling locations (2014-2015). Unless specified, the number of samples used to generate box plots is N=13.

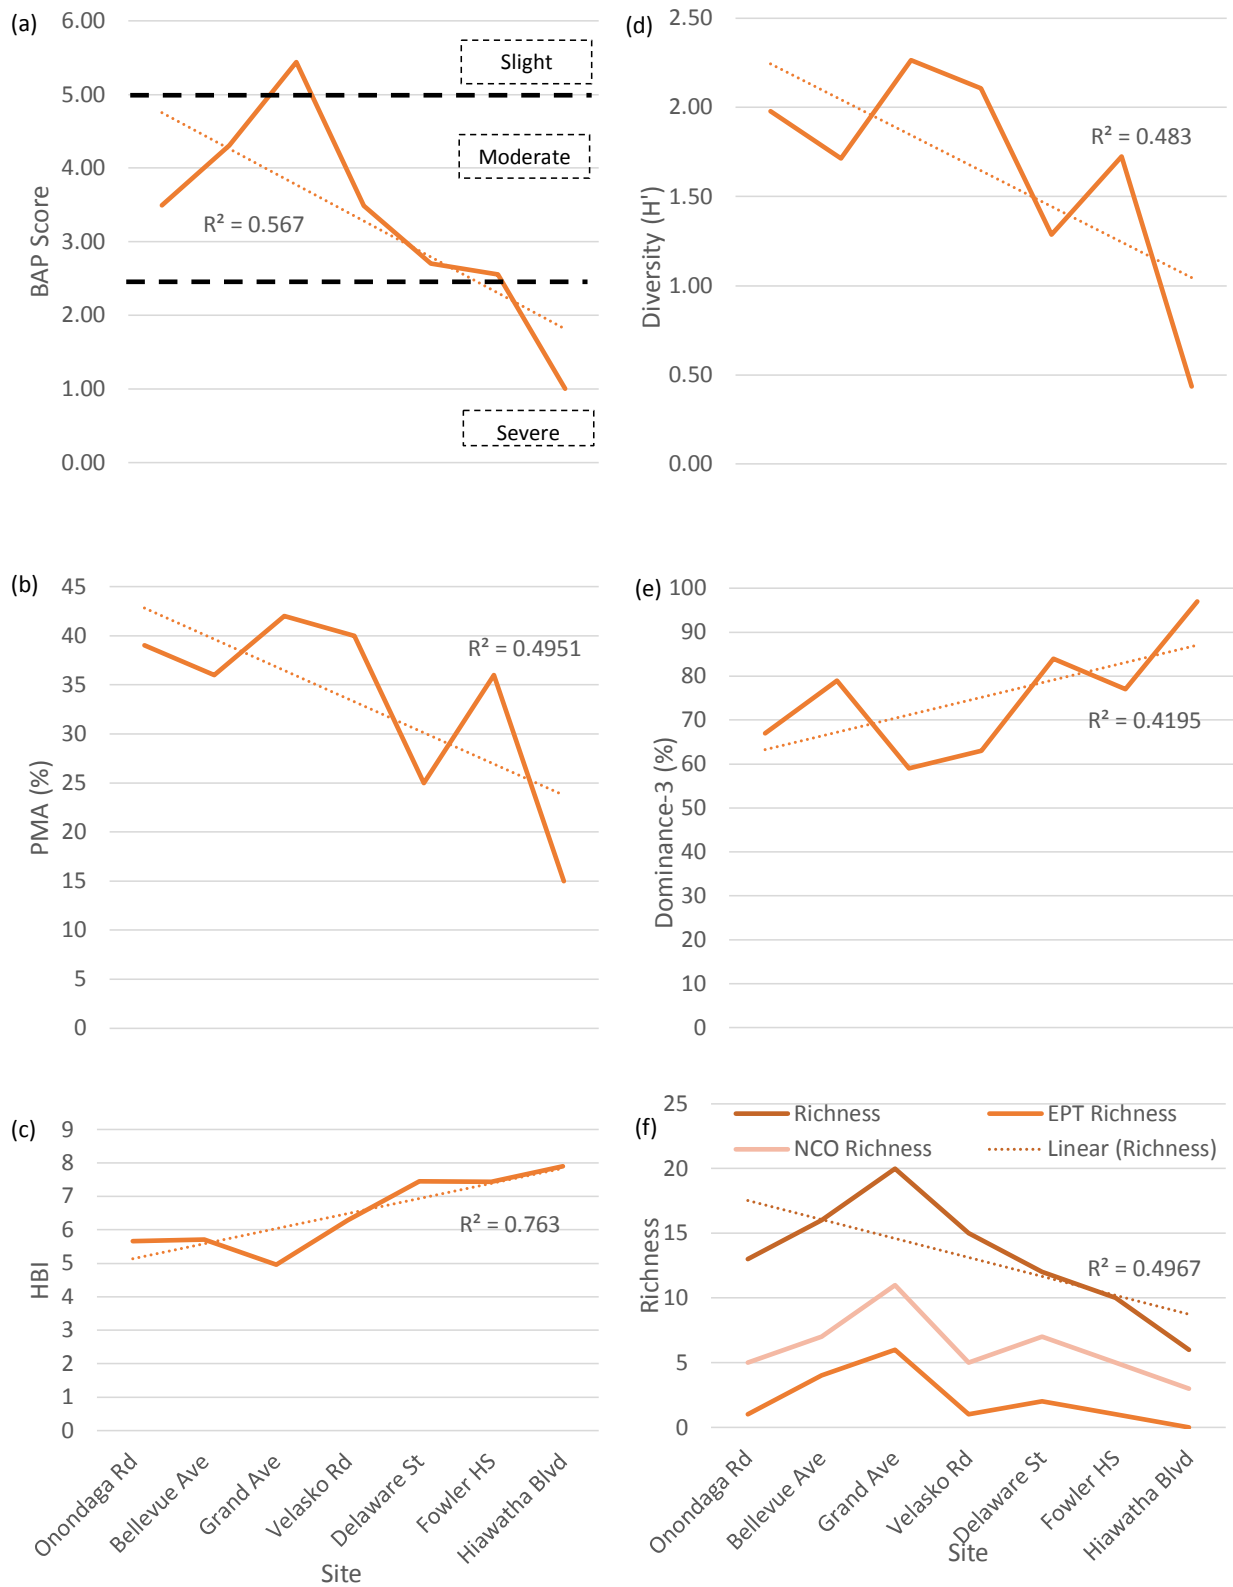
Figure 5. Macroinvertebrate metrics for Harbor Brook. A linear regression trend line is displayed (R^2). Sites are arranged in downstream order.

Percent Model Affinity (PMA), a measure of macroinvertebrate community similarity to a model, non-impacted stream, was comparatively low for all sites in Harbor Brook (15-42%) (Table 5). This suggests that macroinvertebrate community composition is moderately impaired throughout the Harbor Brook watershed. The overall decrease in PMA scores along the stream gradient ($R^2 = 0.50$) corresponds with an increase in Hilsenhoff Biotic Index (HBI) scores; a measure of organic pollution. HBI scores steadily increased downstream, highlighting the longitudinal and compounding effects of stream impairment. Of all the metrics calculated, HBI scores displayed the strongest linear trend ($R^2 = 0.76$) (Fig. 5c).

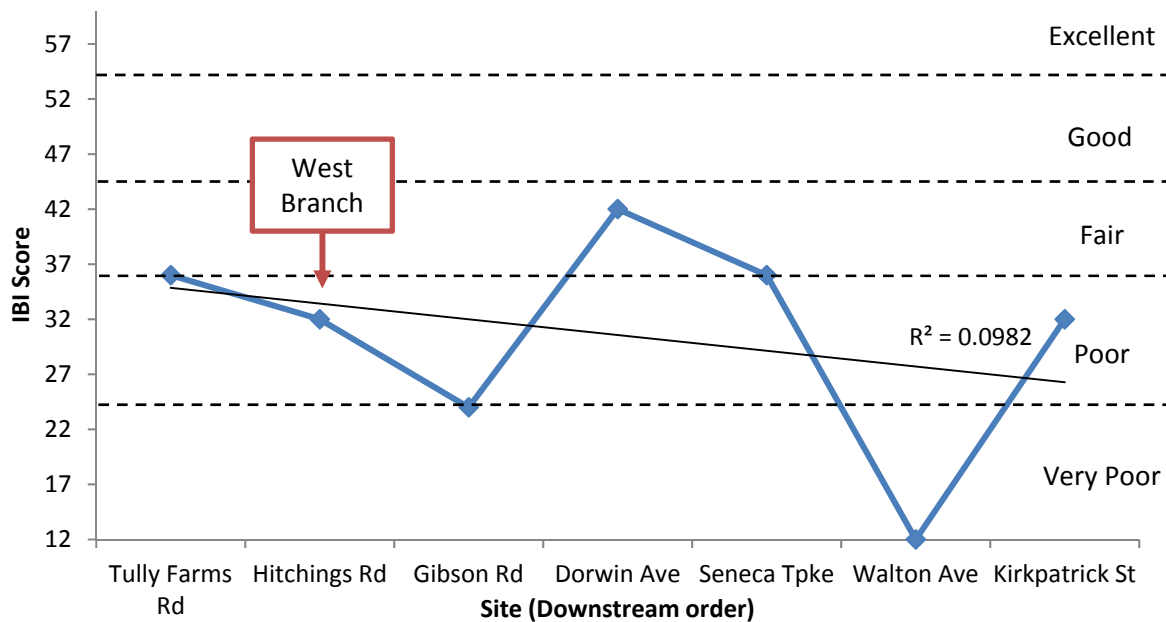
Figure 10. Fish IBI scores for Onondaga Creek (2015). Sites that could not be sampled due to accessibility issues are not displayed.

Based on the IBI, fish community structure at routine locations in Onondaga Creek were considered predominantly fair/poor (Fig. 10). Tully Farms Rd and W Seneca Tpke had IBI scores of 36, which is on the line between poor and fair. Dorwin Ave had the highest IBI score with a value of 42 ('fair') (Fig. 10). Both Gibson Rd and Walton Ave had the lowest IBI ratings, being considered very poor. Trends in IBI scores, as would be expected, mirrored the trends observed for abundance, richness, and diversity; with two noticeable downstream declines being observed.

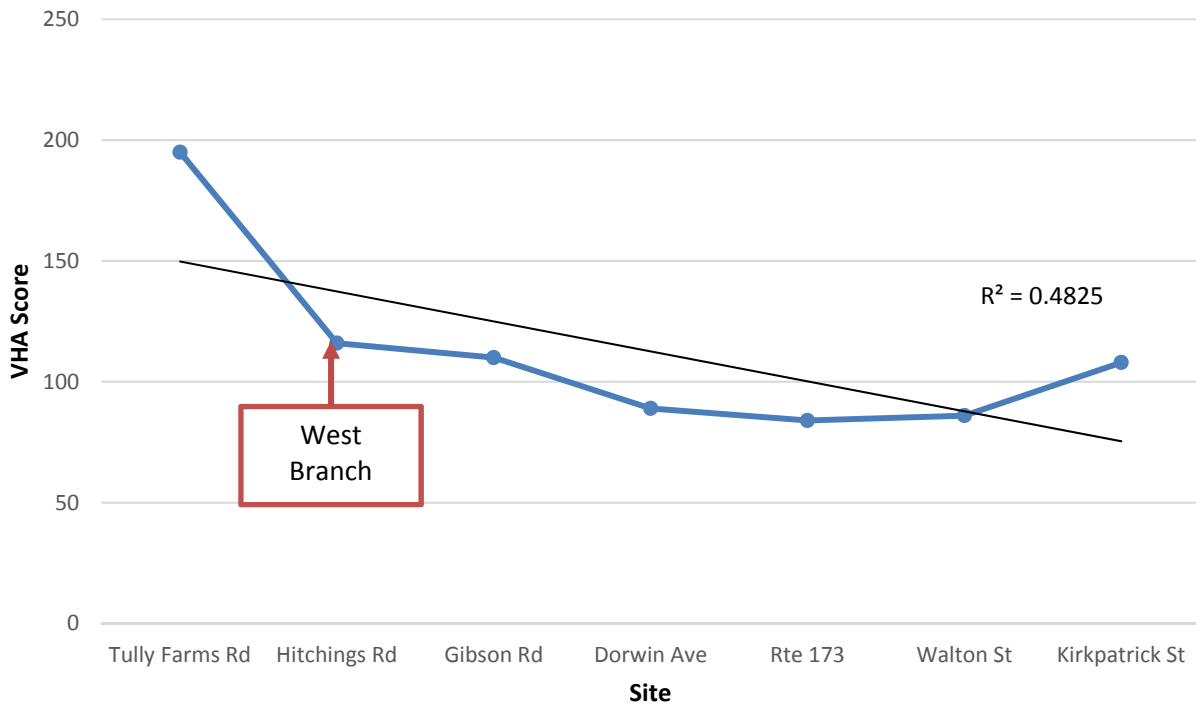
Figure 12. Visual Habitat Assessment (VHA) scores for Onondaga Creek sampling locations. A linear regression trend line is displayed (R^2).
