# SPDES DISCHARGE PERMIT Detailed Mixing Zone Form

CLAY SANITARY DISTRICT  
OAK ORCHARD FORCE  
MAIN & EFFLUENT SEWER

# **CORMIX Modeling**

## **Oak Orchard Wastewater Treatment Plant**

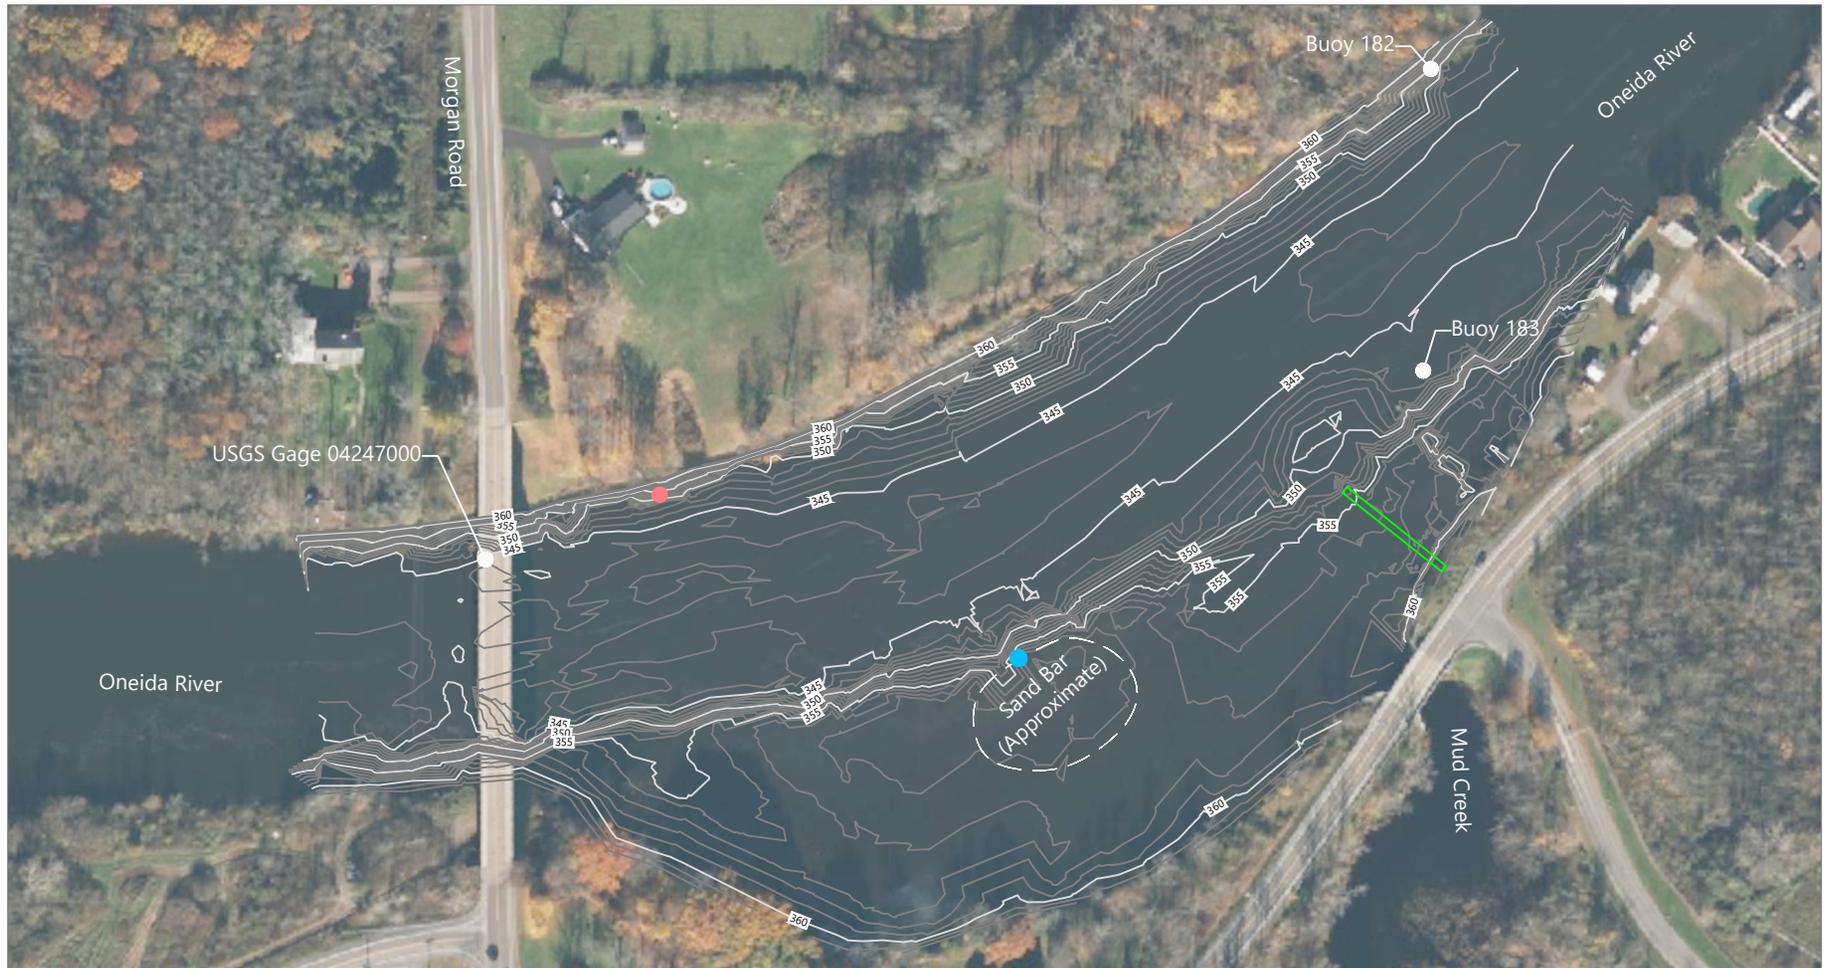
**Figure 3**  
**Bathymetric Survey Results**

The outfall pipe location was confirmed to be 175 feet upstream of the mouth of Mud Creek (Figure 3). It was easily located with the probing rod by contacting the rectangular concrete casing that houses the pipe. The structure was found 40 feet from shore and able to be followed out into the river with the probing rod. Its location is also marked on land on the south streambank by two concrete posts between the shoreline and Oak Orchard Road (Appendix A, Photograph 4). Using the probing rod and Trimble Catalyst GPS, the outfall pipe was measured to be 132 feet in length, extending into the river from the south shoreline. The overall width of the concrete casing was measured at 13 feet. Water depths over the structure ranged from 6.0 to 6.5 feet from the top of the structure to the surface, as determined by the probing rod. Sediment has built up evenly with the top of pipe elevation along each side and consists of 3 to 4 feet of medium to coarse sand and gravel (refusal of the probing rod was encountered beyond the 3 to 4 feet depth). Based on the water depths collected, the elevation of the top of the concrete structure ranges from 356.2 to 356.7 feet NAVD88.

The risers shown in the as-built drawings appear to have been broken off, because none were visible during video surveys or identified while probing. Furthermore, multiple ports were located using the probing rod, confirming the absence of the risers. Probing inside the openings revealed the presence of silt and sand (approximately 6 inches) at the bottom of the pipe, with a hard surface detected below that. Overall, probing determined the concrete structure surrounding the pipe is intact. Immediately beyond the end of the pipe opening, the water depth increases to 11 feet. Buildup of

Structures and hazards located above the water and beneath the water surface were documented. GPS coordinates were logged, and underwater video was recorded of the equipment associated with the USGS gauge (Appendix A, Photograph 7), which was assessed to be in good condition. The USGS staff gauge was found attached to the northern-most bridge abutment (Appendix A, Photograph 8). A large metal structure was observed above water and located upstream of Morgan Road (Figure 3 and Appendix A, Photograph 9). The purpose of the structure was undetermined. Additionally, GPS coordinates were logged for Buoys 182 and 183 (Appendix A, Photograph 10). A private dock (Appendix A, Photograph 11) is located on the north streambank, downstream of the USGS gauge. After three attempts concentrated in the area of the Morgan Road bridge, the velocimeter associated with the USGS gauge was unable to be located. In the area of the sandbar in the embayment south of the navigation channel, there are multiple large logs caught on the river bottom and protruding above the water surface, as well as boulders just below the surface (Figure 3 and Appendix A, Photograph 12).

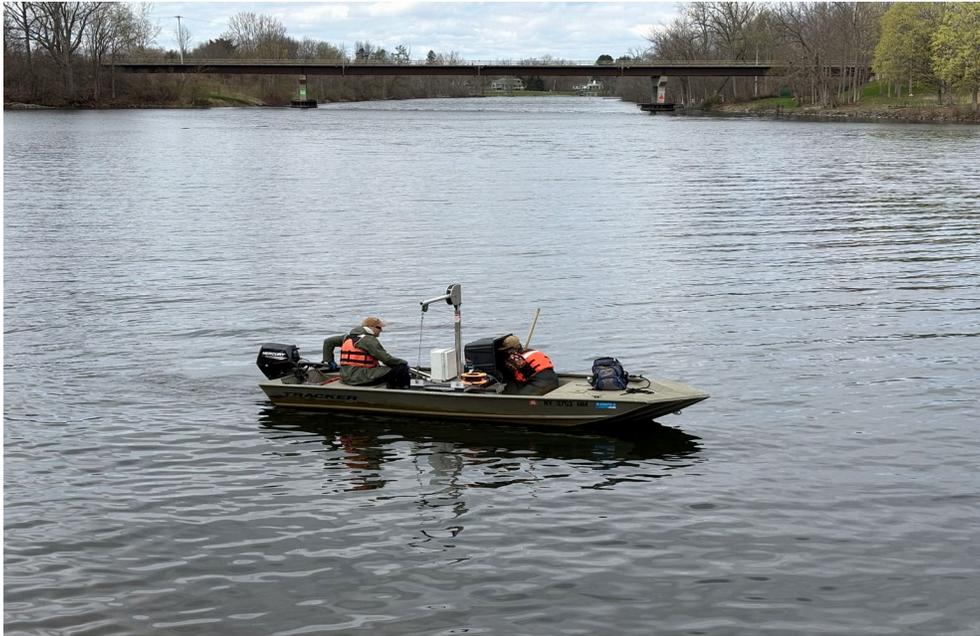
Photograph 1: Flat-bottom jon boat used for shallow water survey.

A single-beam bathymetric survey was performed with a BioSonics MX Aquatic Habitat Echosounder. Specifications for the echosounder include 1.7-centimeter accuracy ( $\pm 0.2\%$  of depth), a depth range of 1 to 100 meters, and a  $9^\circ$  conical beam. The echosounder was mounted to a 16-foot jon boat. The smaller size and flat bottom design of the vessel allowed for surveying in shallow water conditions (Appendix A, Photograph 1). The vessel was navigated through the survey area along 27 target transect lines spaced 50 feet apart perpendicular to the centerline of the river (blue lines in Figure 2). Navigation along the transects was accomplished using a Trimble Catalyst GPS receiver and tablet combination with real-time display and submeter accuracy; actual vessel track lines with dots indicating depth recordings are shown in red in Figure 2. In addition to the original target transects, supplemental transects were completed around the Morgan Road bridge, diffuser pipe, and other areas of interest (Figure 2). Transects in the vicinity of the USGS gauging station (Appendix A, Photographs 2 and 3) were shifted slightly to align more directly with the station north to south (parallel to the Morgan Road bridge). In shallow water areas near the riverbanks not accessible by boat, data were collected by wading with a Trimble R6 rover unit to collect individual points along the target transects (light blue dots in Figure 2). The Trimble R6 receiver used a mobile hot spot to gain connection to the New York State Spatial Reference Network and achieve real-time centimeter level positioning. Trimble R6 accuracies ranged from 0.03 to 0.20 survey foot horizontally and 0.04 to 0.39 survey foot vertically. Most locations were in the range of 0.03 to 0.15 survey foot of accuracy with a few of the nearshore locations ranging higher due to tree cover blocking connection to satellites.

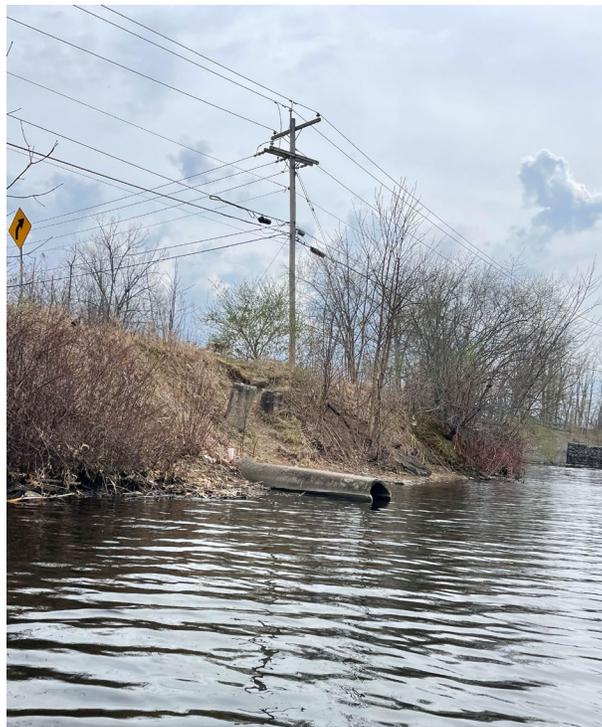
Photograph 4: Diffuser pipe location marked with concrete posts, former concrete outfall pipe.

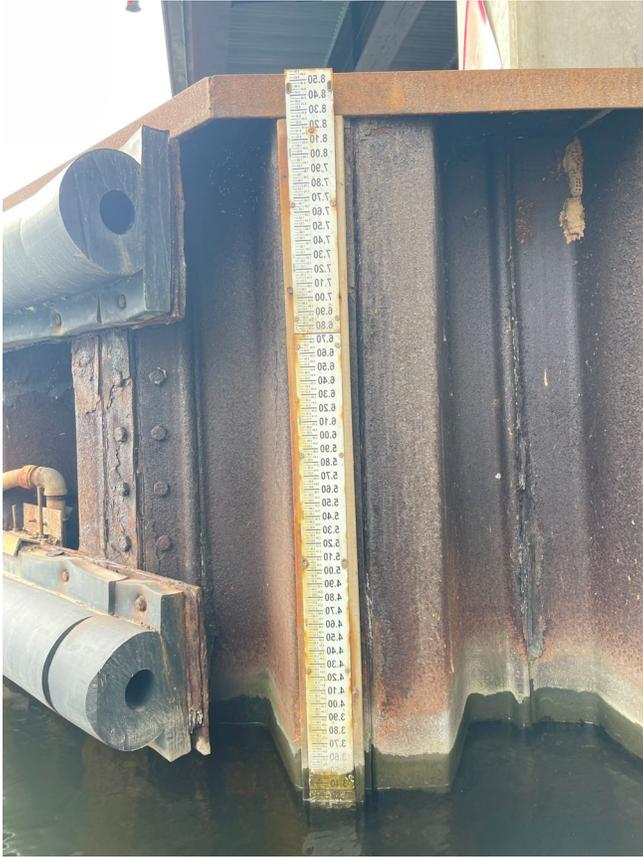
Photograph 8: USGS staff gauge in good condition.
