**ONONDAGA COUNTY
WATER ENVIRONMENT PROTECTION**

**METRO WWTP
SYRACUSE, NY**

**DIGESTER #4 STEEL COVER
ASSESSMENT**

September 11, 2015

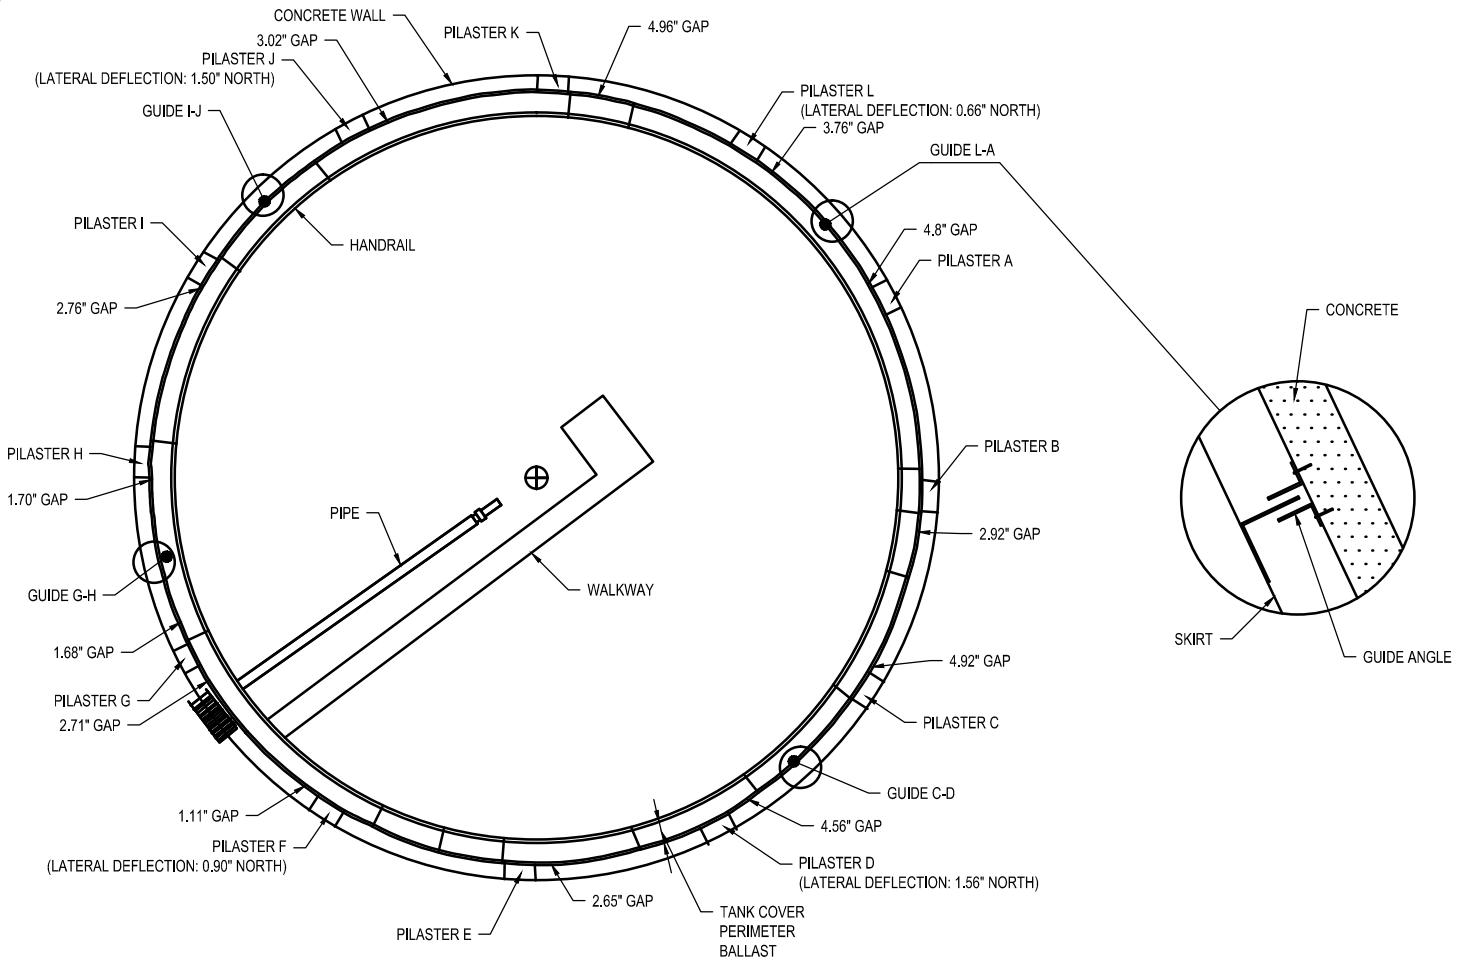
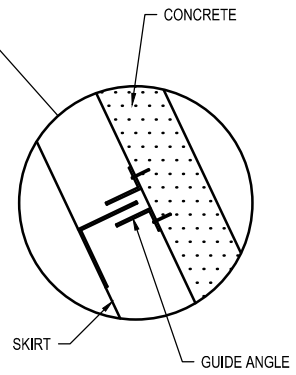
FIGURE 1

- d. Our measurements show the gaps between the skirt and the concrete walls varied from 0” to 7 1/8”. While dropping from position 1 to position 3 the cover appeared to shift laterally in the north south direction resulting in a wider gap at the north side versus the south side. In general the gaps became smaller along the perimeter at the two lower positions, which we believe is due to the irregular shape of the ballast trough along the perimeter of the cover. The largest gap between the skirt and concrete wall of 7 1/8” was recorded at guide angle LA. Refer to Figure 1 and tabulations in Appendix 1.

NOTE : ALL GAP MEASUREMENTS TAKEN FROM SCAN 1, WHEN TANK WAS FULLY EXTENDED.

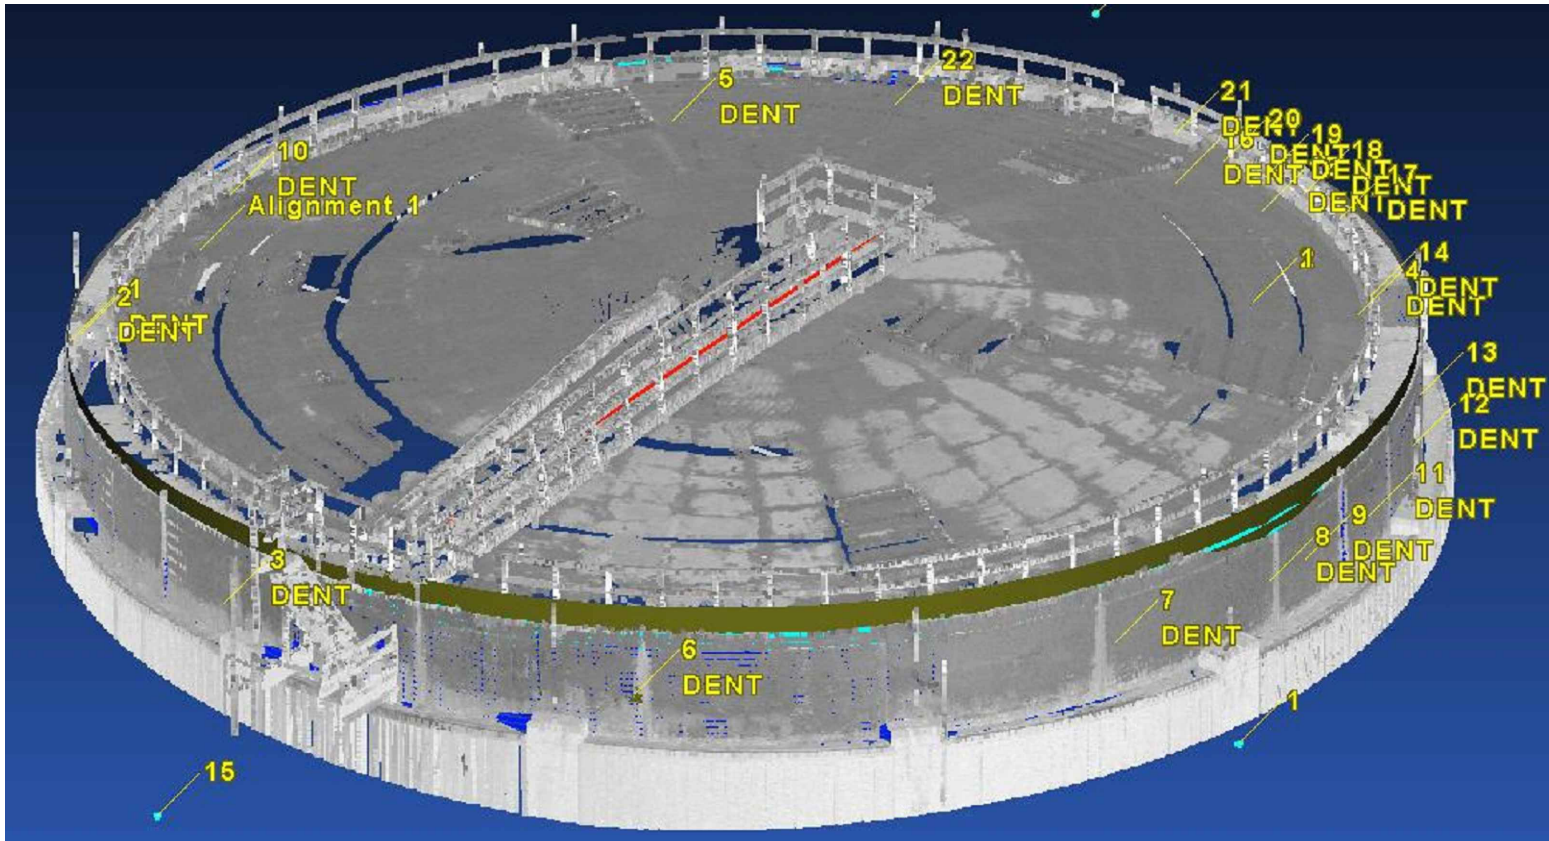
FIGURE 2

- b. Generally the gap measurements did not show a uniform pattern of increasing and decreasing around the circumference of the cover.
 - c. The skirt contains several localized inward and outward indentations of up to 1 ½” that may have contributed to the non-uniformity of the gap measurements. Refer to the Figures 2, 4, and 5. These irregularities in the skirt surface indicate that the skirt is not perfectly round. However, we believe that overall the skirt is reasonably round when compared to best-fit circle with a maximum out of round deviation of up to 2”. Note that we don’t have access to accurate as-built information relating to the tank cover and concrete tank to compare to the present conditions.

**COVER SKIRT
 DENTS**

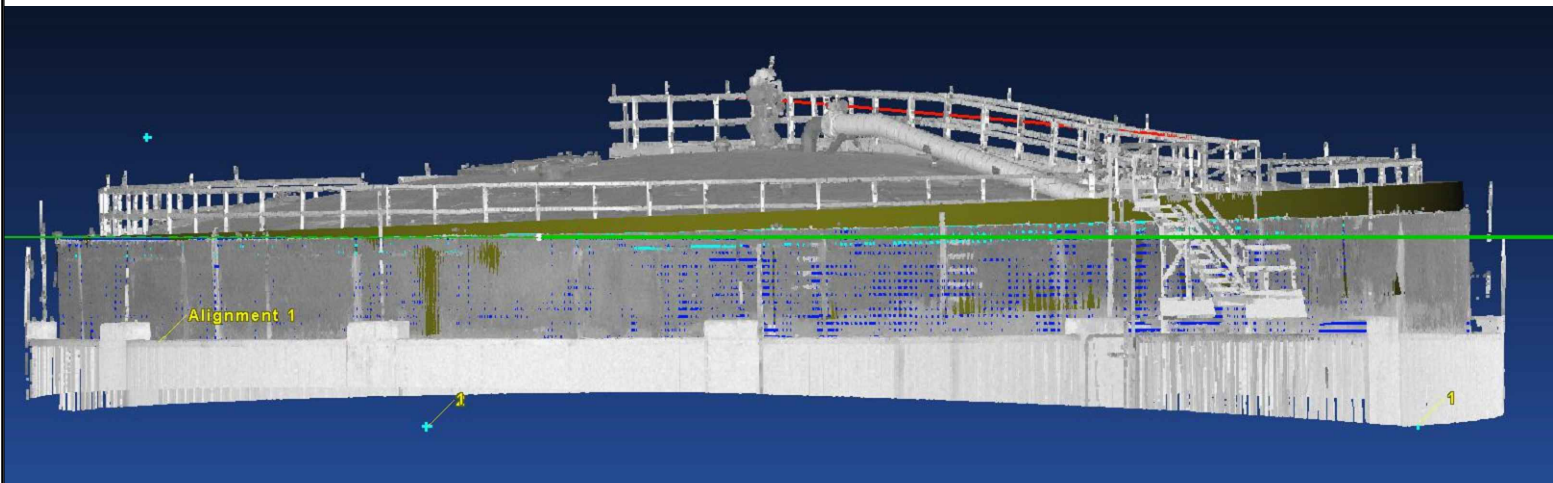
FIGURE 3

- a. Cover position 1 - skirt rim approximately 8 feet above top-of-tank (max height)
 - i. 28 inch elevation variation, refer to Figure 3 in Appendix 2.
