Onondaga County, NY  
Condition Assessment Report  
Baldwinsville-Seneca Knolls Wastewater Treatment Plant

January 2015

# 7. Disinfection Evaluation

## Appendix K - Condition Assessment Photos

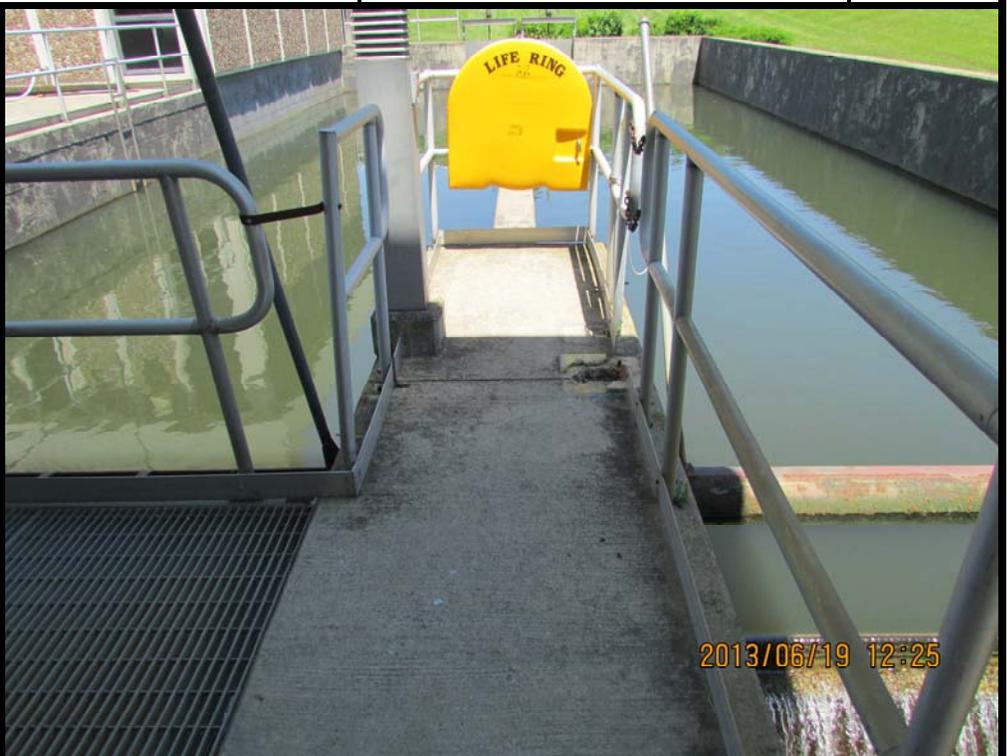
Location: Chlorine Contact Tanks	Photo Name:	Photo #:
Looking east	CCTe_002.jpg	16
<p>Description(s):</p> <p>View of walkway between tanks.</p>
