**CONESTOGA-ROVERS  
& ASSOCIATES**

## TECHNICAL MEMORANDUM

RE: Metro WWTP - Compliance Alternatives for Outfall 002 and Tertiary Treatment Bypass

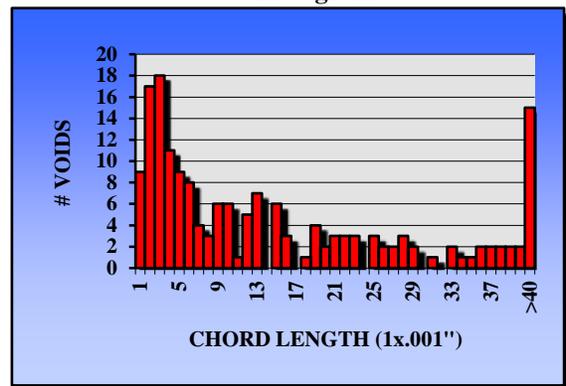
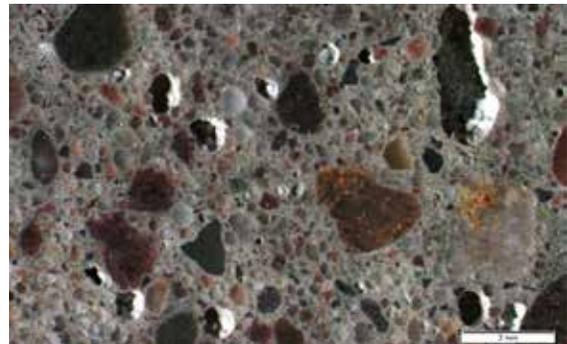
Air Void Content, %	4.3
Entrained, %	3.2
Entrapped, %	1.1
Air Voids/inch	2.28
Specific Surface, in <sup>2</sup> /in <sup>3</sup>	210
Spacing Factor, inches	0.028
Paste Content, % estimated	37.2
Magnification	50x
Traverse Length, inches	75
Test Date	1/29/2013

Description: Overall hardened air content

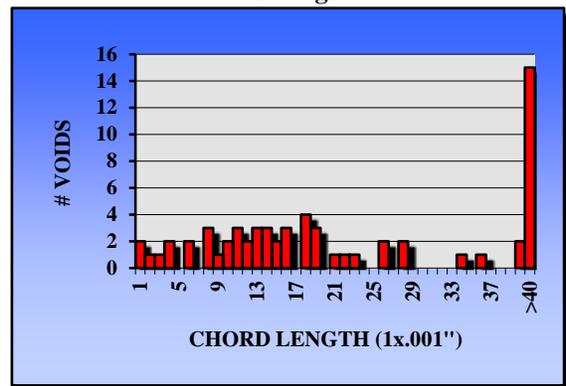
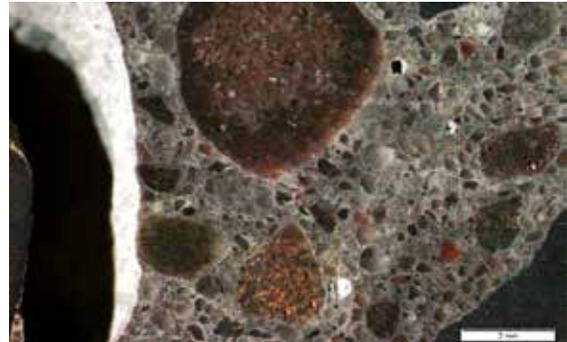
Air Void Content, %	2.7
Entrained, %	0.9
Entrapped, %	1.8
Air Voids/inch	0.63
Specific Surface, in <sup>2</sup> /in <sup>3</sup>	90
Spacing Factor, inches	0.064
Paste Content, % estimated	22.0
Magnification	50x
Traverse Length, inches	100
Test Date	1/29/2013

Description: Overall hardened air content

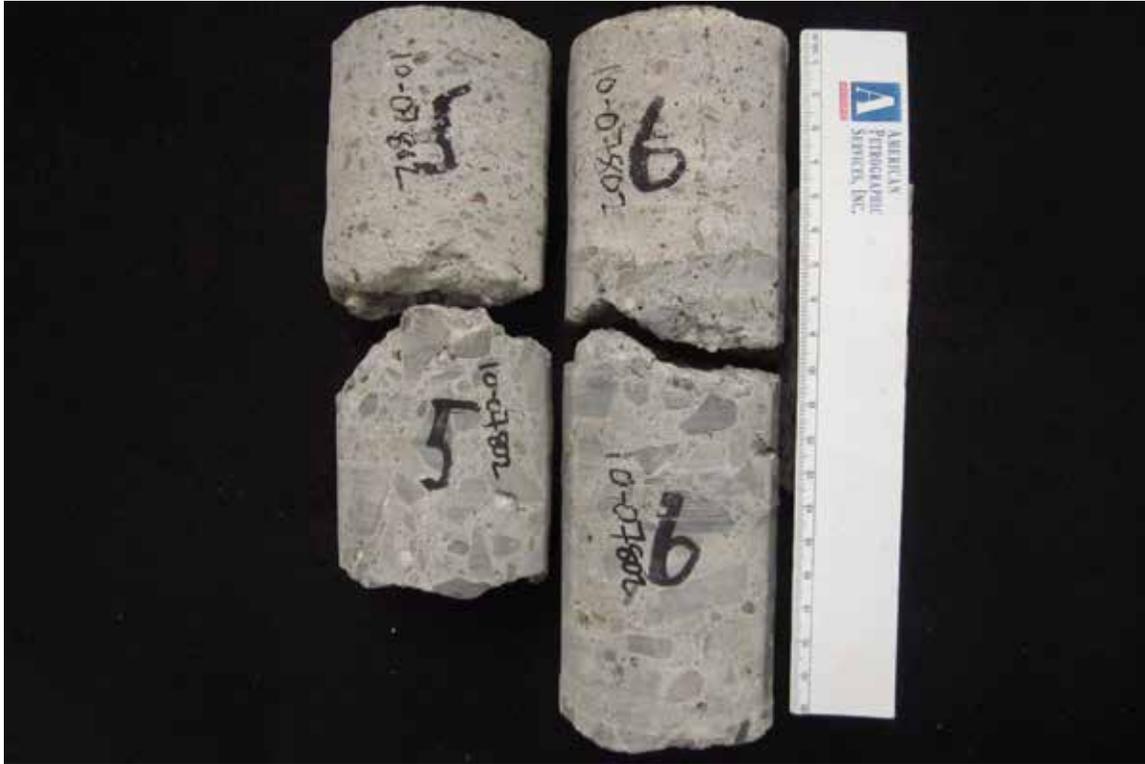
SAMPLE ID: 5 and 6 DESCRIPTION: Overall view of concrete core samples as received.

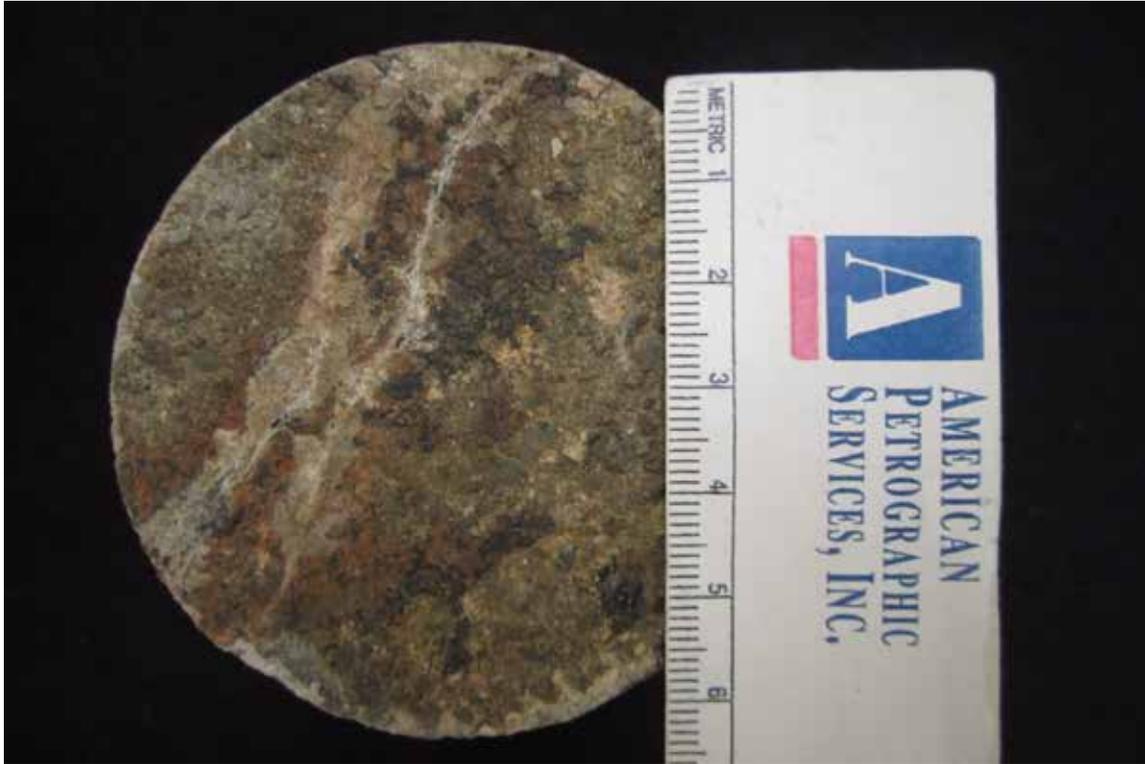
SAMPLE ID: 6 DESCRIPTION: Overall view of the outer surface of the sample.

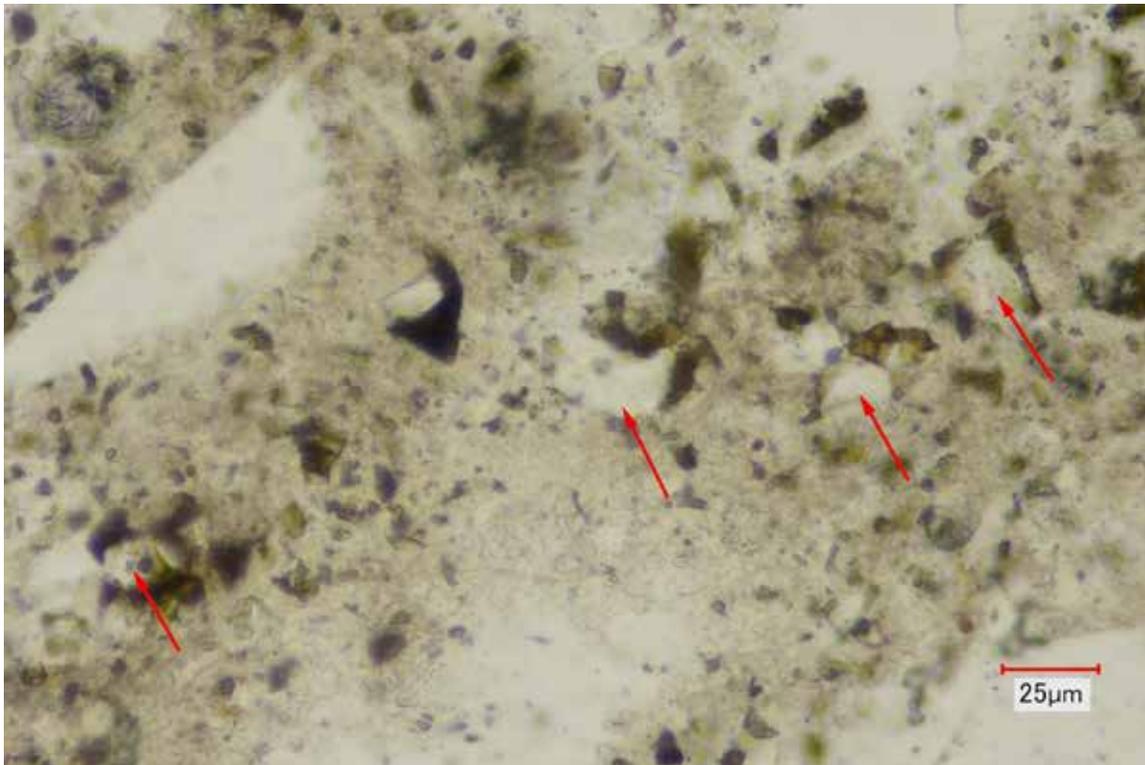
SAMPLE ID: 5 DESCRIPTION: Fully hydrated portland cement clinker particles (red arrows) in thin  
MAG: 400x section of concrete under plane polarized light.

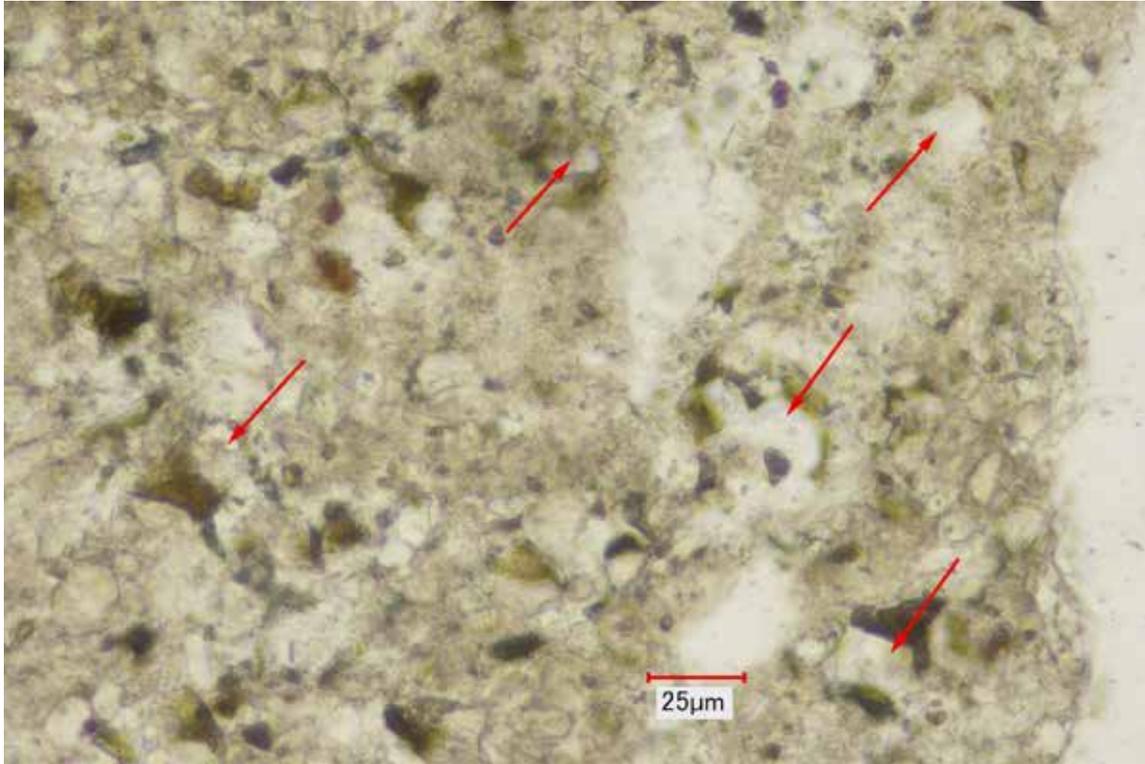
**SAMPLE ID:** 6  
**MAG:** 400x  
**DESCRIPTION:** Fully hydrated portland cement clinker particles (red arrows) in thin section of concrete under plane polarized light.
