Onondaga County Department of
Water Environment Protection
Syracuse Metropolitan WWTP Digester
Cleaning and Miscellaneous Repairs Project
Technical Report

TECHNICAL REPORT
SYRACUSE METROPOLITAN WWTP DIGESTER CLEANING
AND MISCELLANEOUS REPAIRS PROJECT

GHD CONSULTING ENGINEERS, LLC
One Remington Park Drive
Cazenovia, NY 13035

Project No. 8614054

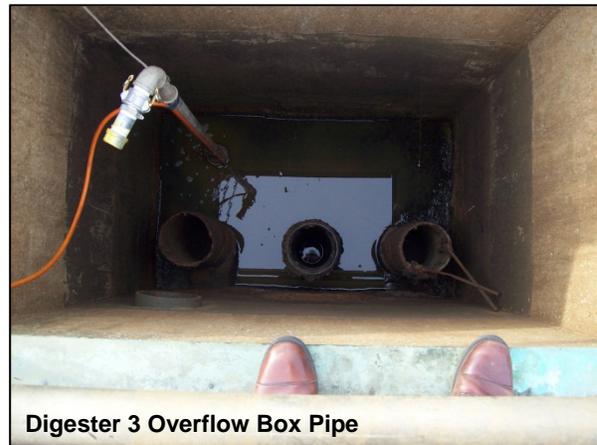
One item that was not initially noted in the Interim Inspection Report but was observed later was the condition of the piping in the digester overflow boxes. The condition of this piping is poor, showing severe corrosion and loss of material. It is recommended these pipes be replaced in Phase 2.

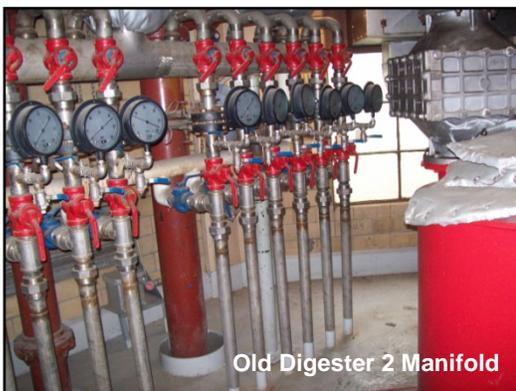
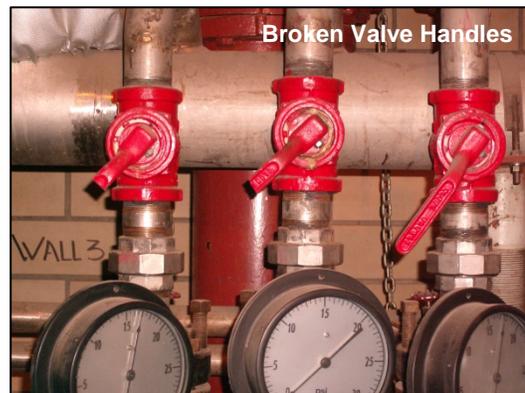
Each digester is equipped with its own gas balancing manifold and balancing valves to each mixing gun used to balance the gas flow between each mixing gun. The balancing valves were 2-inch DeZurik plug valves and have been in use for approximately 17 years. In addition to the balancing valves, each manifold was equipped with 12 isolation valves (also 2-inch plug valves from DeZurik). Plant operators stated some of these valves are inoperable and some valve handles were broken.

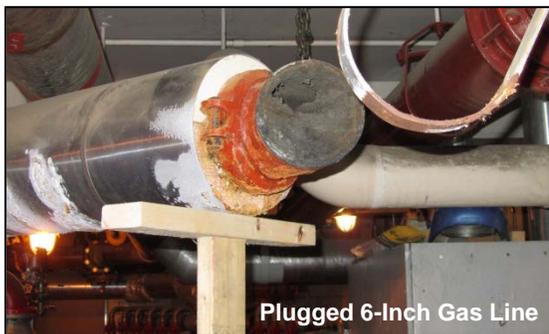
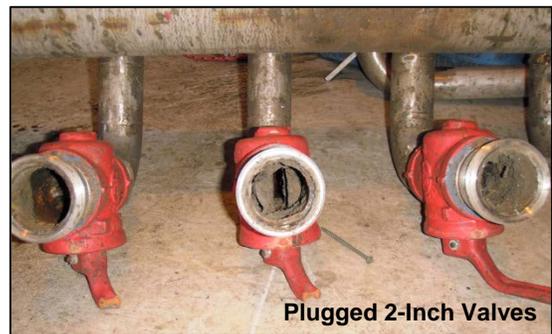
When Digester 1 was taken out of service, it was discovered that the check valves on the 2-inch gas feed lines to each mixing gun (downstream of the gas balancing manifold) which prevented sludge from backing up from the digester had failed, resulting in sludge plugging the lines all the way back to the compressors. This caused a significant decrease of gas flow to each of the mixing guns and resulted in significantly reduced mixing. It was also discovered that the plug valves on the gas distribution manifold used for isolation and balancing, and the orifice flanges used to measure gas flow, were no longer operational due to the filling and plugging of sludge. It was recommended to immediately replace all of the 6-inch gas piping and check valves downstream of the compressors, the 6-inch manifold assembly including all valves and flow meters, and associated 2-inch gas feed piping in order to regain proper operation of the digester mixing system. This work was completed in Phase 1.

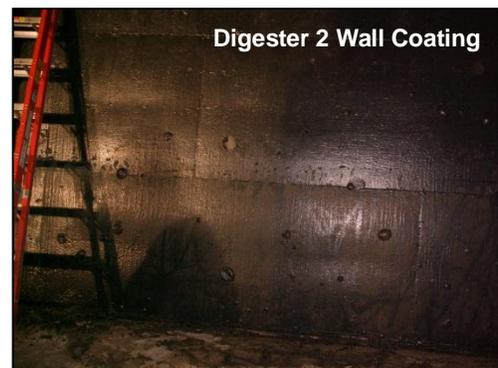
The interior concrete walls, roofs, and floors appear to be in good condition with the exception of a few spalled areas on the floors. The concrete appears to be structurally sound with no material loss or damage. There appears to be a coating on the walls, large portions of which have deteriorated. It is unknown if the coating is lead based. We recommended repairing the spalls while the digester was

out of service; this work was completed in Phase 1. We also recommended recoating all the interior digester walls and roof with high build epoxy coating in Phase 2.

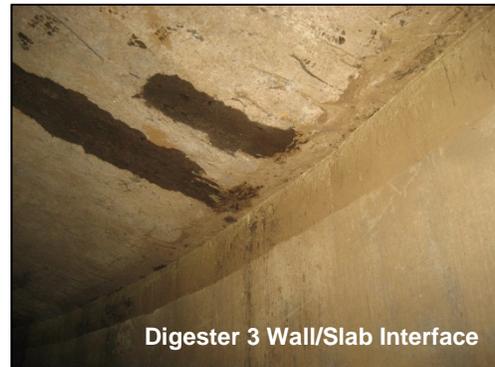
In Digester 3, the walls and roof were replaced in the early 1970s. The concrete roof was replaced with a steel dome. Therefore, some differences from the other primary digesters were discovered. Groundwater was leaking in along the base of the wall/slab interface. Based on the record drawings, there is no waterstop along this interface, just a sealant along the seam coated with coal tar epoxy. A second layer of epoxy material appears to have been applied over this interface which is now starting to separate from the base slab and is cracked at various locations. We recommended the full length of this wall/base slab interface be pressure injected with a polyurethane type of material in Phase 2. This material should stop the leaks immediately and provide a flexible joint that should not crack if movement of the wall or base slab occurs.

The failing epoxy coating (approximately 80 square feet) on the wall-to-slab interface should be removed and patched with a polymer-modified cementitious repair material. We recommended completing this repair during Phase 2.

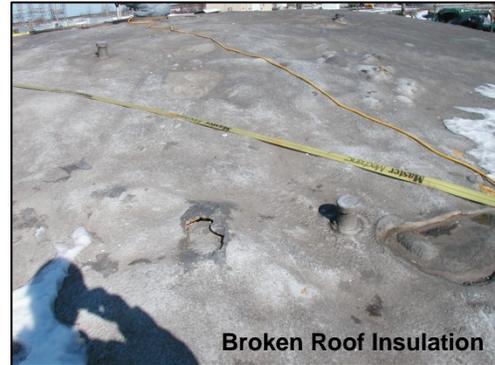
The insulated roofs were found to be in fair condition, with some areas where the shell has broken through. Some of these broken shell areas appear to have been previously repaired. It is estimated that less than 5 percent of the roof area on the primary digesters has this type of damage. As an immediate repair, we recommended patching the broken areas. This work was not completed in Phase 1 but will be done so by the County in the near future. During Phase 2 of the digester repairs, we recommended all of the insulation on the roof be replaced. Complete replacement of the insulation is recommended since all of the insulation has been damaged due to the previously broken shell.

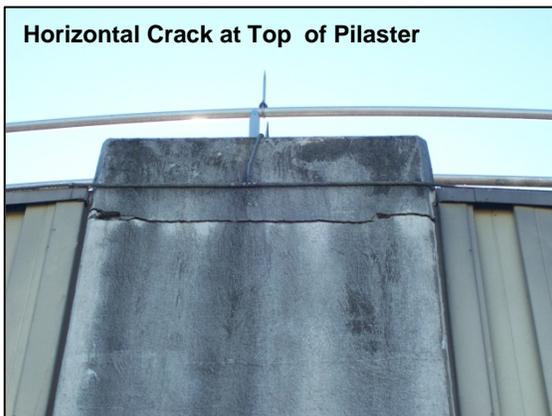
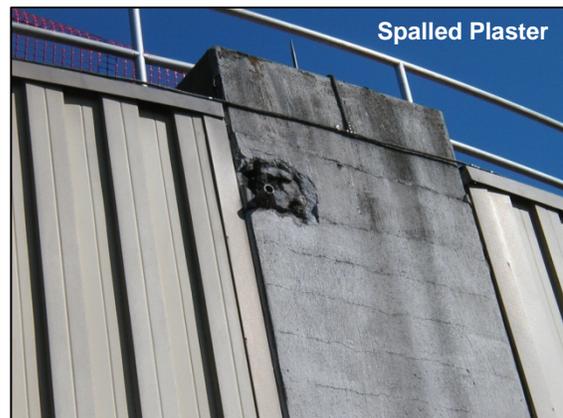
The exposed pilasters appears to have a stucco finish which needs to be repaired in several different areas. There is a significant horizontal crack near the top of every pilaster below the parapet extensions, with the exception of Digester 3, which does not have parapet extensions. Some of the parapet extensions are spalled where the guardrail posts are embedded. In these areas, the concrete has broken away from the face of the concrete wall, leaving inadequate support for the guardrail. In these areas, we recommended that the embedded posts be replaced with surface mounts and the spalls repaired during Phase 1 of the project. This work was not completed in Phase 1 but will be done so by the County in the near future. We recommended repairing the remaining cracks and spalls and recoating the pilasters in Phase 2. We recommended replacing the remaining embedded guardrail posts with surface mounts in Phase 2.

Cracked Parapet Extension

Spall Caused by Embedded Post

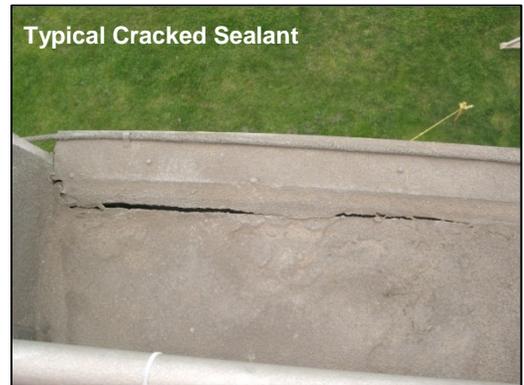
Typical Cracked Sealant

On Digesters 1 and 2, the sealant between the top of the tank wall and the flashing cap over the metal siding was cracked at several locations and appears to have exceeded its useful life. We recommended replacing the entire sealant around the perimeter of the tank with an elastomeric sealant in Phase 1. However, since this work is not critical and could be done at any time, it was decided to include it as part of the Phase 2 improvements. Therefore, only the most severely cracked portions were repaired during Phase 1.

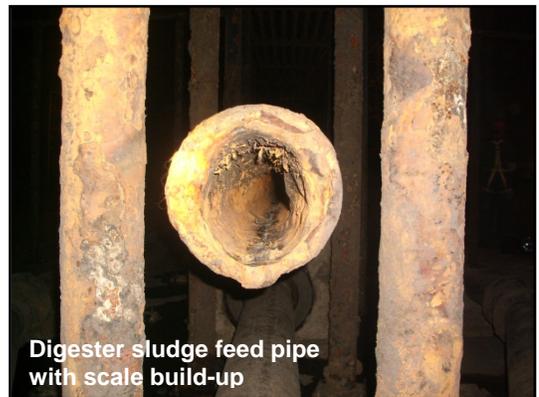
The majority of sludge piping (withdrawal pipes, feed pipes, and recirculation and supernatant elbows) and associated concrete supports appear to be in fair condition. Some of the 8-inch sludge feed pipes had scale build-up in Digester 1 and 3. For Digester 1, the high sludge feed pipe was replaced while the digester was out of service during Phase 1. For Digester 3, both feed pipes had scale build-up. Aided by the contractor, the County was able to clean much of the scale out of the pipe when flushing the pipes. It was determined that these pipes were adequate until Phase 2 and it is recommended that both pipes be replaced at that time.

Digester sludge feed pipe with scale build-up

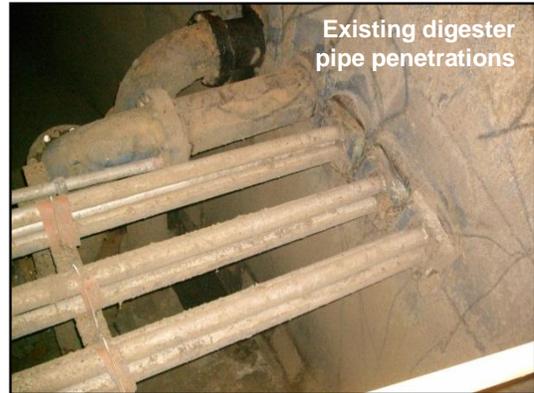
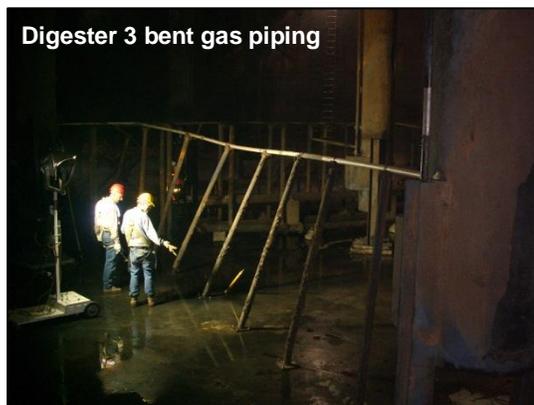
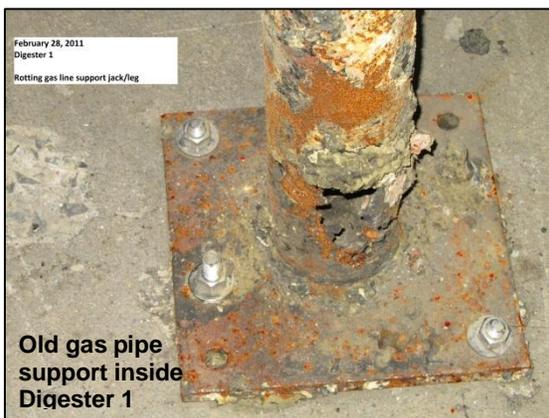
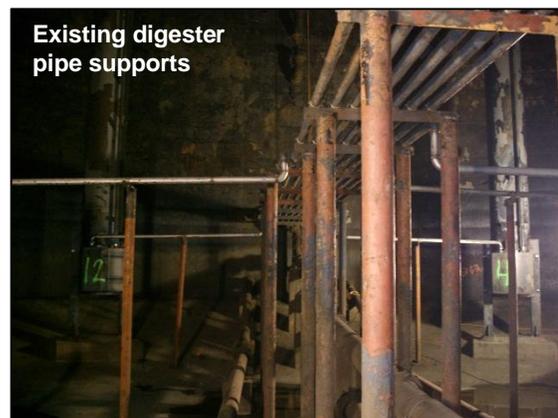
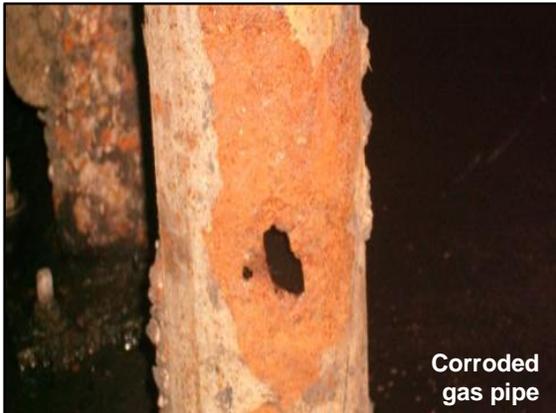
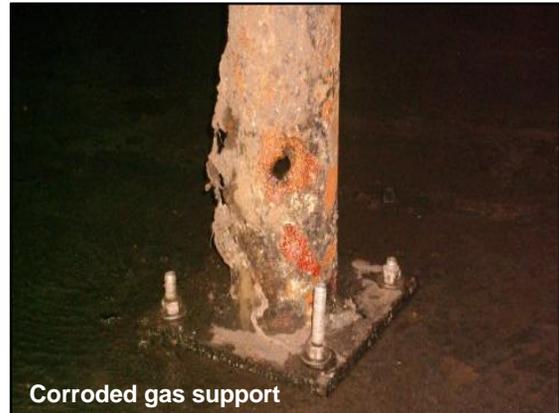
In Digesters 1 and 3, the carbon steel supports for the 2-inch gas feed piping were found to be in poor condition, showing signs of severe corrosion. In some cases, the support was completely corroded through. In Digester 2, the supports were in better condition with only some minor surface corrosion. It was recommended that the supports be replaced in kind using stainless steel in lieu of carbon steel for Digesters 1 and 3 to ensure adequate support of the gas piping. This work was completed in Phase 1. We believed that the supports in Digester 2 were capable of adequately supporting the gas pipe until Phase 2, and thus recommended their replacement in Phase 2. The County agreed but also decided to recoat them while the digester was out of service to increase their longevity.

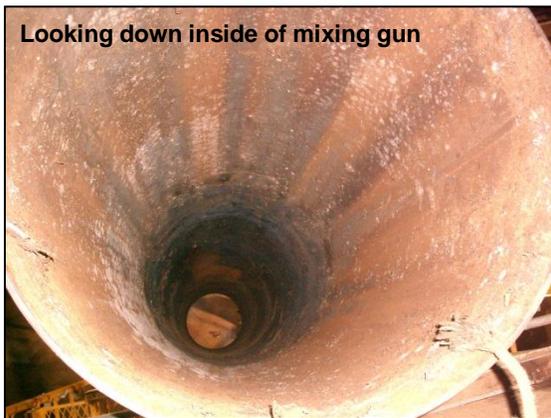
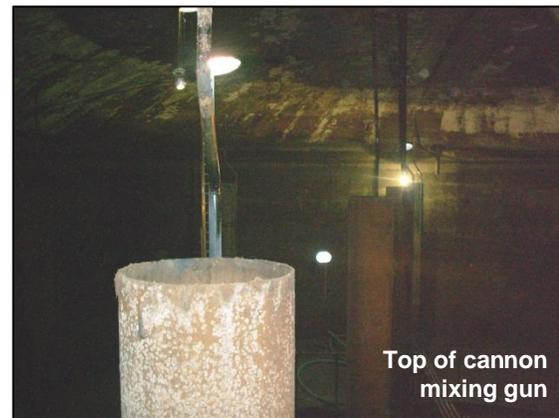
The mixing guns (draft tubes) and bubble generators appear to be in fair condition; however, much of the coating has worn off. No loss of structural thickness was observed for the mixing gun tubes. It is recommended that the mixing guns be recoated in Phase 2. Some loss of material and corrosion was found around the throttle plate openings at the bottom of the bubble generators. It was recommended to repair these corroded areas while the digester was out of service to prevent further damage. This work was completed in Phase 1. The openings were all still in compliance with the manufacturer's specifications. It is recommended that the bubble generators be either recoated or replaced with new stainless steel bubble generators in Phase 2.

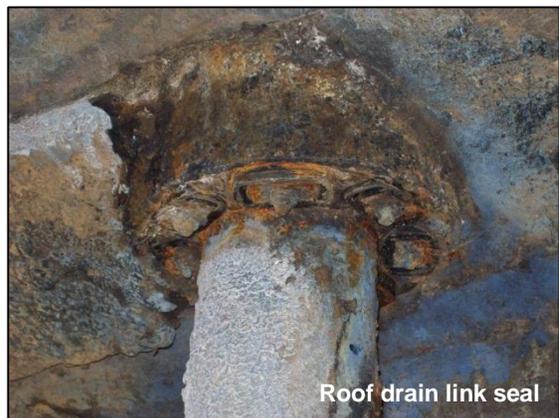
The roof drains in Digesters 1 and 2 are internal to the digester. They were made of cast iron and original to the digester. The roof drains appeared to be in poor condition and some of the joints appeared to be leaking. The pipe showed signs of pitting and corrosion. When water was added to one of the roof drains, it was found that the mechanical seal had failed and was leaking. Also, the roof drain supports were severely corroded and broken in some places. It was recommended that the roof drains in

Digester 1 be replaced during Phase 1. This work was completed. In Digester 2, the roof drains were in better condition and were not recommended for replacement during Phase 1. However, the County requested they also be replaced during Phase 1. This work was completed.

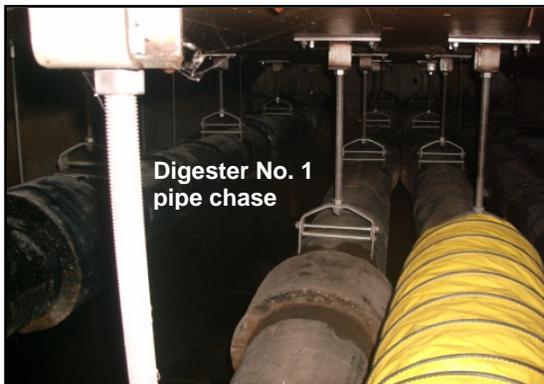
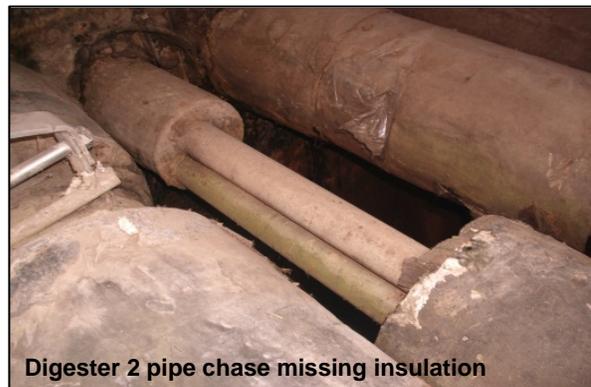
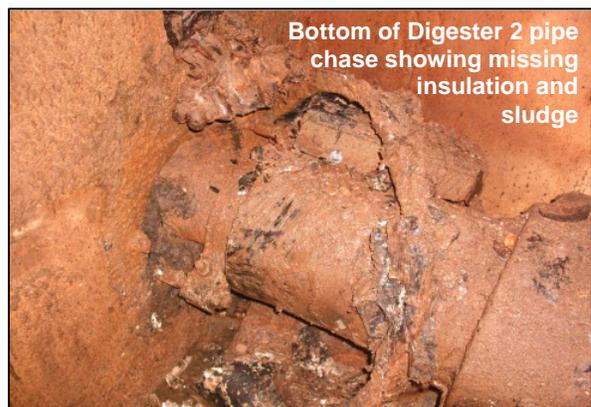
Groundwater is leaking in the joints of the pipe chase, leaving the majority of the pipe chase submerged. The groundwater had to be pumped out to observe the pipe chase. The piping in the pipe chases was wrapped with submersible insulation which did not allow for assessment of the piping. The insulation appears to be in fair condition in Digesters 1 and 3, but poor condition in Digester 2. Some of the wrapping fell off the piping. It is recommended this wrapping be replaced in Phase 2 in order to adequately protect the piping. Digesters 2 and 3 had sludge on the bottom of the pipe chase which should be removed during Phase 2 because it is a safety hazard. The pipe supports in the chase appear to be in good condition.

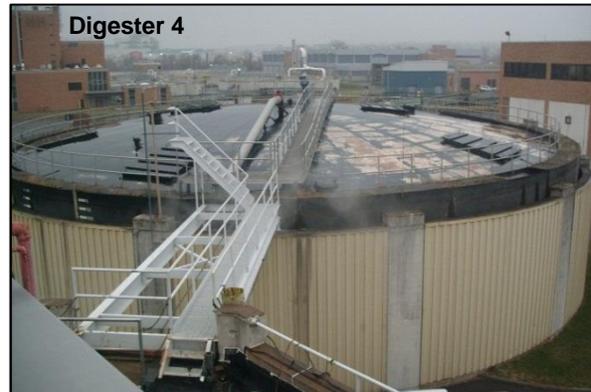
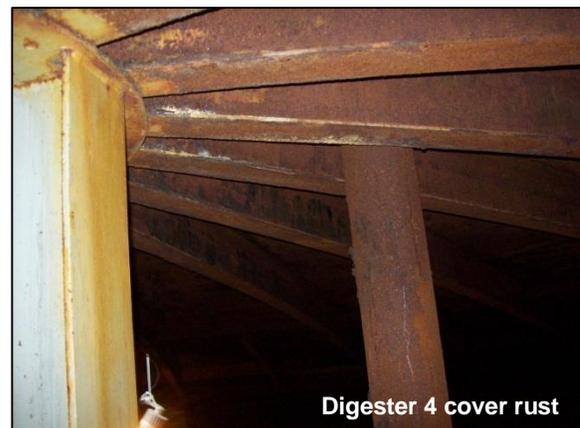
The secondary digester is equipped with a gas holder-type floating cover which maintains a set pressure so the volume of gas can increase or decrease as it is used. The carbon steel cover panels and structural members on the interior of the cover appear to be in good structural condition. It appears that sections of the interior of the cover had been more recently rehabilitated than others. Hence, some sections of the inside of the cover showed more corrosion than others. However, between these different sections, no variation in structural thickness could be measured. Therefore, we believe that the corrosion is limited to the surface. On the exterior top section of the cover, the coating appears to be in fair condition with some areas of corrosion. Also, during inspection it was discovered that the floating gas holder cover was visibly tilted, caused by the cover tie rods failing. In the future, if the cover is to be rehabilitated, we recommended removing the entire cover from the digester to aid in a full rehabilitation of the cover and tank. Removing the cover is necessary in order to access the center column, skirt, and walls. Cover rehabilitation should include:

(1) sandblasting and recoating the cover; (2) sandblasting and recoating the center column; and (3) sandblasting and recoating concrete walls.

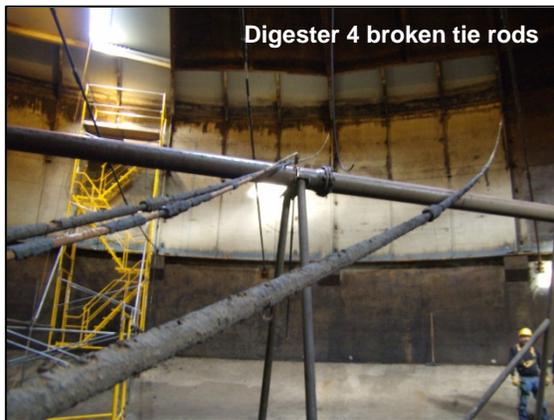
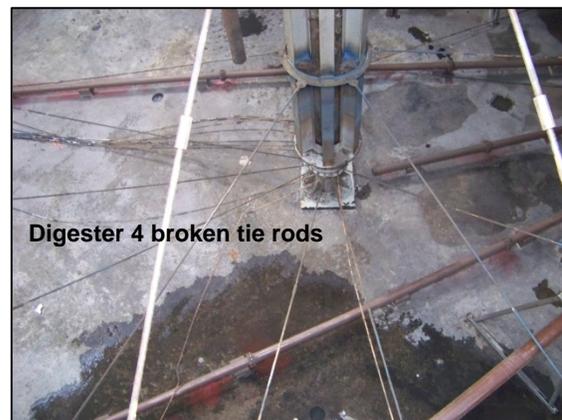
Eighteen diagonal tie rods connect the top perimeter of the cover to the base of the exterior moveable column. Each diagonal tie rod (Type B) consists of five segments connected to each other with threaded turnbuckles. Each rod is connected to a hub at the base of the outer (moveable) center column with a hemispherical nut. Over time, many of the tie rods unscrewed from the turnbuckles and fell to the floor of the digester. Many of the fallen tie rods were bent. No issues with these rods were identified in the 1999 inspection report. The diagonal tie rods are necessary for the structural integrity and balance of the cover over its range of travel. Therefore, it was recommended to replace as necessary and reinstall the tie rods before the digester was placed back in operation. This work was completed in Phase 1.

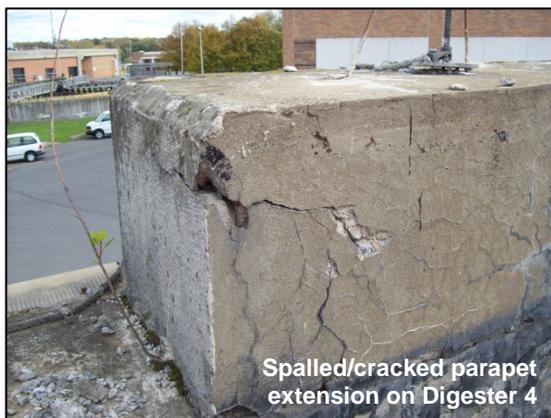
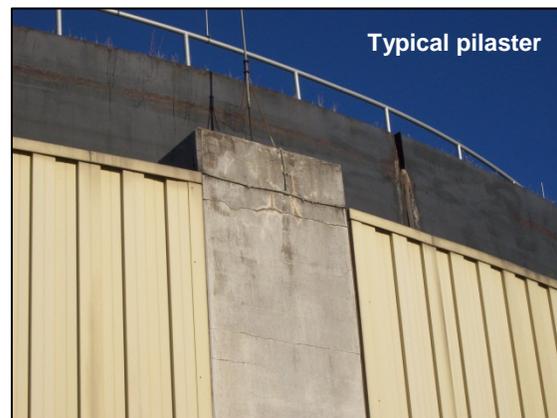
The pilaster appears to be in fair condition, with some dark staining and horizontal cracking. The stucco-type coating needs to be repaired in several areas. There is a significant horizontal crack along the top of every pilaster. The inside face and tops of the pilasters have damage due to cracking and deterioration. We recommended repairing the cracks and recoating in Phase 2.

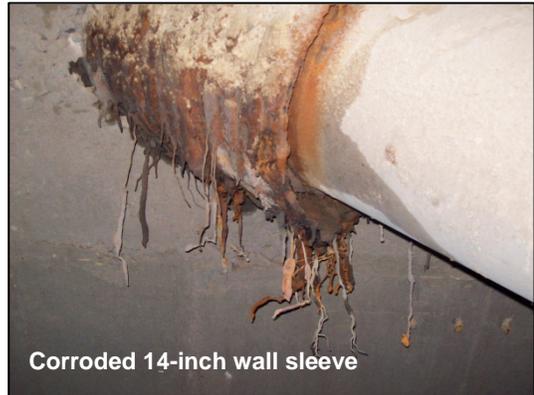
The pipes in the pipe chase are ductile iron and appear to be in good condition. Most of the pipes and couplings located below the normal groundwater level have been coated with a coal tar epoxy which has protected the piping from corrosion. Replacement of pipe is not necessary or recommended.

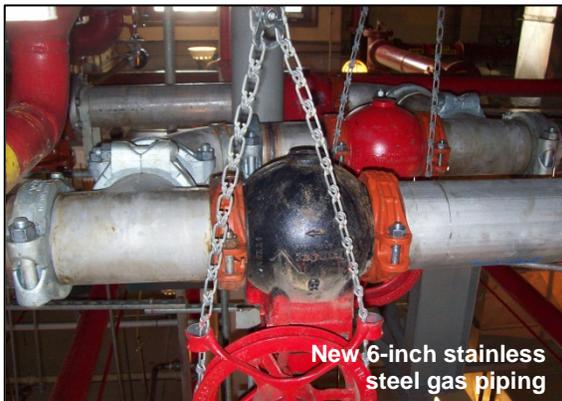
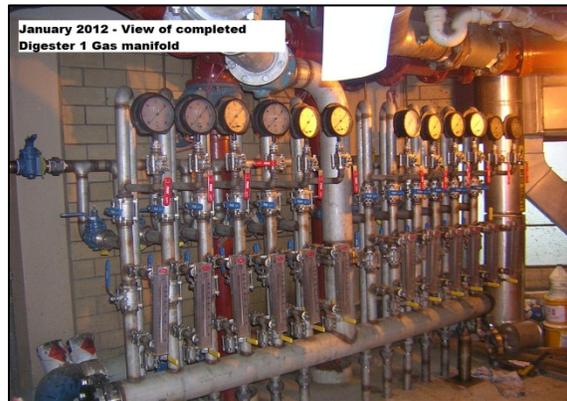
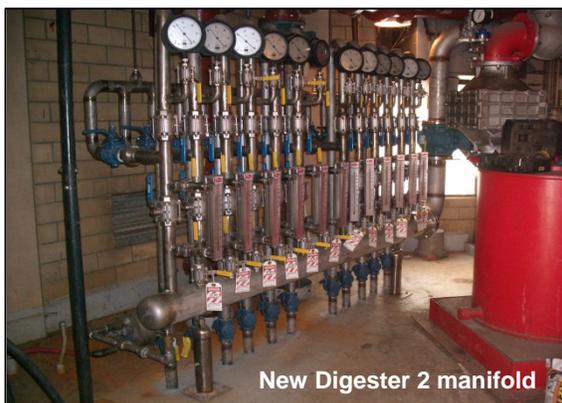
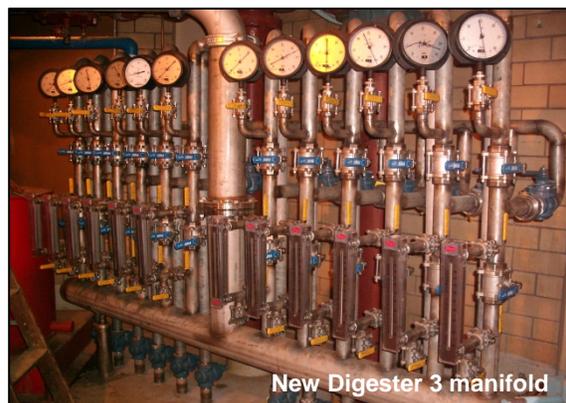
Several Phase 1 improvements were made to the DCH during this project. The major repairs involved improvements to the gas mixing system. During construction, it was discovered that the 6-inch gas compressor discharge piping was completely plugged with sludge as a result of check valve failure on the 2-inch gas feed piping. For each of the five compressors, the existing steel 6-inch diameter gas compressor discharge piping header was replaced with new Schedule 40 stainless steel grooved pipe. For each primary digester, the existing stainless steel 6-inch gas discharge manifold, the entire gas balancing manifold system including balancing and isolation plug valves, and associated 2-inch diameter stainless steel piping were replaced. The new manifold is equipped with new stainless steel ball valves and new rotameters for gas flow measuring.

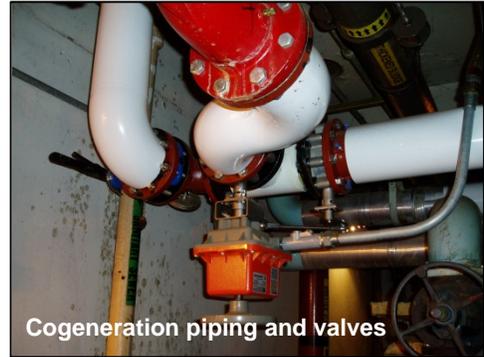
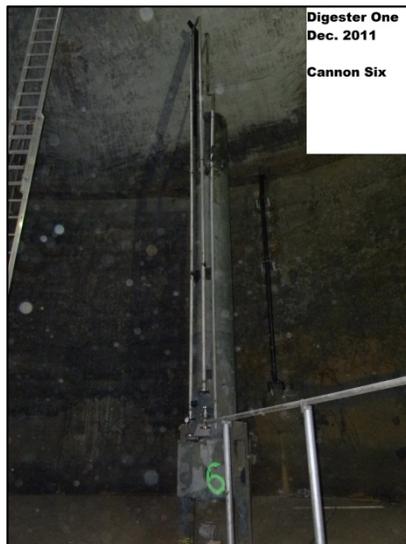
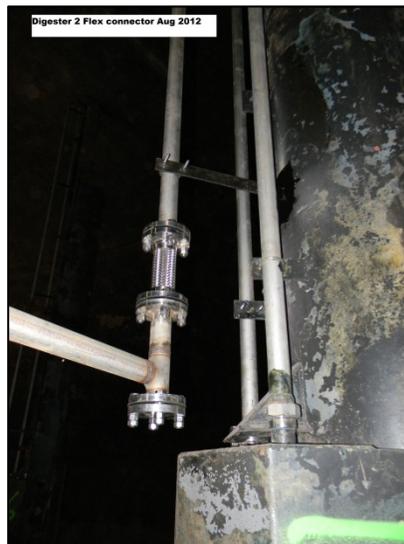
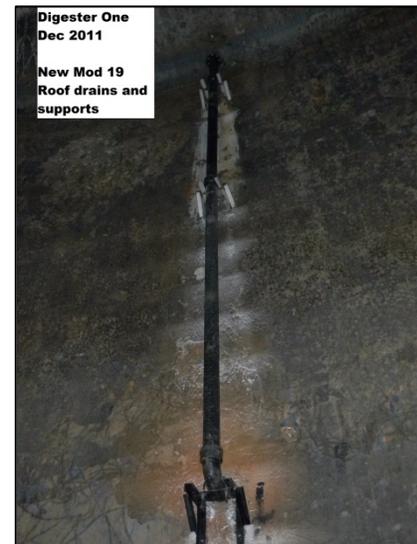
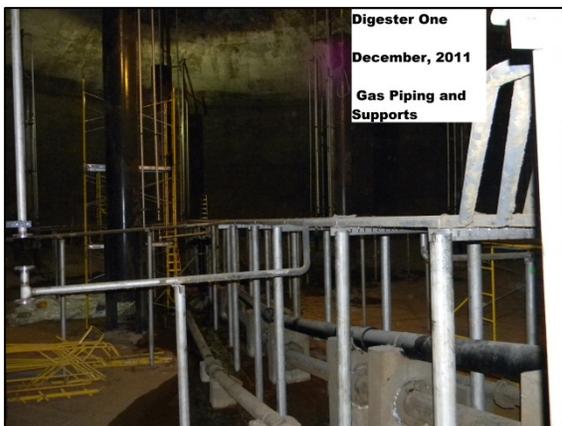
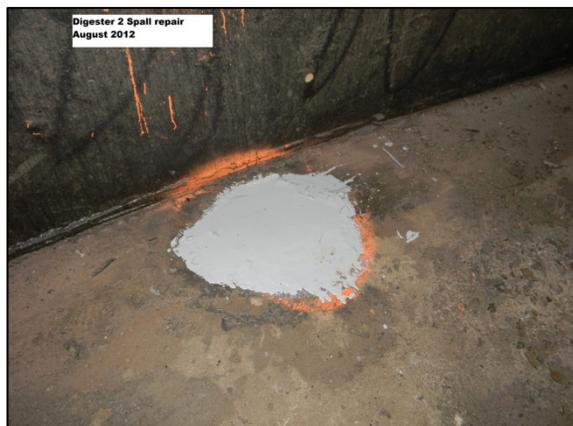
Several Phase 1 improvements were made to the primary digesters. The major repair/upgrade was the addition of the "Hartford Loop" on all 2-inch gas feed lines for each mixing gun.

The Hartford Loop is an extension of the 2-inch gas feed piping which rises above the maximum water level so that sludge cannot back up beyond the loop, protecting any piping and equipment upstream of the loop. The Hartford Loop is an improvement to the gas mixing system that reduces the possibility of sludge backing up the piping to the DCH. The system no longer relies on check valves to hold back the pressure of the sludge. The new Hartford Loop arrangement will maximize mixing efficiency and gas production.

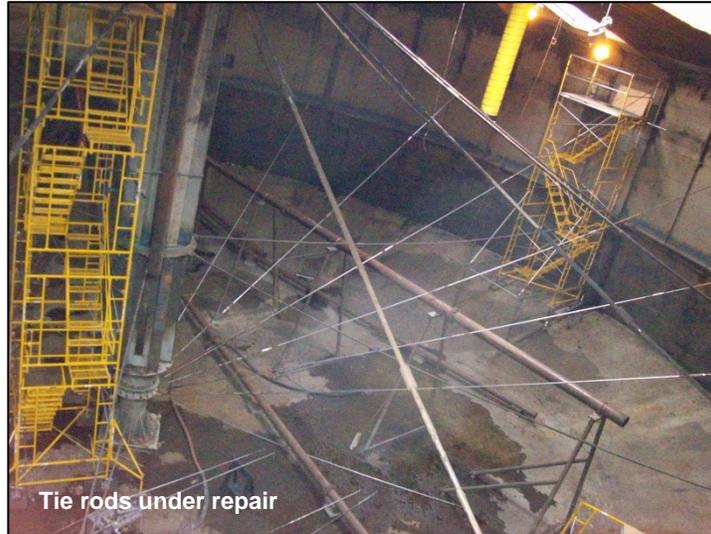
Several Phase 1 improvements were made to the secondary digester (Digester 4). The major repair/upgrade was the rehabilitation of the existing 50-year old floating steel cover. This included replacing and tensioning the damaged stainless steel tie rods; adding locking nuts at the turnbuckles connecting the rods to prevent the tie rods from coming undone again; repair of indentations on the digester skirt; replacement of two deteriorated tie rod connection plates; and balancing and leak testing the rehabilitated cover under the supervision of the manufacturer.

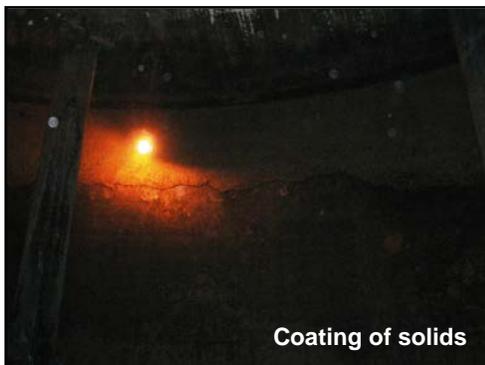
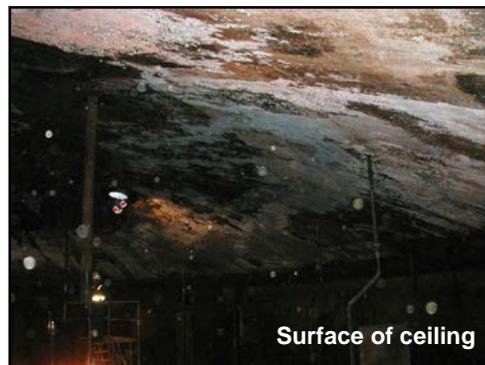
The interior surfaces of the concrete floor and approximately the bottom two-thirds of the wall had been cleaned off and pressure washed. The top third of the wall had a thick coating of solids that had not been removed. The underside of the concrete roof (ceiling) had not been cleaned off and solids still coated much of the surface. Scaffolding located along the outside wall provided access to a portion of the ceiling for structural assessment.

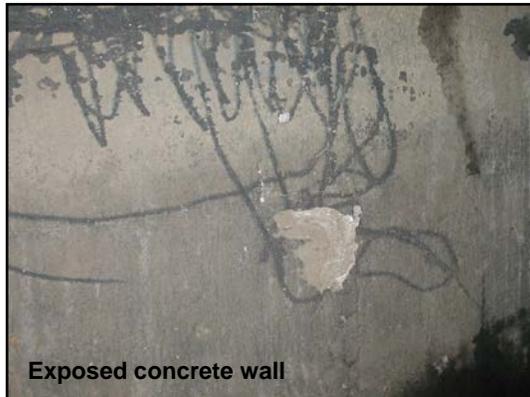
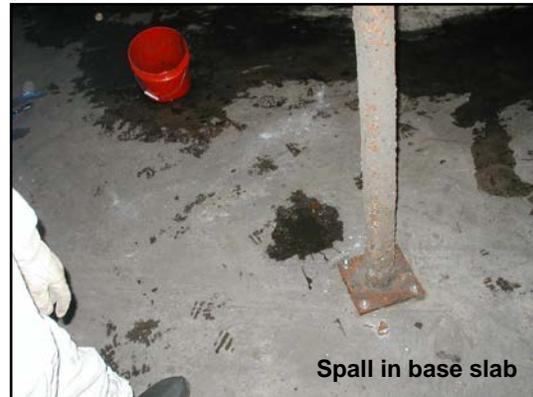
The interior surfaces of the concrete wall, roof, and floor appeared to be in good condition. The concrete appeared to be structurally sound with no material loss or damage. The only noticeable exception is an approximate 2-inch deep, 1 square foot spalled area in the slab that does not appear to expose any rebar (refer to photo). This spall does not appear to have any structural significance; however, we do recommend repairing the spall while the digester is out of service. This work will be covered under Unit Price Payment Item 5. The top third of the wall could not be inspected because of the solids coating.

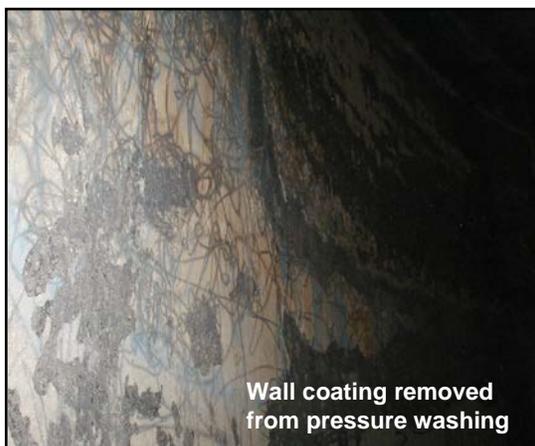
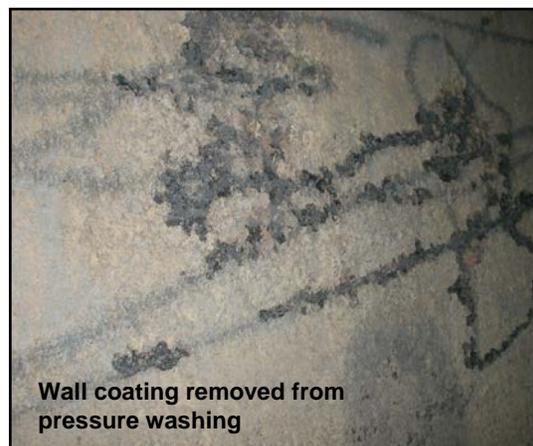
There appears to be a coal tar epoxy coating on the wall and base slab. Approximately 50 percent of the coating remains. Areas of the coating on the wall appeared to have bonding failure and broke off when tapped on. The coating on the base slab appeared to be in good condition with no apparent bonding issue. We recommend recoating the entire interior digester walls and roof with high build epoxy coating (such as Sikagard 62). The estimated time to complete this recoat is two months. Due to the cost and time required to complete this work, we recommend that this recoating be completed as a Phase 2 improvement.

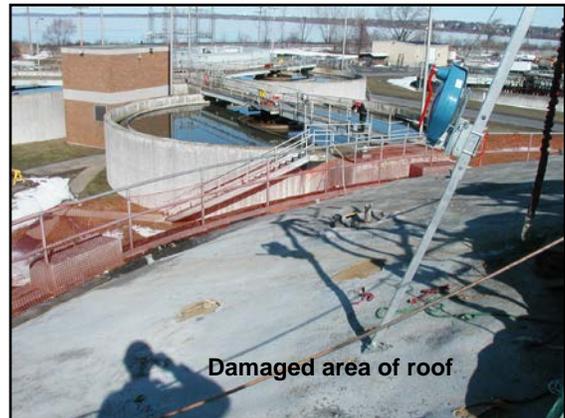
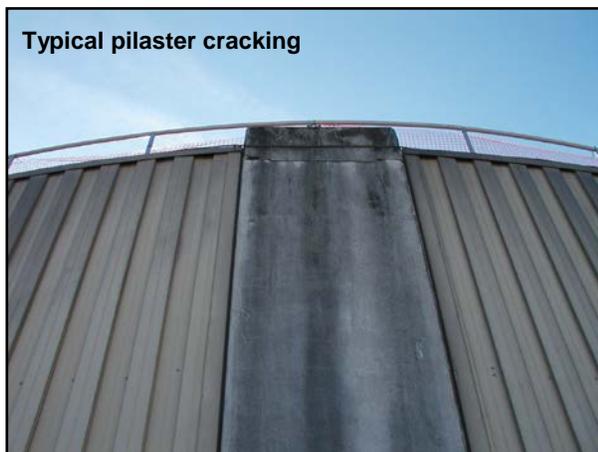
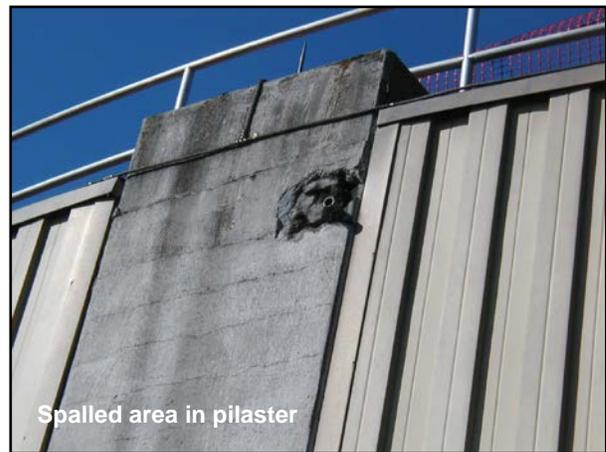
One of the pilasters has significant damage at the top where a drain pipe penetrates through it. We recommend repairing this spalled area.

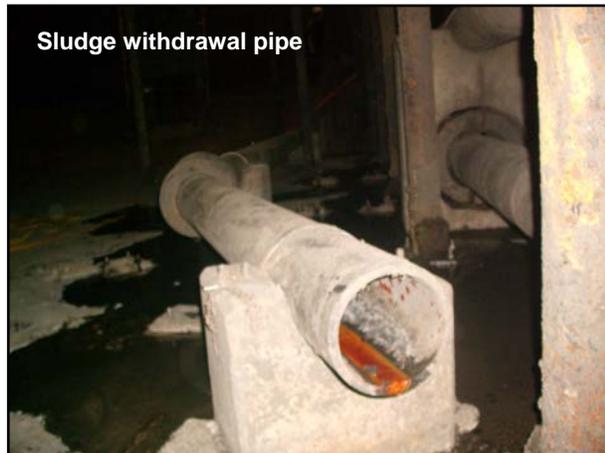
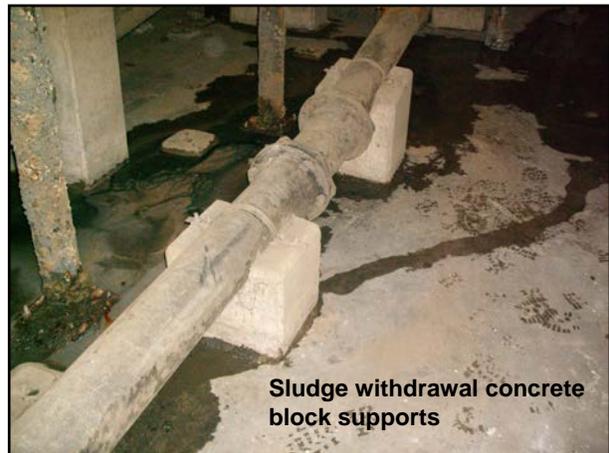
There are two 6-inch diameter ductile iron sludge withdrawal pipes in Digester No. 1. They terminate at the center of the digester and are routed along the bottom slope of the floor. The pipes are supported by concrete block. Both pipes and all supports appear to be in good condition. No recommendations are made at this time for corrective repairs to the sludge withdrawal pipes or supports.

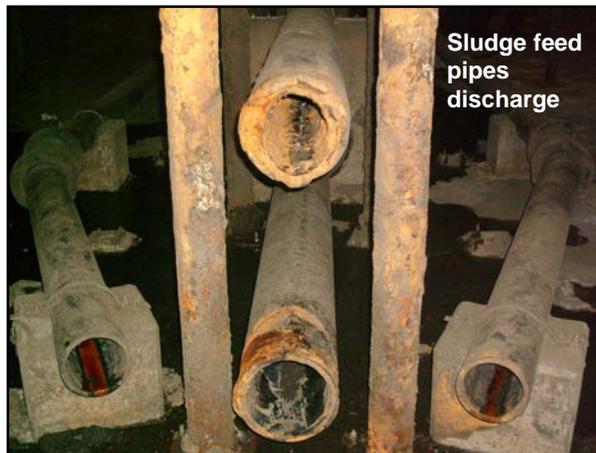
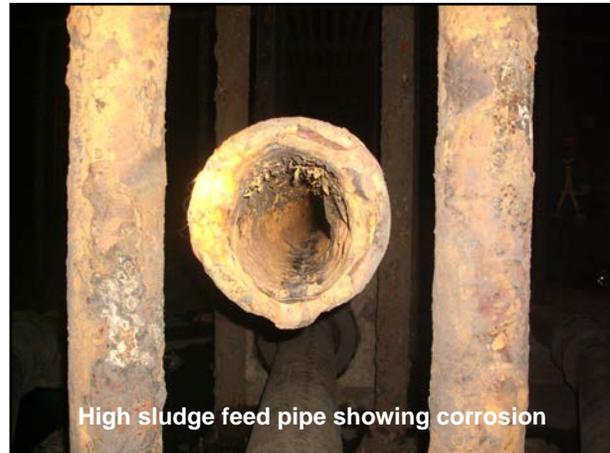
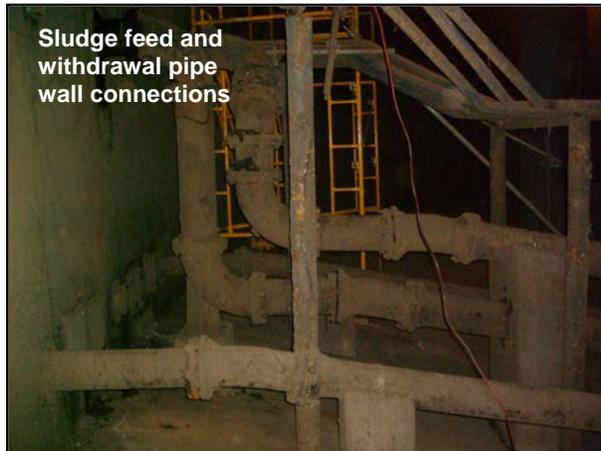
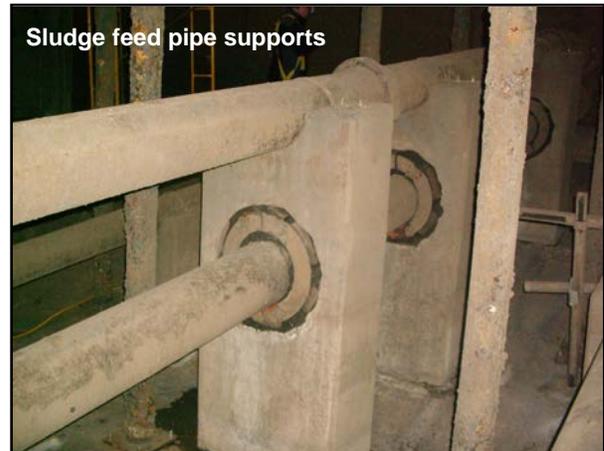
There are two 8-inch diameter ductile iron sludge feed pipes in Digester No. 1 which terminate at the center of the digester. There is a low feed and a high feed as shown in the photo. The low feed is just off the floor and the high feed is about 3 feet above. The pipes are supported by concrete block with wood framing for the low pipe. The low sludge feed pipe appeared to be in good condition. No recommendations are made at this time for corrective repairs to the low sludge feed pipe.

The high sludge feed pipe has significant internal buildup of scale and the working diameter of the pipe has been greatly reduced. We recommend replacing the high sludge feed pipe back to the last isolation valve in the Digester Control House. The new pipe will be 8-inch flanged ductile iron pipe with a plain end discharge. The approximate length of pipe to be replaced is 75 feet. We recommend the new sludge feed pipe match the existing layout and the existing supports be reused. This work would fall under Unit Price Payment Item 8.

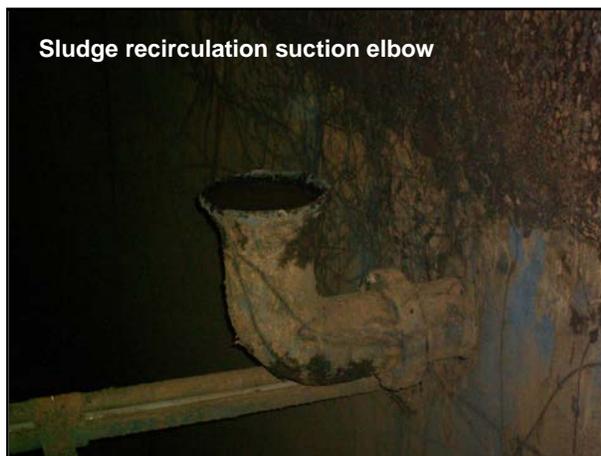
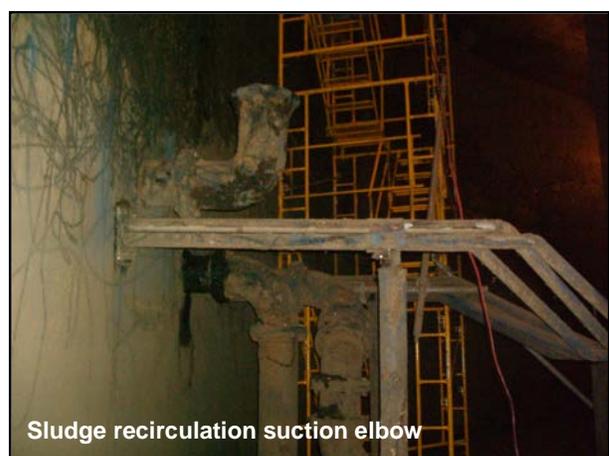
The recirculation elbow appeared to be in good condition, although it was flooded with liquid. No recommendations are made at this time for corrective repairs to the sludge recirculation elbow. However, the Contractor is required to remove all liquid from the digester under the lump sum work, and all sludge pipes should be flushed and drained, including the recirculation suction line.

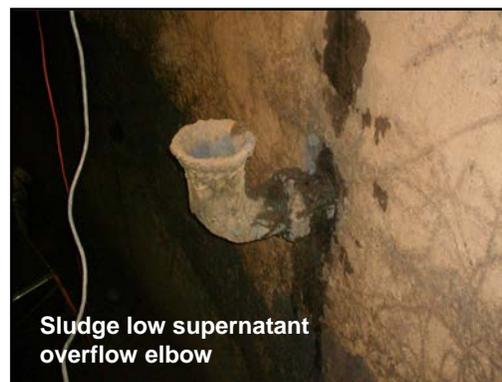
Sludge low supernatant overflow elbow

Each primary digester is equipped with a single 8-inch diameter sludge low supernatant overflow (ductile iron) elbow. The low supernatant overflow pipe enters the digester and elbows up. The intake of the elbow is approximately 22 feet above the bottom of the digester wall.

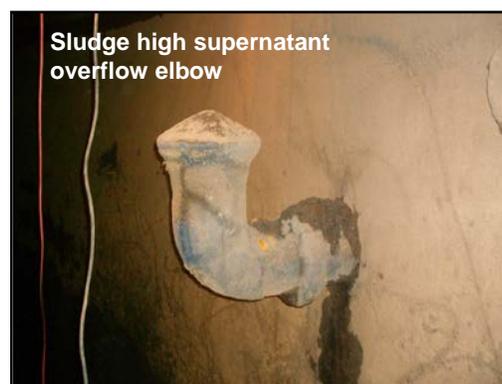
Sludge high supernatant overflow elbow

The high supernatant overflow elbow appeared to be in good condition. However, it was plugged with sludge/scum/grit accumulation. We recommend the Contractor flush and drain the entire sludge high supernatant overflow line. This is required in the lump sum work of the project.

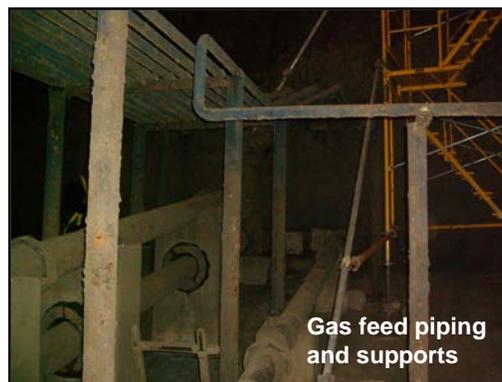
The stainless steel pipes appeared to be in good condition. When attempting to flush each gas pipe, it was discovered that three gas feed pipes were clogged at the elbow just before the entrance to the "bubble generator." All 2-inch stainless gas pipes are required to be free and clean of grit for proper operation of the mixing system. We recommend the clogged pipes be snaked and flushed clean. This work will require a modification.

The pipe supports appeared to be in poor condition. All showed corrosion, and on some of the supports, the bottom of the steel pipe was completely corroded away. We recommend replacing all gas pipe supports with stainless steel supports and hardware. The pipe supports will be replaced in kind, and all replacement hardware and plates will be 316 stainless steel. The existing U-bolts holding the pipes are stainless and can be reused if possible, as is the case with the existing anchor bolts at the baseplate. The supports should be replaced with Type 304 Schedule 40 stainless steel.

Gas feed piping and supports

The estimated quantity to be replaced is 65 pipe supports, each approximately 7 to 10 feet tall. A modification will be required to complete this work. We recommend obtaining a proposal from the contractor to replace all of the pipe supports. If the price exceeds the budget of the project, an alternative approach is to replace only the most severely corroded pipe supports (those that have corroded away at the bottom), and replace the remaining as part of Phase 2.

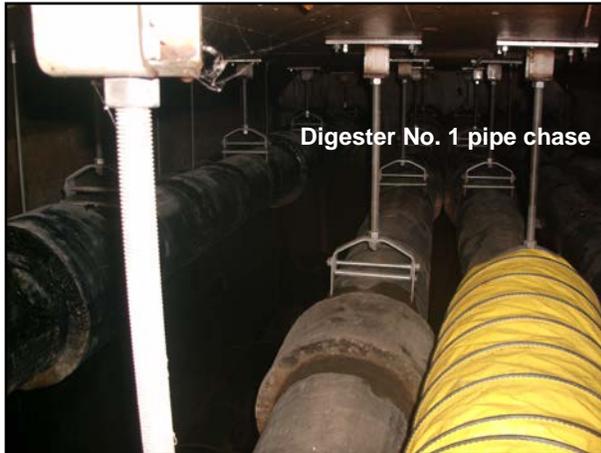
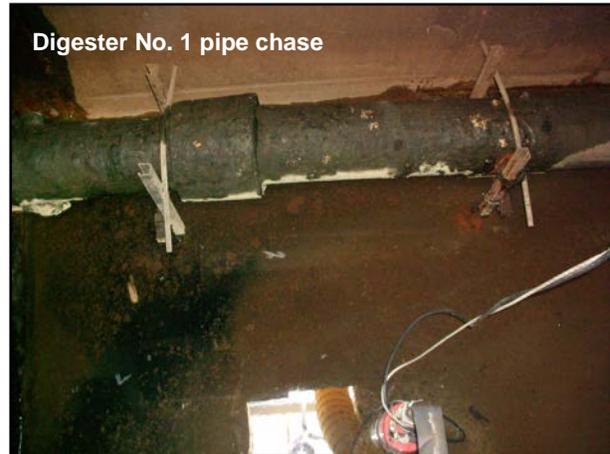
Digester No. 1 Pipe Chase

The pipe chase between the Digester Control House and Digester No. 1 was also observed. The condition of the pipes could not be determined due to the submersible insulation wrapped around all of the pipes. The submersible insulation appeared to be in good condition. It is believed the submersible insulation is adequately protecting the pipes. The pipe supports are all stainless steel and appeared to be in good condition. No recommendations are made at this time for corrective repairs to the Digester No. 1 pipe chase, other than the replacement of the sludge feed pipe previously noted.

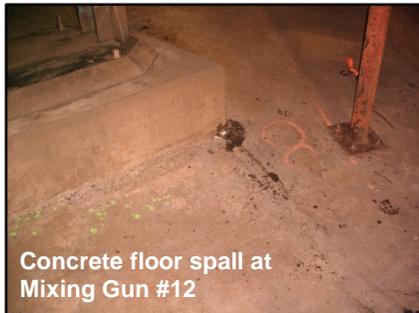
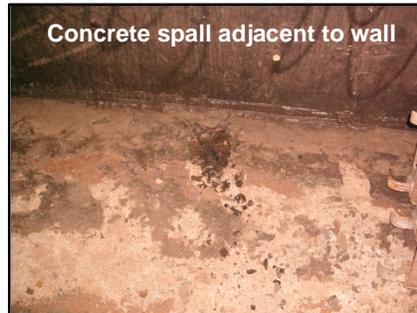
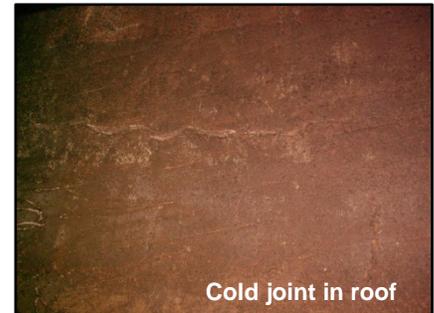
The interior surfaces of the concrete wall, roof, and floor appeared to be in good condition. The concrete appeared to be structurally sound with no material loss or damage. The only noticeable exceptions were two approximate 2-inch deep, 1 square foot spalled areas in the slab that do not appear to expose any rebar (refer to photo). One of these spalls is at the base of Cannon Mixer #12; the other is adjacent to the wall near Cannon Mixer #9. These spalls do not appear to have any

structural significance; however, we do recommend repairing them while the digester is out of service. This work will be covered under Unit Price Payment Item 5. On the roof, a crack was observed that appeared to be a cold joint that was created during concrete placement, likely from original construction. We do not believe there is a structural concern with this cold joint.

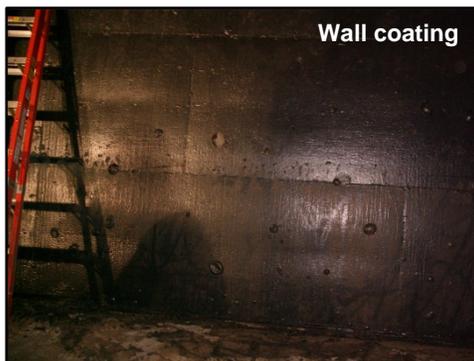
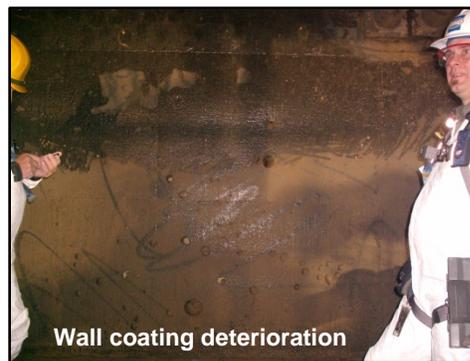
There appears to be an asphalt urethane coating on the wall. Approximately 75 percent of the coating remains. Areas of the coating on the wall appeared to have bonding failure and broke off when tapped on. We recommend recoating the entire interior digester walls and roof with high build epoxy coating (such as Sikagard 62). The estimated time to complete this recoat is two months. Due to the cost and time required to complete this work, we recommend that this recoating be completed as a Phase 2 improvement. There did not appear to be a coating on the slab or roof.

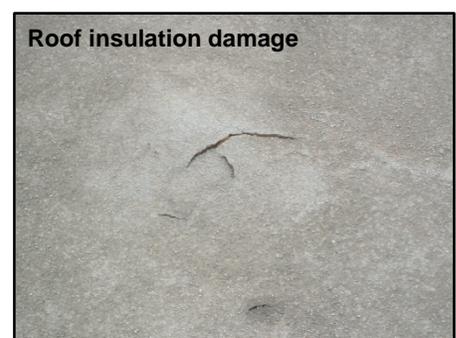
The insulated roof appeared to be in fair condition, with some minor areas of the hard shell broken through. It is estimated that less than 5 percent of the roof area has this type of damage. The granular material from this shell has accumulated in the gutter along the perimeter of the dome roof. It is suggested that these gutters be cleaned out in order to keep the roof drains from being clogged.

The metal siding appears to be in fair condition with some fading of the color and damage along the bottom edge. The damage along the bottom edge is assumed to have been caused by lawnmowing or some other equipment.
