Onondaga County Department of
Water Environment Protection
Syracuse Metropolitan WWTP Digester
Cleaning and Miscellaneous Repairs Project
Technical Report

TECHNICAL REPORT
SYRACUSE METROPOLITAN WWTP DIGESTER CLEANING
AND MISCELLANEOUS REPAIRS PROJECT

GHD CONSULTING ENGINEERS, LLC
One Remington Park Drive
Cazenovia, NY 13035

Project No. 8614054

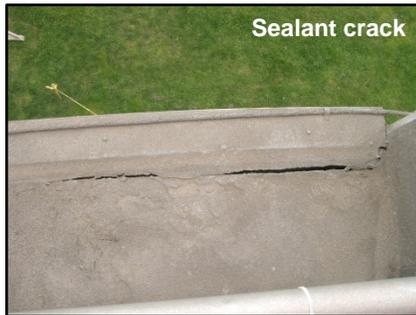
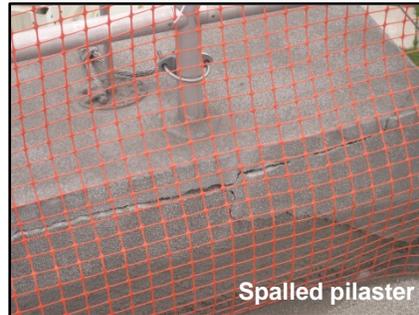
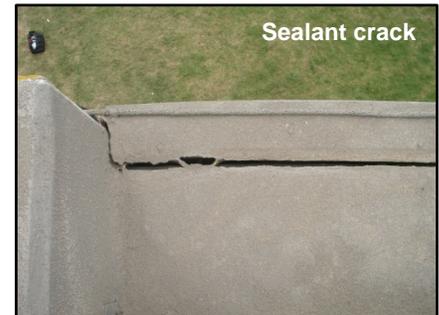
The exposed pilasters appeared to have stucco finish. Many of the surfaces are dark stained, and some areas are showing horizontal cracking on the pilaster face. The stucco-type coating needs to be repaired in several different areas. Along the top of every pilaster (below the parapet extensions), there is a significant horizontal crack which may indicate more than just cracking in the stucco-type coating. We recommend repairing the cracked concrete pilasters. This repair can be completed at any time and thus is considered a Phase 2 repair.

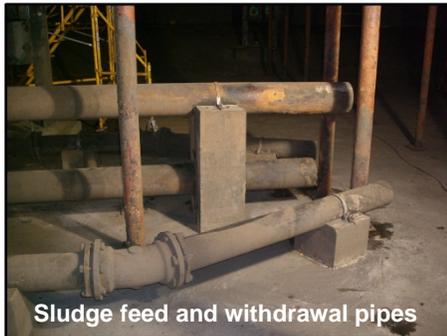
off the floor and the high feed is about 3 feet above. The pipes are supported by concrete block with wood framing. Both sludge feed pipes appeared to be in fair condition. No recommendations are made at this time for corrective repairs.

Sludge feed and withdrawal pipes

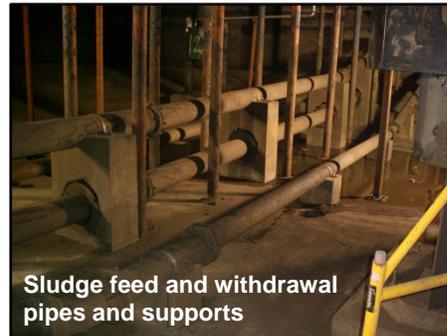
The concrete supports appeared to be in fair condition. No recommendations are made at this time for corrective repairs.

Sludge feed and withdrawal pipes and supports

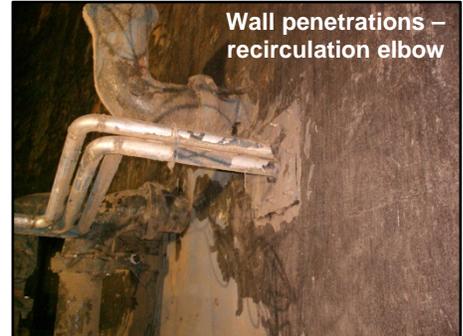
Wall penetrations – recirculation elbow

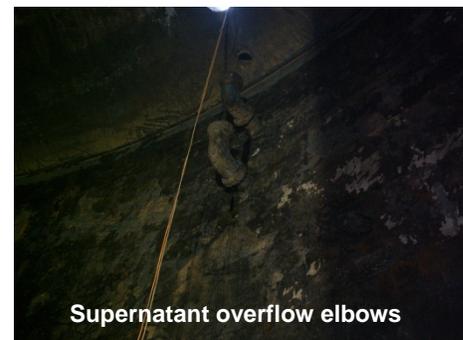
Each primary digester is equipped with a single 8-inch diameter sludge high supernatant overflow ductile iron elbow. The high supernatant overflow pipe enters the digester and elbows up. The intake of the elbow is approximately 26 feet above the bottom of the digester wall. The high supernatant overflow elbow appeared to be in fair condition. No recommendations are made at this time for corrective repairs.

Supernatant overflow elbows

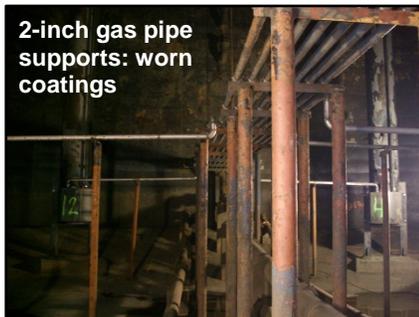
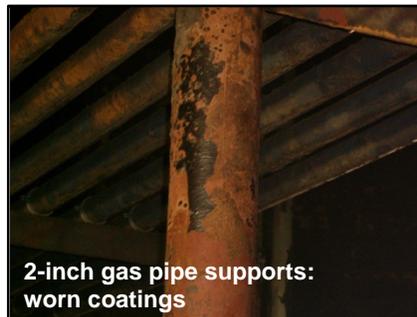
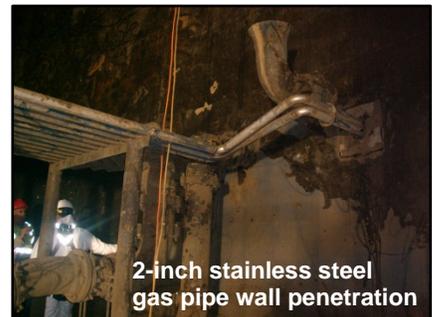
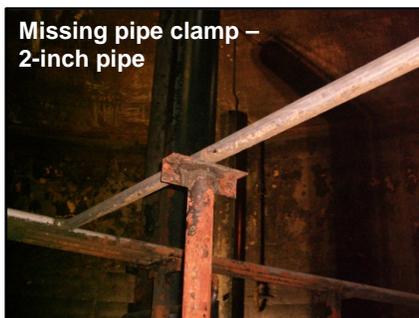
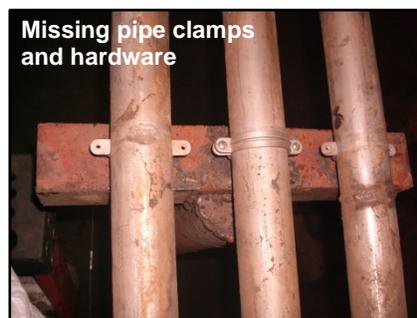
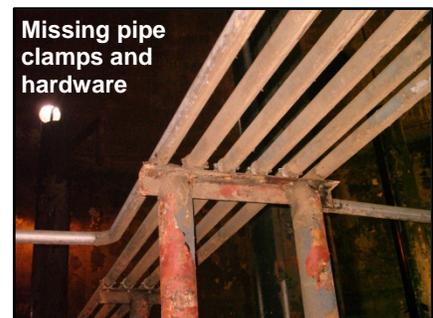
The pipe supports appeared to be in fair condition, although most of the coating protecting the supports has worn off. We believe the carbon steel supports are in sufficient condition to provide adequate support until Phase 2 without any corrective measures. For Phase 2, it is recommended to replace all gas pipe supports with stainless steel supports and hardware. The pipe supports will be replaced in kind, with Type 304 Schedule 40 stainless steel, and all replacement hardware and plates will be 316 stainless steel.

Many of the supports were also missing pipe clamps and screws to restrain the pipe. It is recommended that all pipe supports without clamps or screws be replaced with the appropriate hardware during Phase 1 while the digester is out of service. All replacement clamps or screws should be 316 stainless steel.

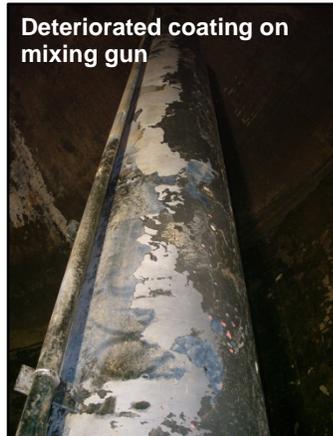
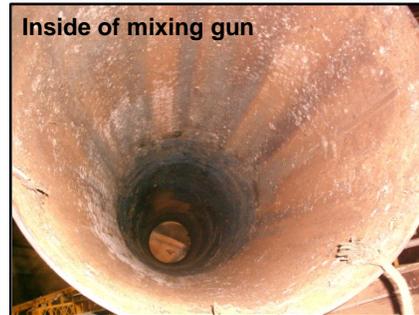
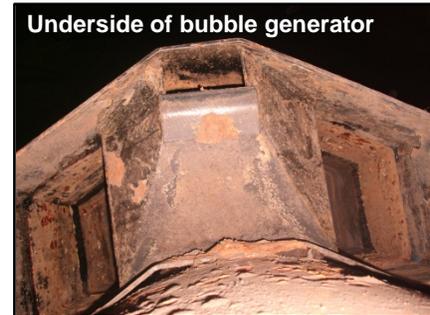
Digester Gas Mixing Guns

This mixing guns appear to be in fair condition; however, much of the coating has worn off of the mixing gun tube. The cost of recoating the mixing guns for Digester No. 2 would be approximately \$120,000.

Due to the time and cost required to recoat the mixing guns, it is recommended that this work be completed during Phase 2. Coating has also worn off the carbon steel bubble generators, resulting in some corrosion around the throttle plate openings on some of the mixers. In Phase 2, it is recommended to either recoat the bubble generators or replace with stainless steel. In addition, mats of hair were seen on the inside of the mixing guns and it did not appear they had been cleaned. The inside should be cleaned/power washed as part of the contractual work of this project.

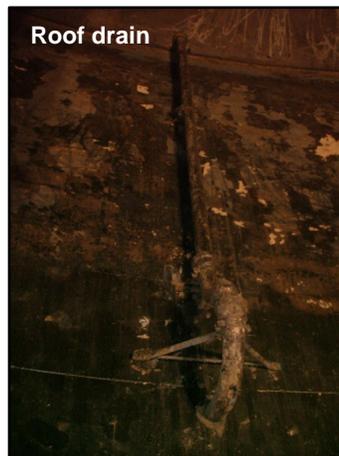
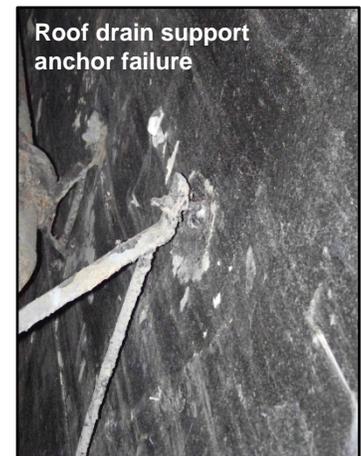
Roof Drains

Each primary digester is equipped with three roof drains. For Digester No. 2, the roof drains are mounted on the inside wall of the digester and discharge through the digester wall below grade and drain to a manhole outside of the digester. The roof drains are believed to be cast iron and original with the digester. According to County staff, one of the roof drains leaked inside the digester at a joint, and the other two drains presumably leaked at an unknown location underground before they discharged to the manhole. This was discovered during a hydrostatic pressure test performed by the County and contractor prior to the inspection.

Some of the roof drain support anchors and the coating system on the supports have also failed. The roof drains/supports appear to be in poor condition; however, replacing them

while the digester is out of service is not a necessity. Because of this and the budget constraints of the project, we recommend replacing all three roof drains and supports with new cast iron pipe and stainless steel supports in Phase 2.

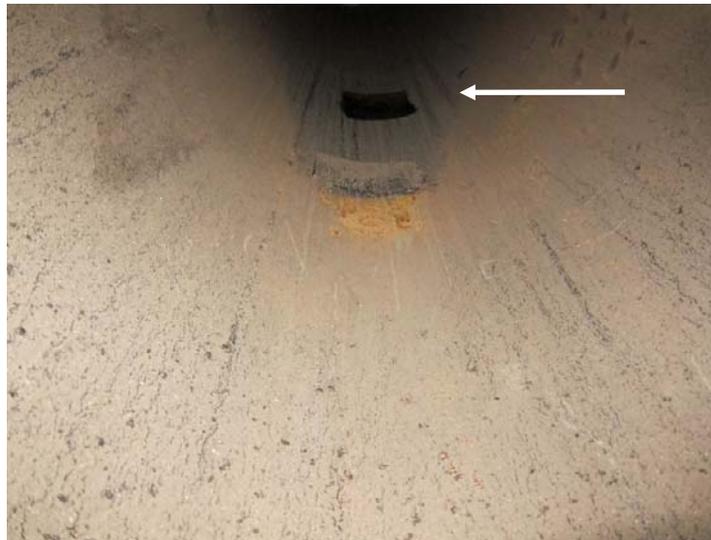
The weld inside the mixer was smooth and does not pose any operational issue. See picture above, black paint indicated area welded.

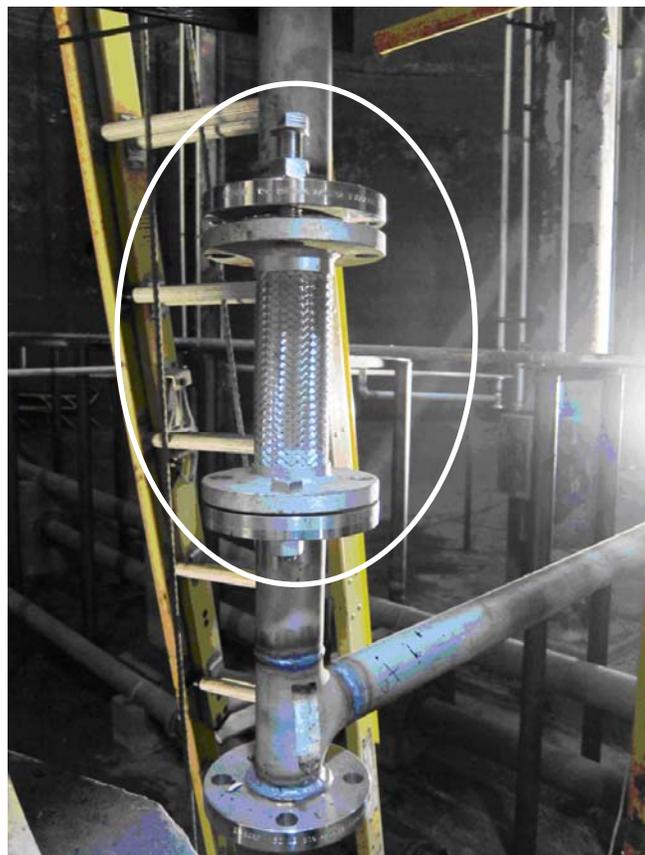
The picture shows the flexible coupling used to prevent the Hartford Loop from stress due to movement of the Cannon Mixers. Each loop would have one of these connections. The bottom of the connection has a flange that would be closed using a blind flange, used only during service to drain and clean the biogas line.

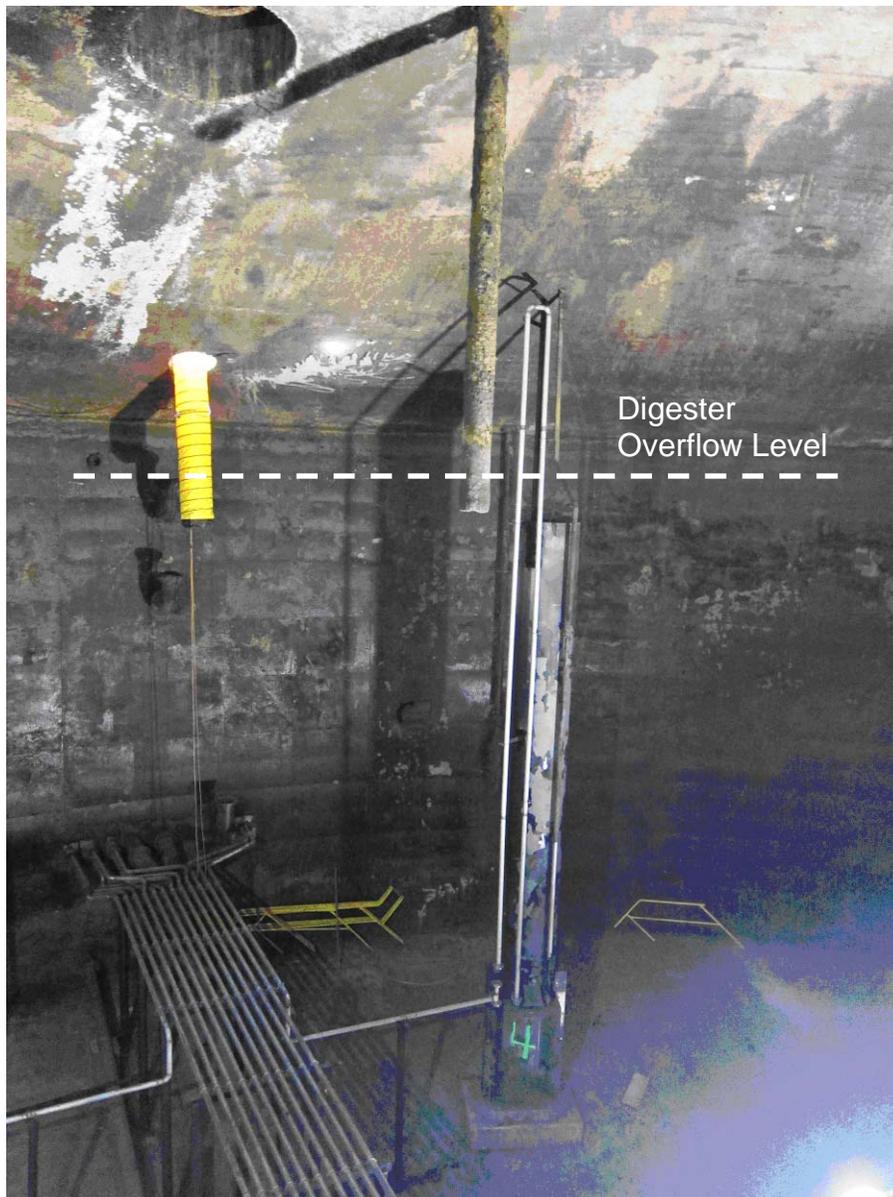
The Hartford loops are designed to be at least 3 feet above the maximum liquid level within the digester. This was confirmed both visually (see picture above) and measured.

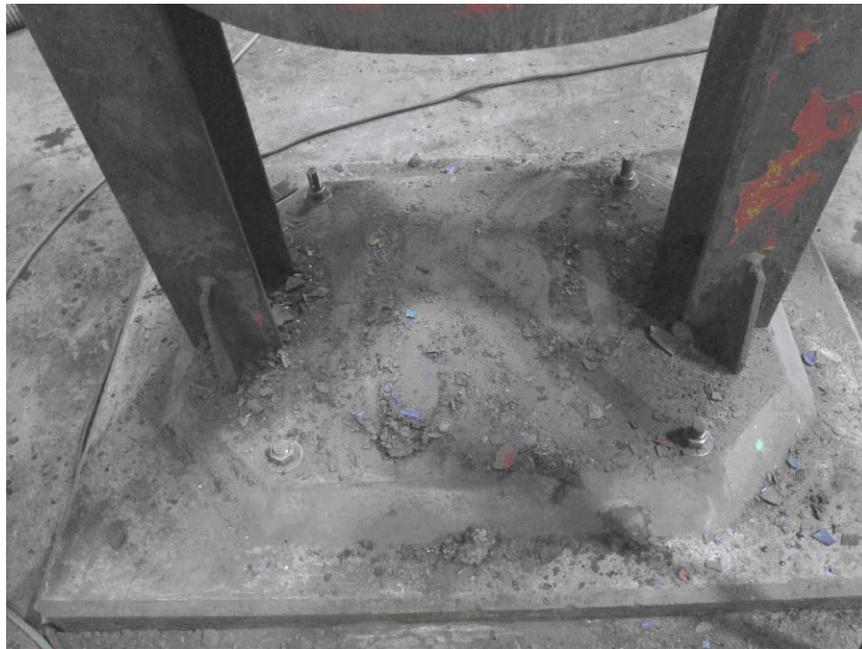
Each mixer was supported on one single base plate secured by at least four (4) anchor bolts. All twelve (12) mixers were properly anchored.

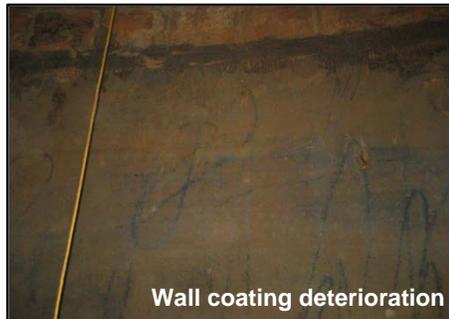
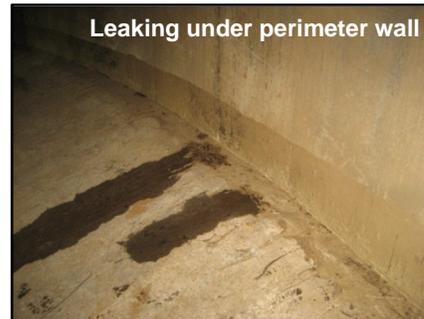
Along the base of the wall, groundwater was infiltrating through the wall and floor (base slab) interface. Based on the record drawings, there is no waterstop along this interface. The drawings only indicate a sealant to be placed along the seam of the interface and then coated over with coal tar epoxy. A second layer of epoxy material appears to have been applied over this interface, which is now starting to separate from the base slab and is cracked at various locations.

We recommend the full length of this wall/base slab interface be pressure injected with a polyurethane type of material such as SikaFix HH+ or equal. Ports should be drilled every 6 inches in control joint to a depth of 2 or more inches deep into the joints until water seepage stops. This material should stop the leaks immediately and provide a flexible joint that should not crack if movement of the wall or base slab occurs.

Also, the failing epoxy coating (approximately 80 SF) on wall-to-slab interface should be removed and patched with a polymer-modified cementitious repair material (Sikagard 62 or equal). This repair requires a specialty contractor; acquiring one will extend the repair time. Because of the extended time, we recommend completing these repairs (pressure injection and repair of the failing epoxy) during Phase 2.

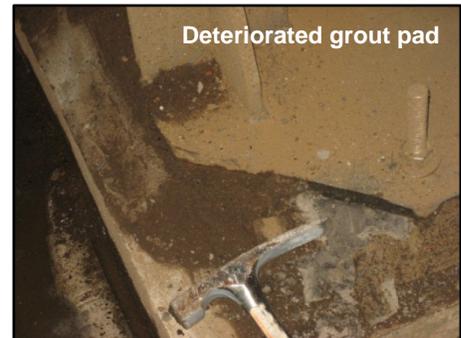
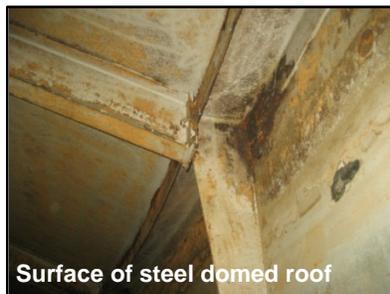
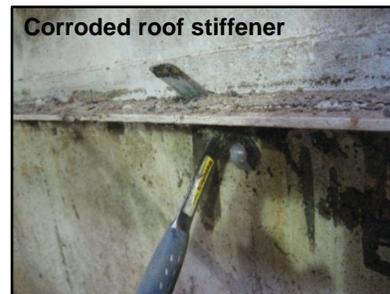
The domed roof is composed of steel plates attached to steel beams arranged in a radial pattern spanning from the perimeter tank wall to the center ring of the domed roof. In general, the steel framing and plates appear to be in good condition. The suspected coal tar epoxy coating on these members appears to be in poor condition, leaving the paint or primer finish on the steel members exposed. This has resulted in minor surface corrosion at various locations. There are a few isolated areas along the bottom stiffener rim plate of the roof skirt where there is full penetration corrosion. Based on the record drawings, we do not believe the corrosion on the bottom rim plate is a structural concern. We recommend having the steel domed roof sandblasted and recoated with an epoxy coating as a Phase 2 improvement. Prior to recoating, we recommend repairing the badly corroded areas by welding in pieces of new steel plates.

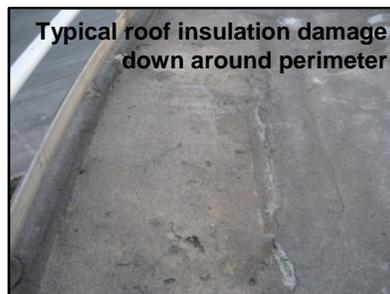
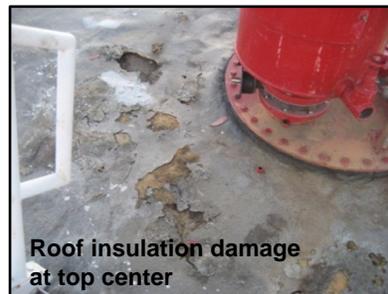
The insulated roof appeared to be in fair condition, with some minor areas where the roof shell is deteriorated or cracked open. It is estimated that less than 5 percent of the roof area has this type of damage. Generally, the deteriorated roof shell was located along the perimeter and the cracked roof shell is located at the top center. We recommend a patch coat be provided to recover the exposed installation and keep moisture out in the areas where the shell is cracked. We recommend repairing these cracks immediately to prevent additional damage.

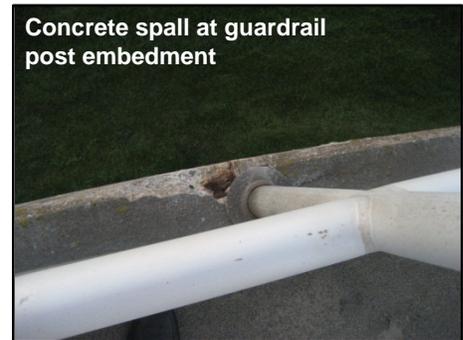
The guardrails along the perimeter of the roof appeared to be in good condition. However, the top of the wall is cracked at locations where all the guardrail posts are embedded. At six locations, these cracks have developed into a spall area where the concrete has broken away from the face of the concrete wall. The posts are therefore not fully supported by the concrete wall in this condition. As an immediate repair, we recommend temporarily removing the guardrail posts at the six locations and patching the pockets and spalled areas with a polymer-modified patch mortar. To prevent re-spalling in the future, we recommend reinstalling the guardrail posts using surface mounts with new aluminum top-mount brackets anchored onto the top of the concrete wall.

All the remaining post embedments appear to be in fair condition. However, we recommend replacing the embedded guardrail posts with surface-mounted posts in Phase 2 to prevent damage caused by the embedded posts.

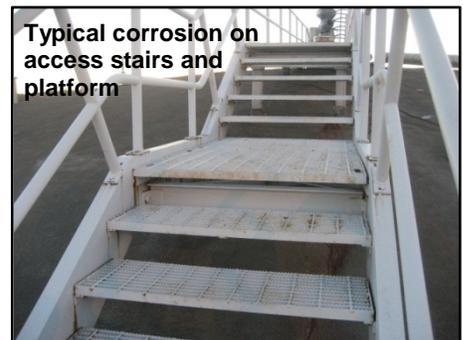
The steel access stairs and platforms on top of the roof are in good condition. However, the paint on the steel components appears to be past its useful life with signs of corrosion starting to leach through. We recommend having these stairs sandblasted and recoated with an epoxy paint as a Phase 2 repair.

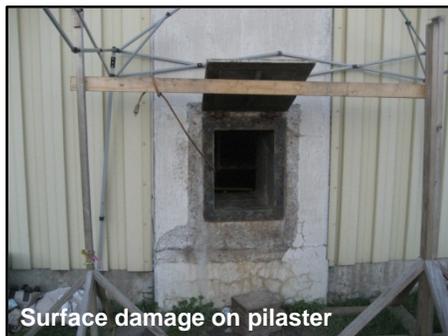
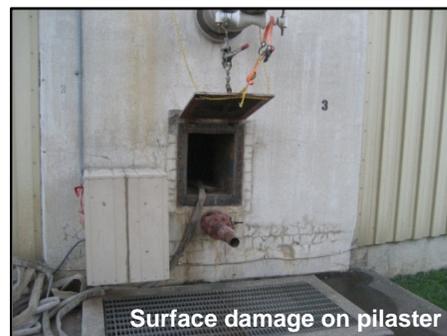
There are two exposed wide concrete pilasters that appear to have a stucco finish. The manways into the tank are cast into these pilasters. The surfaces of the pilasters are dark stained, and some areas are showing horizontal cracking and spalling on the pilaster face. The stucco-type coating needs to be repaired in several different areas. We recommend repairing the cracked and spalled concrete pilasters as prescribed in our "Digester No. 1 Exterior Tank Repair Recommendations" memorandum dated September 26, 2012. This repair can be completed at any time and thus is recommended as a Phase 2 repair.

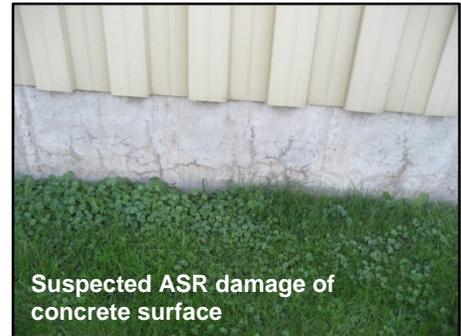
Only a small portion of the exterior surface of concrete wall above grade could be observed because of the metal siding. The observed concrete is in sound condition, but there appears to be suspected alkali-silica reaction (ASR) damage, which is caused when alkali in the cement reacts with silica in the

aggregates, creating a gel formation which causes cracking in the concrete surface. It is difficult and costly to remedy this issue. As long as the concrete surface is not starting to spall off, there is no need to repair the concrete surface. Based on our observations, we do not recommend any repairs of the concrete surface at this time. (Note that the other three digester tanks do not appear to have this surface damage.)

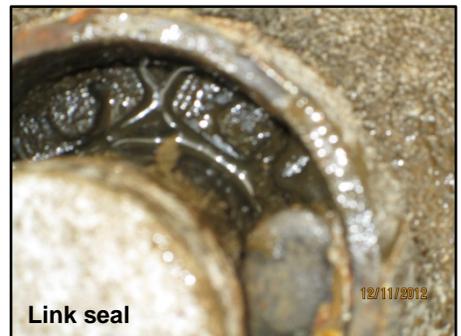
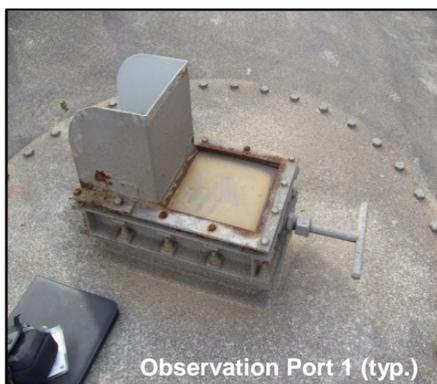
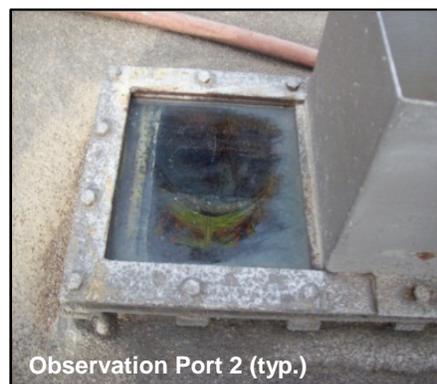
The 2-inch flushing line penetrations were observed. The County staff and the contractor aided in the inspection of these penetrations. On the exterior of the roof, some corrosion of the steel sleeve was observed, but most of the corrosion was from the mixer I.D. tag chain. The County staff and the contractor removed the foam insulation filling the space between the sleeve and pipe at one of the penetrations in order to observe the link seal. When removing the insulation, it was found that there was approximately a 1- to 2-inch water column sitting on top of the link seal, indicating the link seal was not leaking. The County staff removed the water using compressed air. The top of the link seal was observed and appeared to be in fair condition. On the interior, it was difficult to observe the link seal. There was also corrosion around the pipe penetration area.

Since the link seals do not appear to be leaking, it is not recommended to replace them at this time. However, it is recommended that the link seals be replaced during Phase 2, along with sandblasting and recoating the sleeves, at the same time the roof is rehabilitated. As an immediate repair, it is recommended that the pipe penetrations on the exterior be sealed to prevent further water damage. The deteriorated foam insulation should be removed and new spray foam insulation added to fill the void space. One solution to preventing water from entering the gap between the pipe and sleeve is to install a Fernco-type coupling over the area.

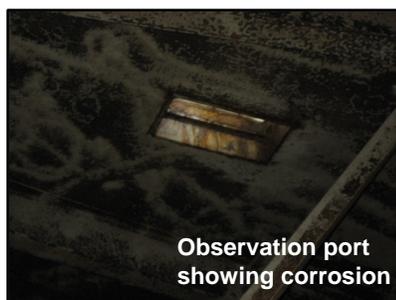
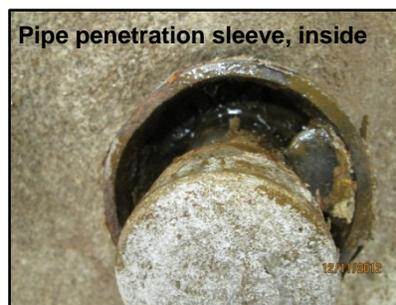
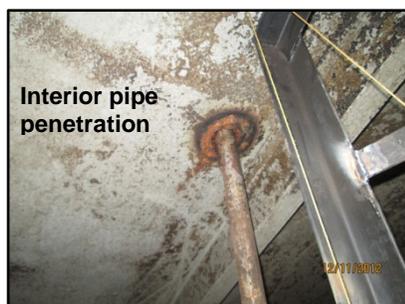
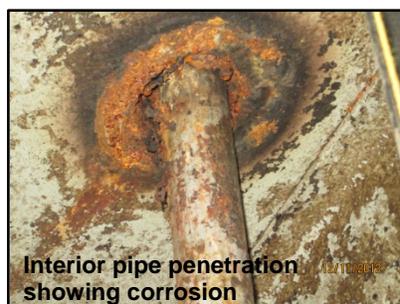
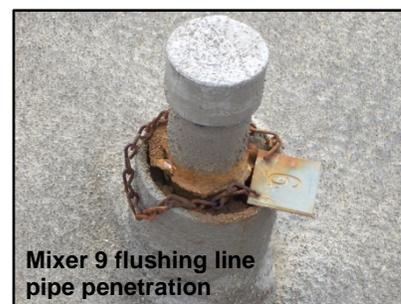
The observation ports were observed and they appear to be in fair condition. The ports are equipped with wipers. No evidence of leaking was found. It is recommended to perform a soap bubble test in the future while the digester is in service to determine whether the ports are gas tight. No recommendations are made for repairs to the observation ports at this time. In Phase 2, the interior of the ports should be sandblasted and recoated at the same time the roof is rehabilitated.

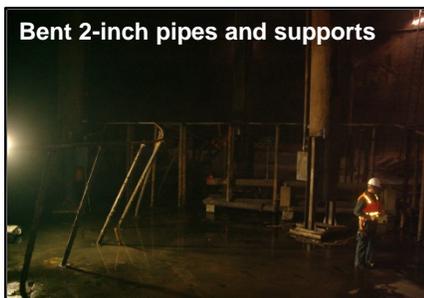
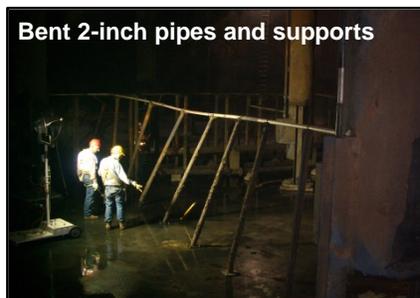
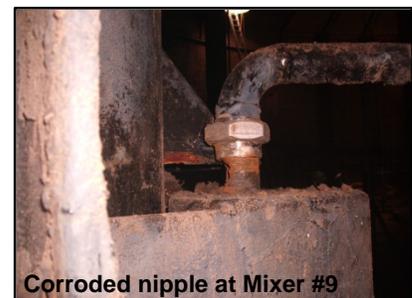
The 2-inch gas feed piping and supports to Cannon Mixers #6, #9, and #10 have failed and are bent over. At a minimum, approximately 120 linear feet of pipe and associated supports should be replaced immediately while the digester is out of service.

All of the gas feed piping supports show corrosion. It appeared to be worse at the bottom, where some of the supports have completely eroded away. It is recommended that all pipe supports be replaced with stainless steel supports and hardware while the digester is out of service. We recommend pipe supports be replaced in kind with Schedule 40, 304 stainless steel, and all replacement hardware and plates with 316 stainless steel. In the current contract, Payment Item 7 should be used to replace 2-inch stainless steel gas feed piping and supports while the digester is out of service. Subsequent to initial submission of this memorandum, the County negotiated a modification for completion of this work.

The nipple for the union connection of the 2-inch gas feed piping that is welded to the bubble generator on Mixer #9 is corroded through. All other unions are considered suspect; therefore, we recommend replacing all 12 nipples with new coated carbon steel nipples while the digester is out of service.

5. Replace 12 nipples at gas feed to bubble generator (one per mixer). This will require a modification.
6. Replace the missing throttle plates on Cannon Mixers #1, #8, #9, and #11. On Mixers #9 and #11, the corrosion has increased the size of the existing opening. Therefore, it will be necessary to replace with larger throttle plates. This work is covered under Unit Price Payment Item 13.
7. Rotate all throttle plates so that the opening is approximately 4 inches by 2 inches. This work will require a modification.
8. Repair corrosion on areas around throttle plates for Cannon Mixers #6, #9, and #11. This work is covered under Unit Price Payment Item 11.
9. Repair corrosion on bottom perimeter of Cannon Mixer #10 draft tube. This work is covered under Unit Price Payment Item 11.
10. Seal gap between flushing pipe and steel sleeve to prevent further water damage.

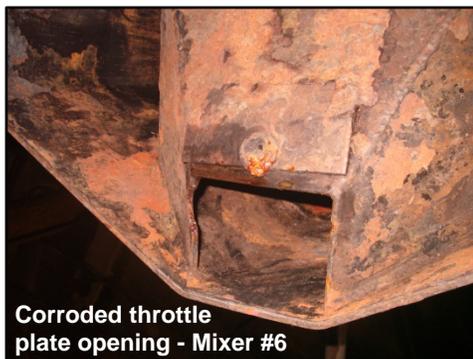
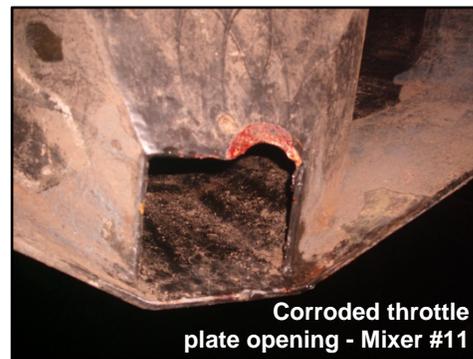
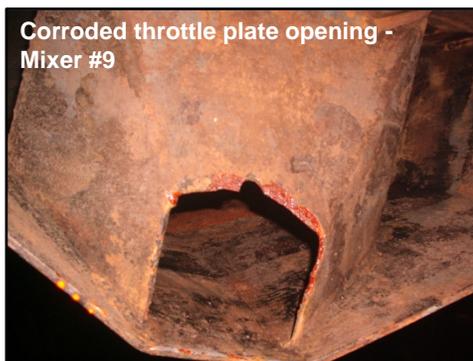
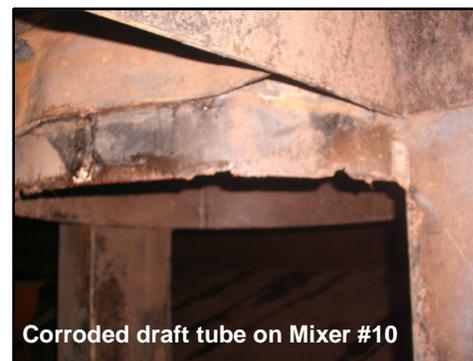
Cannon Mixers #1, #8, #9, and #11 were missing the throttle plates at the bottom of the bubble generator. We recommend adding new throttle plates while the digester is out of service. On Mixers #9 and #11, a new custom throttle plate should be made to fit over the existing hole because the corrosion has led to an increase in the opening size. All of the existing throttle plates were installed improperly. They should be rotated 180° so the size of the opening is approximately 4 inches by 2 inches.

Some of the steel around the area of the throttle plate openings showed corrosion on Mixers #6, #9, and #11. The corroded areas should be surface prepared for recoating and recoated.

Mixer #10 showed corrosion around the bottom perimeter of the draft tube. This corrosion should be surface prepared for recoating and recoated while the digester is out of service.

Replacing throttle plates is covered under Payment Item 13, Steel Repair. Repairing the corroded areas is covered under Payment Item 11, Miscellaneous Painting/Coating.

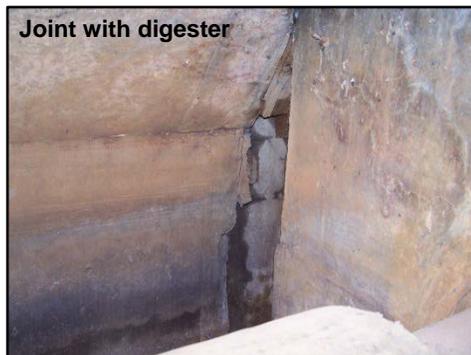
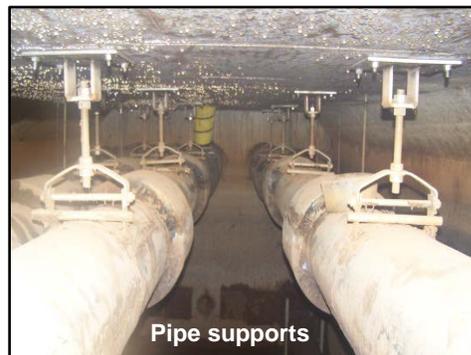
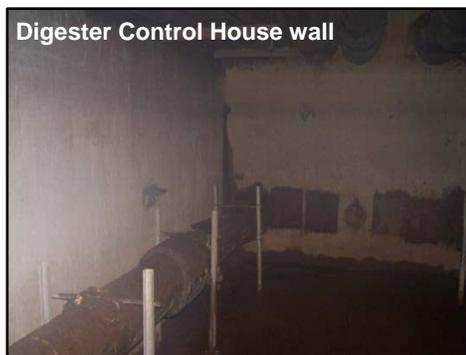
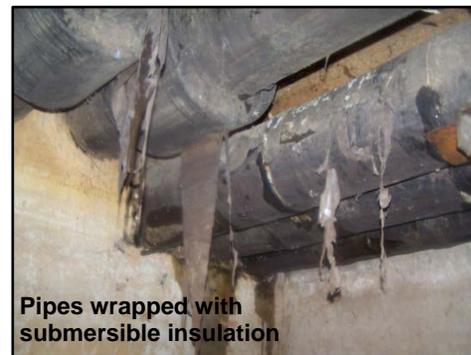
The pipe chase between the Digester Control House and Digester No. 3 was visually observed. The joints between the pipe chase and the Digester/Digester Control House walls did not show as much evidence of leaking as the other pipe chases. The condition of the pipes could not be determined due to the insulation wrapped around all of the pipes. The insulation appeared to be in fair condition. No recommendations are made at this time for repairs to the pipe insulation.

There appeared to be sludge covering the bottom of the pipe chase and the lower pipes. It is recommended that all the sludge sediment in the chase be washed off the pipes and pumped out. This can be done at any time and thus is a Phase 2 recommendation.

The pipe supports appeared to be in fair condition. No recommendations are made at this time for corrective repairs to the Digester No. 3 pipe chase supports. The following are photos of the pipe chase.

11. Clean sludge out of pipe chase.
12. Replace sludge feed pipes back to Digester Control House.

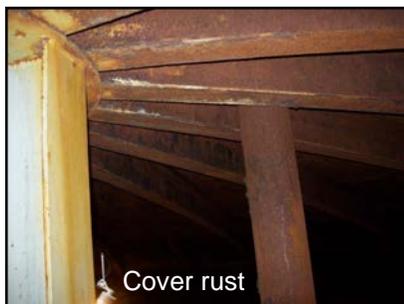
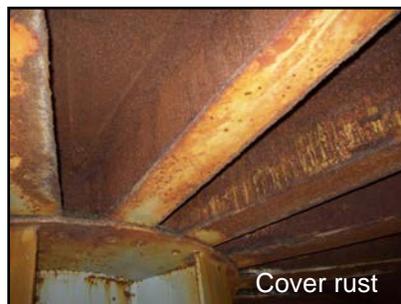
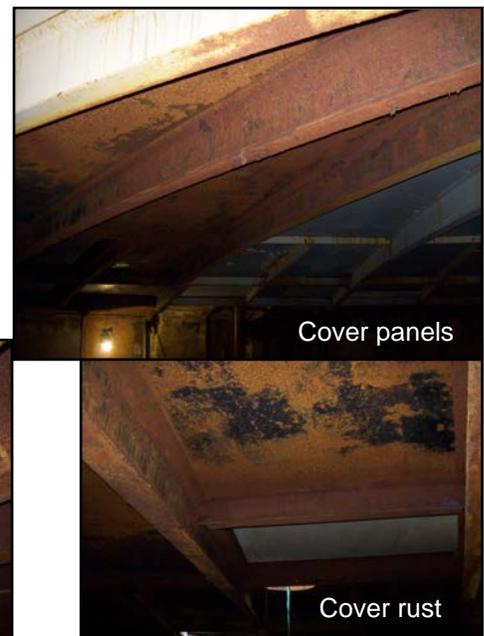
The carbon steel cover panels and structural members appear to be in good structural condition. The condition of the surface varies. On the interior of the dome (roof) portion of the cover, some of the panels have previously been recoated/rehabilitated, as could be seen from the difference in color between the panels. It appears that the light-colored sections have been more recently recoated, and

the black and apparently uncoated sections have not been refinished. The light-colored sections appear to have only isolated areas of surface corrosion. The black sections and uncoated sections appear to have widespread areas of surface corrosion. When evaluating the light, black, and uncoated colored members, no variation of structural member thickness could be measured. In 1999, an inspection was conducted and the paint was found to contain lead; however, the sample location drawing and sample analysis could not be located.

Due to the time constraints for surface preparation and paint application, we do not recommend recoating the entire cover at this time. We anticipate it would take a minimum of two months to perform sandblasting and coating of the entire cover. This includes disconnection and reconnection of all the tie rods, resetting scaffolding, and lead abatement measures. This would delay the return of the digester to service and its benefits in providing supplemental heating. Secondly, since we did not measure any loss of thickness between structural members, we believe the corrosion is limited to the surface. However, we recommend that this be verified by ultrasonic thickness measurements. This testing could be completed from the exterior of the digester, at any time. According to the manufacturer, the panels are typically 1/4-inch thick, with 1/8-inch thickness for structural integrity and 1/8-inch thickness for corrosion allowance.

In the future, if the cover is to be rehabilitated, we recommend removing the entire cover from the digester to aid in a full rehabilitation of the cover and tank, including: (1) sandblasting and recoating the cover; (2) sandblasting and recoating the center column; and (3) sandblasting and recoating concrete walls. However, before rehabilitation is done, ultrasonic thickness testing should be completed again to determine if there is any loss of thickness. Also, the cost of cover replacement should be compared with the cost of rehabilitation. This evaluation will be done as part of the Technical Report in Task 6.

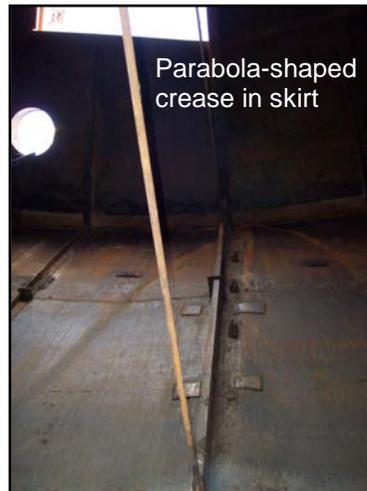
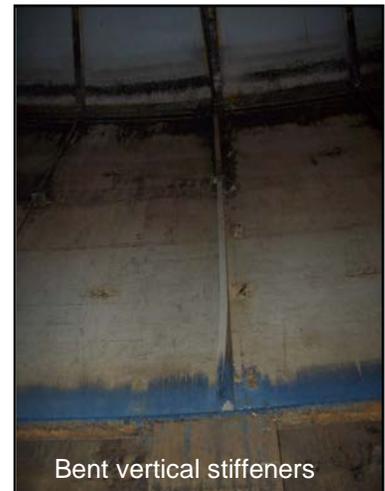
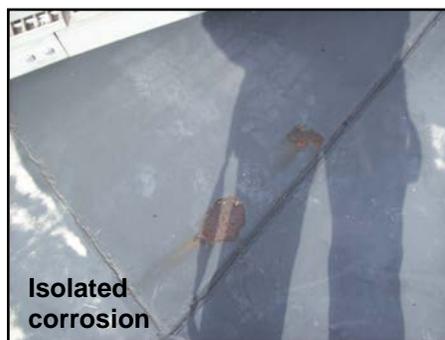
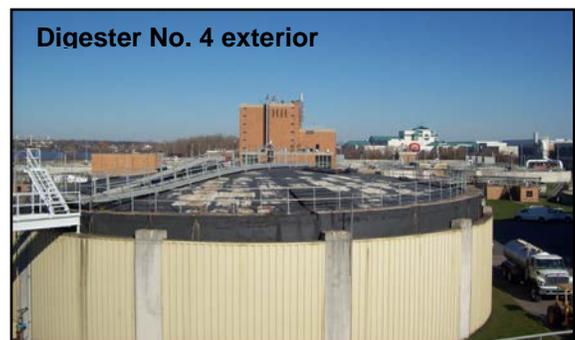
The inside of the digester skirt (vertical section of cover) appears to be in good condition with only minor surface corrosion. One section of the vertical skirt was damaged such that a parabola-shaped crease was formed. This deformation was not identified in the 1999 inspection report. This crease does not appear to pose a structural or functional problem, and we make no recommendations to repair the crease. Some of the vertical stiffeners are slightly bent where the diagonal tie-rods are connected. These bent stiffeners do not appear to impair the structural integrity of the cover. We make no recommendation to correct them at this time.

On the exterior top (roof) section of the cover, the coating is in fair condition with some isolated areas of corrosion present. The exterior surface of the skirt could not be observed since it is not accessible with the cover in place. However, the top portion of the exterior skirt was visible and appeared to be in good condition in our November 18, 2009 inspection. As can be seen in the "Digester No 4 exterior" photo below (taken in November 2009), we observed that the cover was tilted. This was confirmed by County employees.

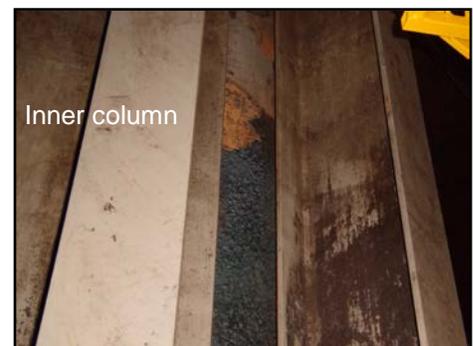
- The 12 tie rods that stabilize the inner center column assembly (Type A) appear to be in good condition. One of the tie rod anchor plates on the concrete is cracked as shown in the photo on page 5 labeled "Cracked anchor plate." This was noted in the 1999 inspection report.

The condition of the plate is consistent to what was described in the 1999 inspection report and does not appear to be have deteriorated further. Three of the four anchor bolts are unaffected by the crack, which is limited to the top right corner of the plate. However, while the digester is out of service, we recommend either repairing by welding or replacing this plate in kind.

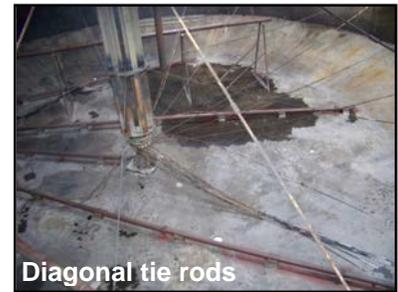
- Eighteen diagonal tie rods connect the top perimeter of the cover to the base of the exterior moveable column. Each diagonal tie rod (Type B) consists of five segments connected to each other with threaded turnbuckles. Each rod is connected to a hub at the base of the outer (moveable) center column with a hemispherical nut. Over time, many of the tie rods apparently unscrewed from the turnbuckles and have fallen to the floor of the digester. Many of the fallen tie rods are bent. No issues with these rods were identified in the 1999 inspection report.

These diagonal tie rods are necessary for the structural integrity and balance of the cover over its range of travel. Therefore, it is recommended to replace as necessary and reinstall the tie rods before the digester is placed back in operation.

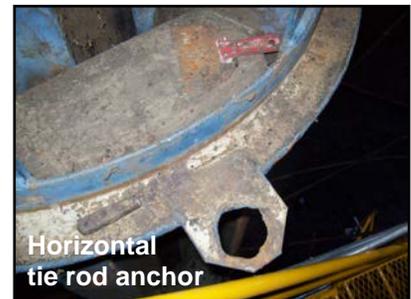
- The six horizontal tie rods (Type C) appear to be in good condition and were intact with the exception that some of them were slacked. These tie rods are also composed of sections joined with threaded turnbuckles. We recommend all of these rods be retensioned.

These rods are pinned to connecting plates that are welded to the moveable center column. Two of the connecting plates at the center column assembly had large deformation (wear) of the mounting holes that appeared to have been caused by movement of the tie rods over time.

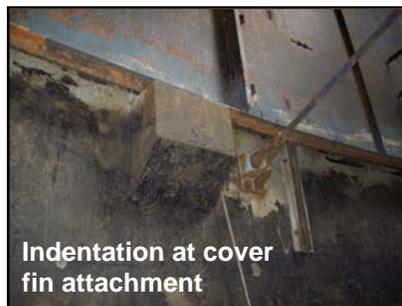
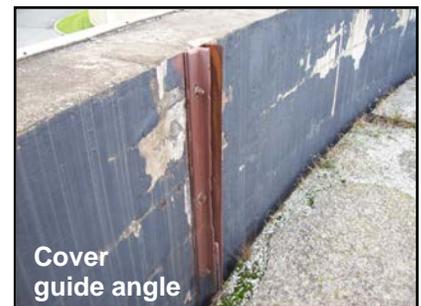
Four guides are installed on the digester walls to prevent rotation of the cover. The guides are constructed of vertical steel angles bolted to the concrete wall. Each angle engages a fin welded to the exterior of the cover skirt. Three out of the four digester cover guide angles appear to be in good condition. However, there is one guide angle that appears to have been modified. This modification may have been added to alleviate binding of the cover. No recommendations are made for this cover guide angle. It should be evaluated again after operation of the cover.

On the inside of the cover skirt, there are indentations where the fin attachment is welded to the skirt. Some of these indentations are corroded and if allowed to corrode further, could create a through-hole and result in a point for leakage of gas. In order to protect this area from corrosion, we recommend welding a steel plate on the inside of the digester skirt over the area of the indentations. This repair should be completed prior to placing the digester back on line. Since the paint is lead based, surface preparation must be completed in accordance with SSPC-6, Guide for Containing Debris Generated during Paint Removal Operations, and SSPC-7, Guide for the Disposal of Lead-Contaminated Surface Preparation Debris.

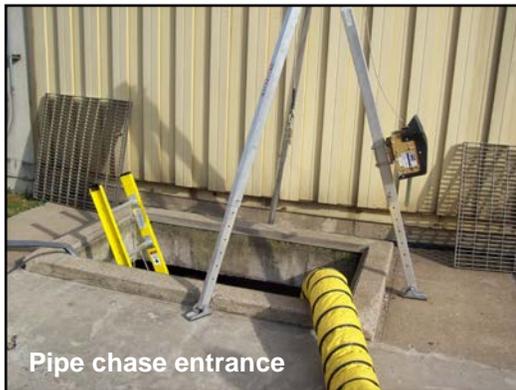
Pipe chase entrance

The pipe chase between Digester No. 4 and the Digester Control House was inspected on November 16, 2010. It is below grade and houses all of the below-grade piping between the two structures. The pipe chase is approximately 10 feet wide by 10 feet tall by 30 feet long. Under normal conditions, the bottom half of the chase is below groundwater level. Therefore, the chase had to be pumped out for the inspection. The groundwater appears to be entering at gaps in the connection of the chase to the Digester Control House. It is recommended these gaps be sealed to reduce the groundwater surcharge in the pipe chase. These gaps can be sealed at any time and are therefore considered Phase 2 Improvements.

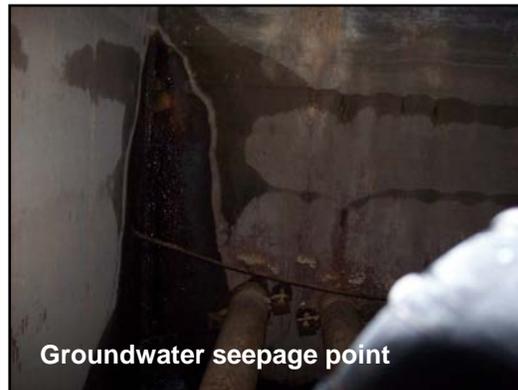
Groundwater seepage point

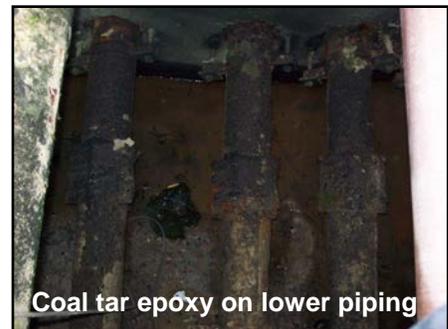
Coal tar epoxy on lower piping

The coal tar epoxy coating is flaking off the pipes. It is recommended that the existing piping and couplings in the pipe chase which have a coal tar epoxy coating be sandblasted and recoated with coal tar epoxy for protection. In addition to this, all of the existing piping and couplings which are not coated should be coated with coal tar epoxy. This work can be done at any time and is considered a Phase 2 improvement.

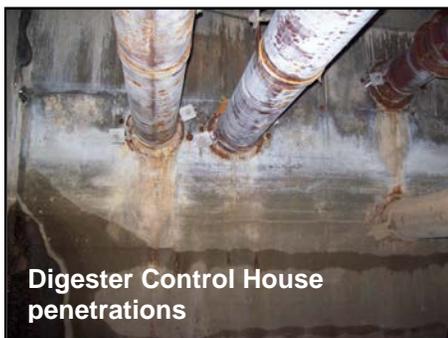
Digester Control House penetrations

The pipe penetrations and link seals appear to be in good condition. Replacement of link seals is not necessary or recommended. However, the wall sleeve for the penetration of the 14-inch gas line is corroded. This corrosion should be sandblasted and recoated with coal tar epoxy. This work can be done at any time and is recommended to be completed as a Phase 2 improvement.

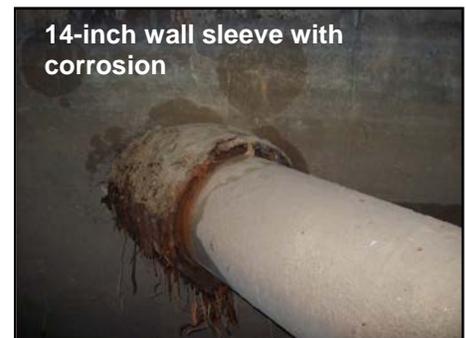
14-inch wall sleeve with corrosion

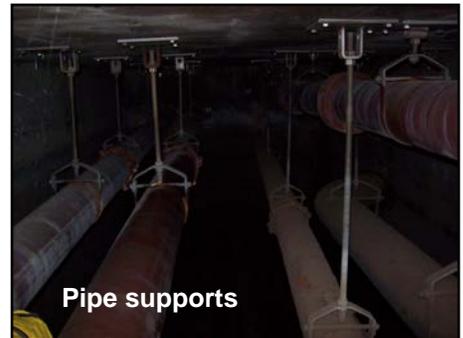
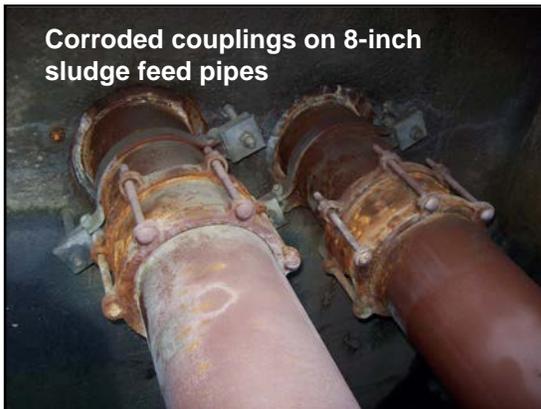
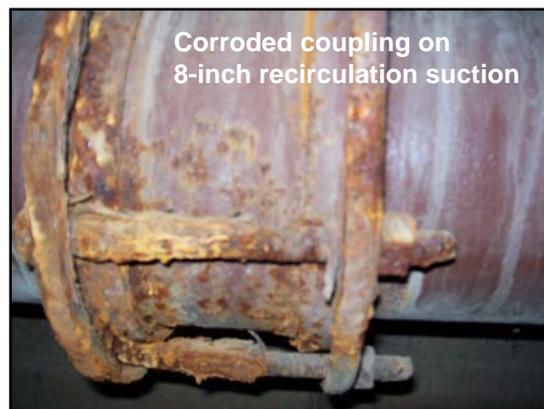
The couplings were also observed. Seven 8-inch couplings show corrosion. All of the corroded couplings are on pipes that did not have coal tar epoxy protection and experience occasional submergence. It is recommended that these seven couplings be replaced while the digester is out of service. Prior to installation, the couplings shall be coated with two coats of coal tar epoxy.

7. Replace corroded Dresser couplings on 8-inch piping in pipe chase between Control House and digester. There are seven couplings recommended for replacement. Attached to this memorandum is a drawing dated June 1, 1971 titled "Existing Gas Holder." Section 2 of this drawing shows the pipes in the chase. This drawing should be used for reference in locating the couplings to be replaced. The seven couplings recommended for replacement are listed as follows: (a) the couplings on both 8-inch sludge feed lines closest to the digester (total quantity = 4); and (b) the last three couplings on the recirculation suction line closest to the Digester Control House (total quantity = 3). These couplings shall be replaced with ductile iron fittings, Smith Blair Model 441 or equal with stainless steel bolts and nuts. The couplings shall receive two coats of coal tar epoxy paint prior to installation. A Modification Order would have to be prepared for this work.

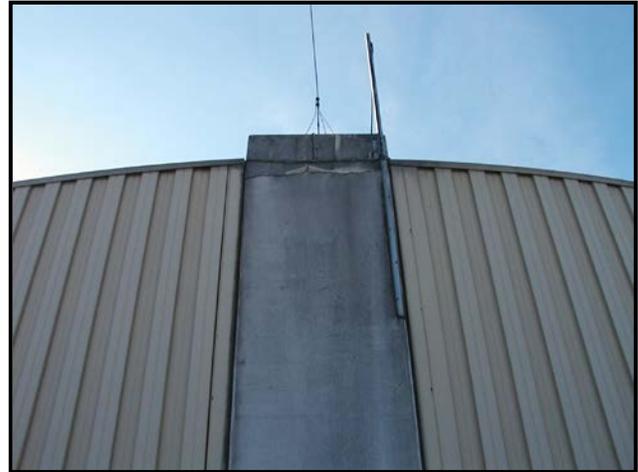
Photo 2: Typical Pilaster (Exterior)

The extent of damage varies among the pilasters. Some pilasters show deterioration with vegetative growth on them. The exposed pilasters appear to have a stucco finish. Many of the surfaces are dark stained and some areas are showing horizontal cracking evenly spaced from the top to approximately halfway down the pilaster. The stucco-type coating needs to be repaired in several areas. There is a significant horizontal crack along the top of every pilaster, which may indicate more than just cracking in the stucco-type coating. The inside face and tops of the pilasters have damage due to cracking and deterioration.

We recommend repairing the cracked/spalled and deteriorated concrete pilasters and recoating all of the exposed surfaces. This repair can be completed at any time and, therefore, is classified as Phase 2 repair recommendation. The approximate square footage of cracked/spalled and deteriorated concrete requiring repair is 240 square-feet. Payment Item No. 5 could be used for this repair. The approximate square footage of coating repair is 960 square-feet. A modification would be required for the exterior coating repair. The estimated cost of concrete repair for the pilaster of Digester No. 4 is \$19,000.

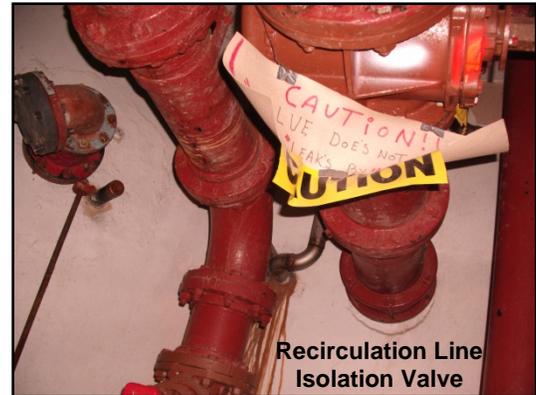
Each digester has a number of plug valves associated with it which enable it to be isolated from the system. There are 11 sludge isolation valves including a single 3-way valve for each of Digesters 1 through 3. There are a total of 13 sludge isolation valves for Digester 4, including a single 3-way valve. Due to the location and isolating function of these valves, they can only be replaced when the digester is empty. Many of the valves have reached their expected useful life, and some of them leak. For these reasons, it is recommended that all isolation valves be replaced during Phase 1 when each digester is taken out of service, and thus are classified Priority 1 improvements.

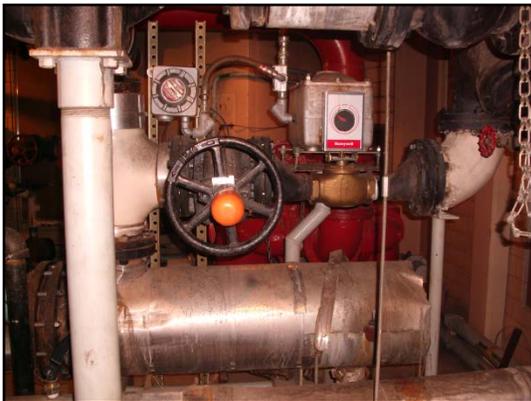
Hot Water Heat Exchanger

There are three hot water heat exchangers on the second floor, manufactured by the Carrier Corporation. These heat exchangers have been in service in excess of 35 years. Steam from the Plant Operations Building supplies heat to the hot water via these heat exchangers, which is then used for the sludge heat exchanger. The heat exchangers' insulation is deteriorating. The work order history was reviewed on the CMMS and revealed that the hot water heat exchangers experience about two corrective maintenance issues per year. The majority of these involve steam valve leaks, steam trap leaks, and low or high temperature. Due to the age of these heat exchangers, it is recommended that the heat exchanger and associated insulation be replaced in the Phase 2 improvements.

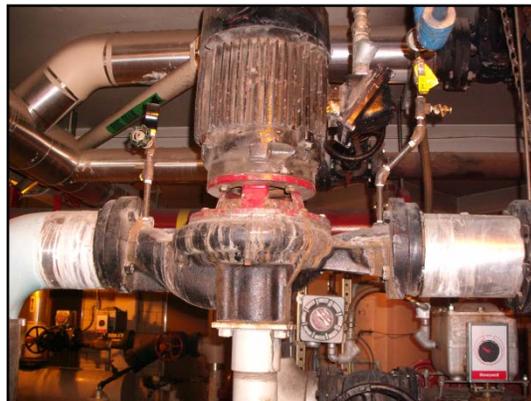
Hot Water Recirculation Pumps

There are three hot water recirculation pumps on the second floor, manufactured by Bell & Gossett. The motor nameplate is illegible. These pumps have been in service in excess of 35 years. The pumps circulate hot water from the heat exchangers to the sludge heat exchangers. A visual inspection indicated seal leakage. A review of the work order history on the CMMS revealed that these pumps have had few corrective maintenance issues, but those that occurred involved seal leaking and line leaking. Due to the age of these pumps, it is recommended they be replaced as part of Phase 2, and are classified as Priority 2 improvements.
