Onondaga County Department of
Water Environment Protection
Syracuse Metropolitan WWTP Digester
Cleaning and Miscellaneous Repairs Project
Technical Report

TECHNICAL REPORT
SYRACUSE METROPOLITAN WWTP DIGESTER CLEANING
AND MISCELLANEOUS REPAIRS PROJECT

GHD CONSULTING ENGINEERS, LLC
One Remington Park Drive
Cazenovia, NY 13035

Project No. 8614054

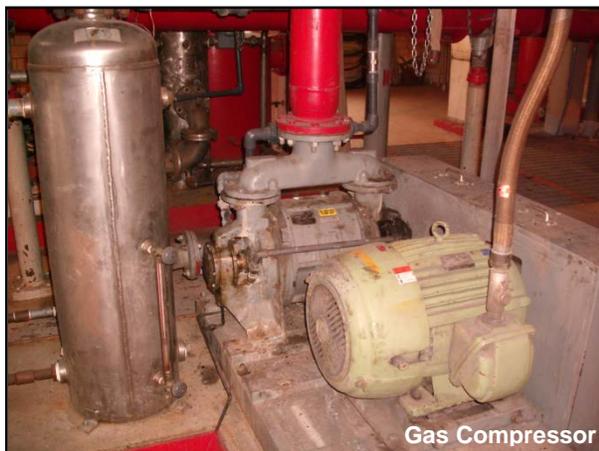
Gas Compressor

There are five gas compressors (three active, two spare) on the first floor. They are liquid ring pumps, manufactured by Nash Engineering Co., and are approximately 17 years old. The compressor capacity is 370 SCFM at 14.2 psig. The 40 HP motors are manufactured by Emerson Electric. The compressors compress the digester gas before feeding it to the bubble generators on the gas mixing guns. Review of the work order history on CMMS revealed that these compressors experience an average of five to six corrective maintenance issues per year. The majority of these involve seal water ball valve cleaning, water leaking, repacking, difficult valve operation, seal water system issues, and belt replacements. Due to this and the fact that the compressors are nearing the end of their useful life, it is recommended that these units be replaced as part of Phase 2 and are classified as Priority 2 improvements.

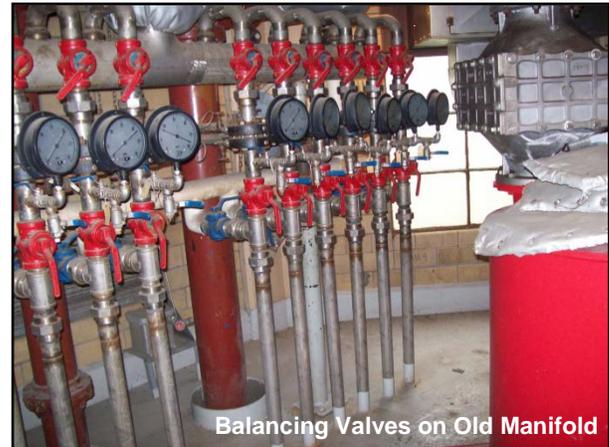
Each digester is equipped with its own gas balancing manifold and balancing valves to each mixing gun used to balance the gas flow between each mixing gun. The balancing valves were 2-inch DeZurik plug valves which have been in use for approximately 17 years. In addition to the balancing valves, each manifold was equipped with 12 isolation valves (also 2-inch plug valves from DeZurik). Plant operators stated some of these valves are inoperable. Some valve handles are broken. During construction, it was discovered that none of the 2-inch plug valves were operable and required immediate replacement.

It was also discovered that the method of flow measurement used (combination of orifice flange plates and manometer) for each 2-inch gas feed line was also inoperable. Therefore, a new method was also immediately required. Hence, in Phase 1, entire new balancing manifold assemblies were provided, equipped with new balancing and isolation valves (stainless steel ball valves were provided to replace the plug valves) and new rotameters for flow measurement.

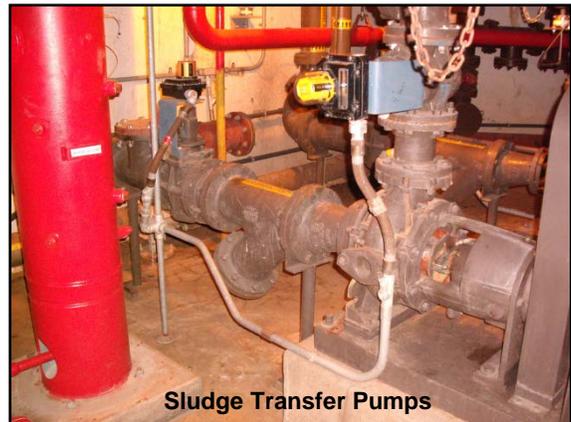
There are two sludge transfer pumps located in the basement, manufactured by Hayward Gordon, which have been in service for approximately 10 years. The 10 HP motors for these pumps are manufactured by Westinghouse Electric. The pumps' main operating point is 250 gpm at 71 feet TDH. Review of the work order records on the CMMS revealed that these pumps experience about one corrective maintenance issue per year, and these have primarily been minor issues. These pumps appear to be in good condition and plant operators did not indicate any major issues. The pumps can be isolated from the system and could be replaced at any time if necessary; therefore, they are classified as Priority 3 improvements.

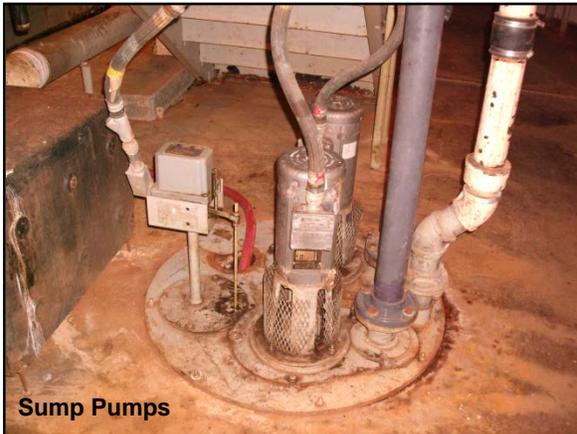
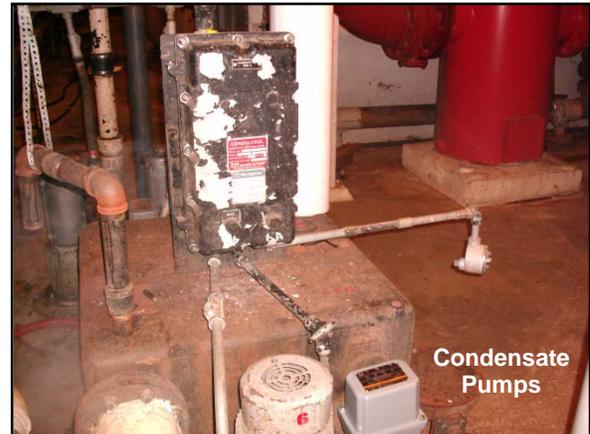
The condensate pumps/receiver are located in the basement. The pumps are manufactured by ITT Flygt. At the time of the inspection, one pump was removed from service for repair and will be replaced. The pumps have been in service in excess of 35 years. Review of work records revealed the condensate pumps experience approximately three corrective maintenance issues per year, the majority of which are to repair the seals. Due to the age and condition of the condensate pumps, it is recommended they be replaced in Phase 2, and are classified as Priority 2 improvements.

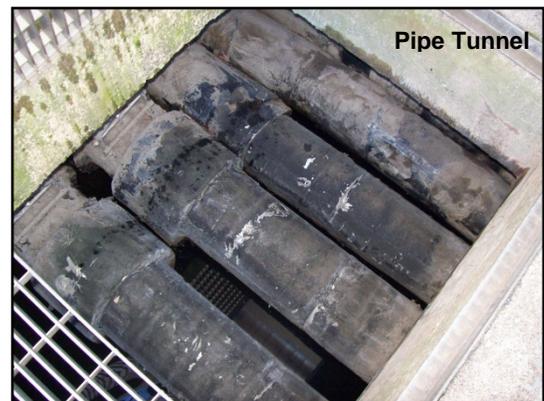
The pipe tunnels from the Digester Control House to each digester were viewed from the hatch above. The tunnels are infiltrated with groundwater. Further evaluation must be done to determine the extent of this problem and to identify potential improvements. It is recommended that this evaluation be included in the Phase 2 project scope of work.

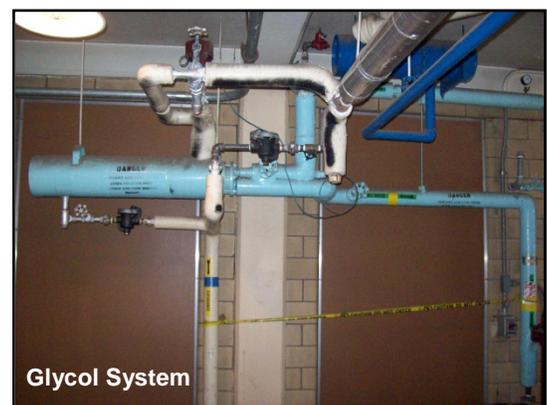
The 8-inch sludge gas line and the supernatant lines all have freeze protection consisting of a 3/8-inch hot water line with glycol solution that runs along the outer edge of pipe and is contained inside the pipe insulation. This system is believed to be over 35 years old. The system is recirculated by a pump on the second floor of the Digester Control House. This pump circulates the hot water/glycol through 4-inch lines. All of the insulation that surrounds the 4-inch hot water feed and return lines is asbestos. Due to the age of this system, the inability to maintain the piping because of the asbestos insulation, and the health concern of the asbestos, it is recommended this system be replaced in Phase 2, and is considered a Priority 2 improvement.

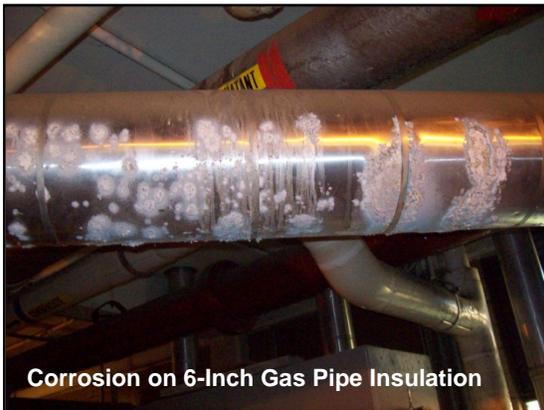
There was some corrosion on the supernatant sludge piping and on the insulation jacket to the 6-inch gas feed piping. The reason for the corrosion is unknown. Before a recommendation can be made, further evaluation of the cause of corrosion must be completed. This 6-inch gas feed pipe was replaced during Phase 1 and the insulation removed.

Corrosion on 6-Inch Gas Pipe Insulation

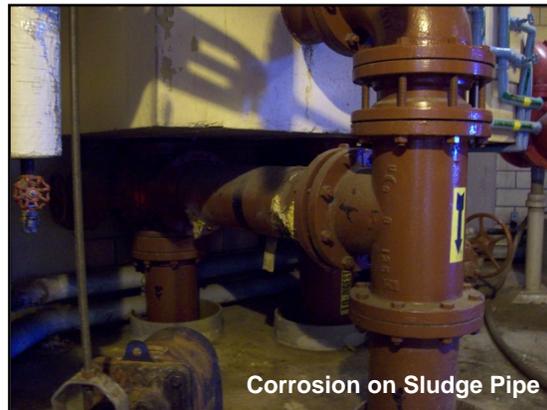
Corrosion on Sludge Pipe

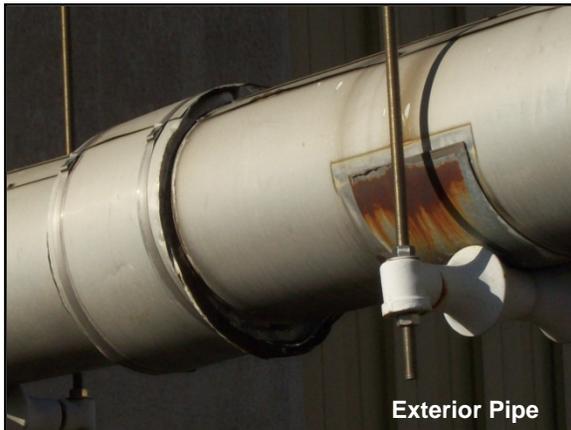
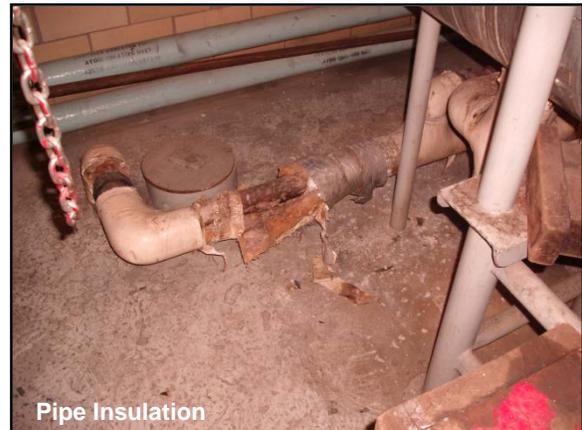
Digester supernatant overflow pipes and digester gas pipes are exterior to the Digester Control House. The insulation jackets around these pipes are deteriorating. This may also result in a deterioration of the insulation. It is recommended that the insulation jackets be replaced and the quality of the insulation and pipe be checked. This work can be done at any time and is recommended for Phase 2, and is therefore classified as a Priority 2 improvement.
