# SPDES DISCHARGE PERMIT Detailed Mixing Zone Form

# **CORMIX Modeling**

## **Oak Orchard Wastewater Treatment Plant**

**Onondaga County Department of Environmental Protection**

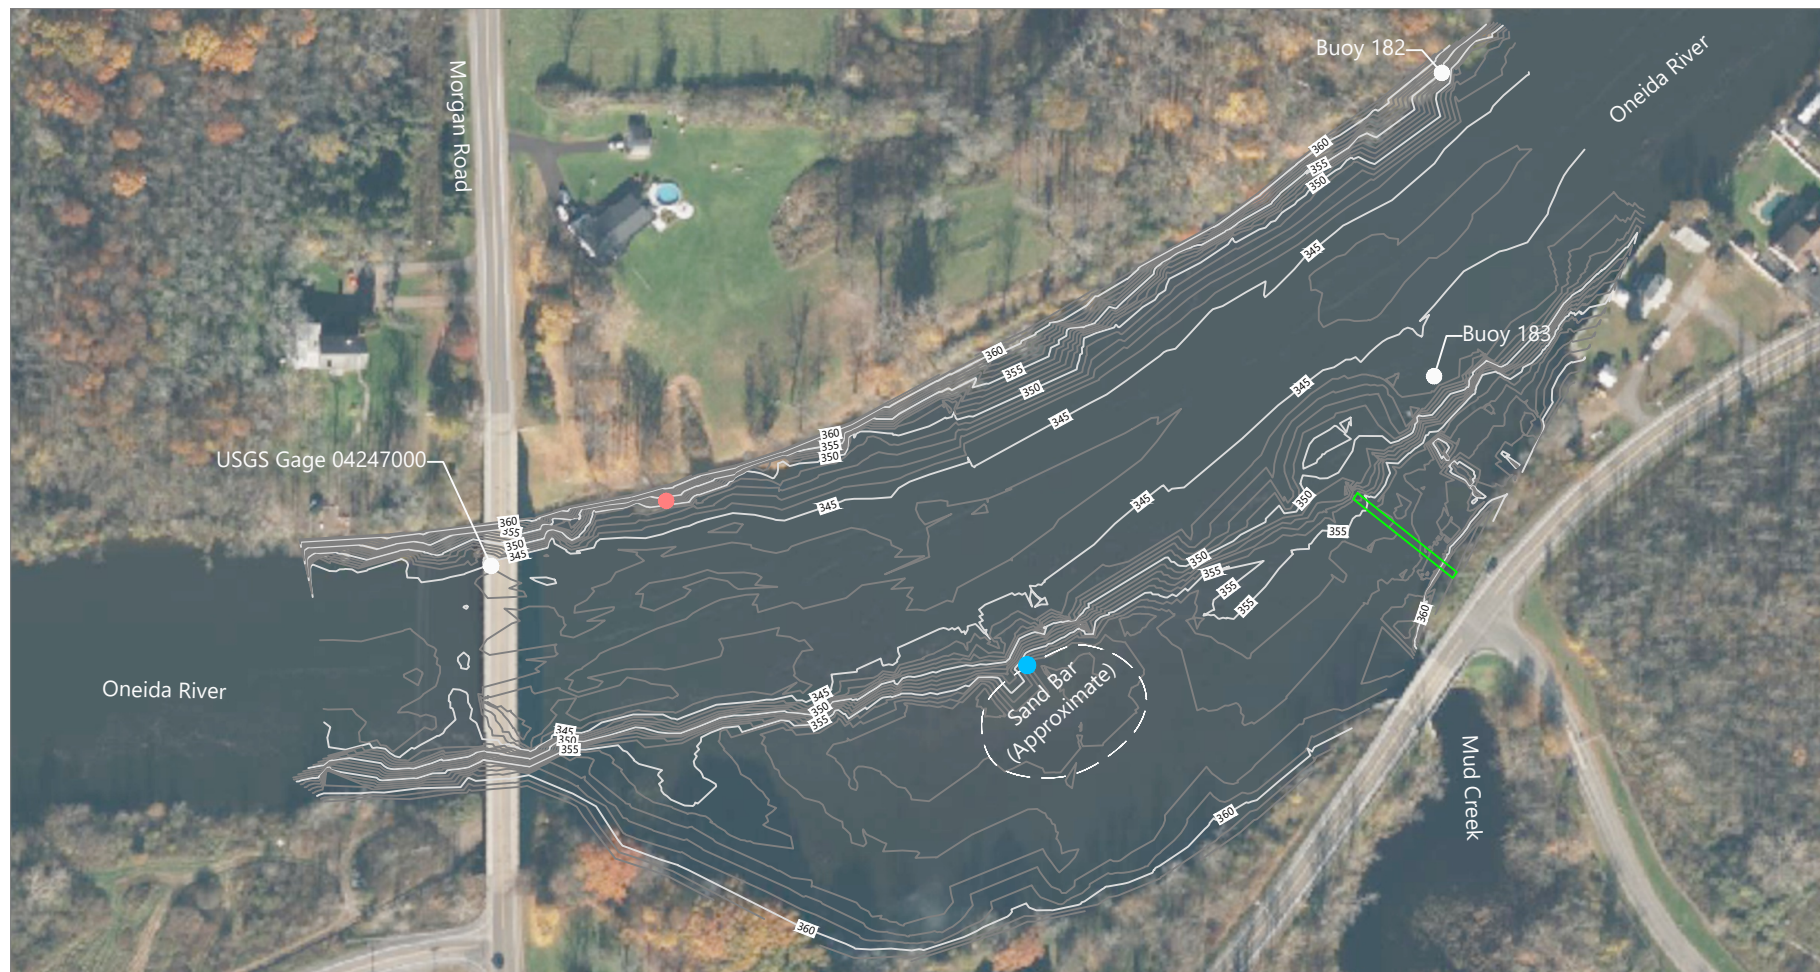
The outfall pipe location was confirmed to be 175 feet upstream of the mouth of Mud Creek (Figure 3). It was easily located with the probing rod by contacting the rectangular concrete casing that houses the pipe. The structure was found 40 feet from shore and able to be followed out into the river with the probing rod. Its location is also marked on land on the south streambank by two concrete posts between the shoreline and Oak Orchard Road (Appendix A, Photograph 4). Using the probing rod and Trimble Catalyst GPS, the outfall pipe was measured to be 132 feet in length, extending into the river from the south shoreline. The overall width of the concrete casing was measured at 13 feet. Water depths over the structure ranged from 6.0 to 6.5 feet from the top of the structure to the surface, as determined by the probing rod. Sediment has built up evenly with the top of pipe elevation along each side and consists of 3 to 4 feet of medium to coarse sand and gravel (refusal of the probing rod was encountered beyond the 3 to 4 feet depth). Based on the water depths collected, the elevation of the top of the concrete structure ranges from 356.2 to 356.7 feet NAVD88.

Structures and hazards located above the water and beneath the water surface were documented. GPS coordinates were logged, and underwater video was recorded of the equipment associated with the USGS gauge (Appendix A, Photograph 7), which was assessed to be in good condition. The USGS staff gauge was found attached to the northern-most bridge abutment (Appendix A, Photograph 8). A large metal structure was observed above water and located upstream of Morgan Road (Figure 3 and Appendix A, Photograph 9). The purpose of the structure was undetermined. Additionally, GPS coordinates were logged for Buoys 182 and 183 (Appendix A, Photograph 10). A private dock (Appendix A, Photograph 11) is located on the north streambank, downstream of the USGS gauge. After three attempts concentrated in the area of the Morgan Road bridge, the velocimeter associated with the USGS gauge was unable to be located. In the area of the sandbar in the embayment south of the navigation channel, there are multiple large logs caught on the river bottom and protruding above the water surface, as well as boulders just below the surface (Figure 3 and Appendix A, Photograph 12).

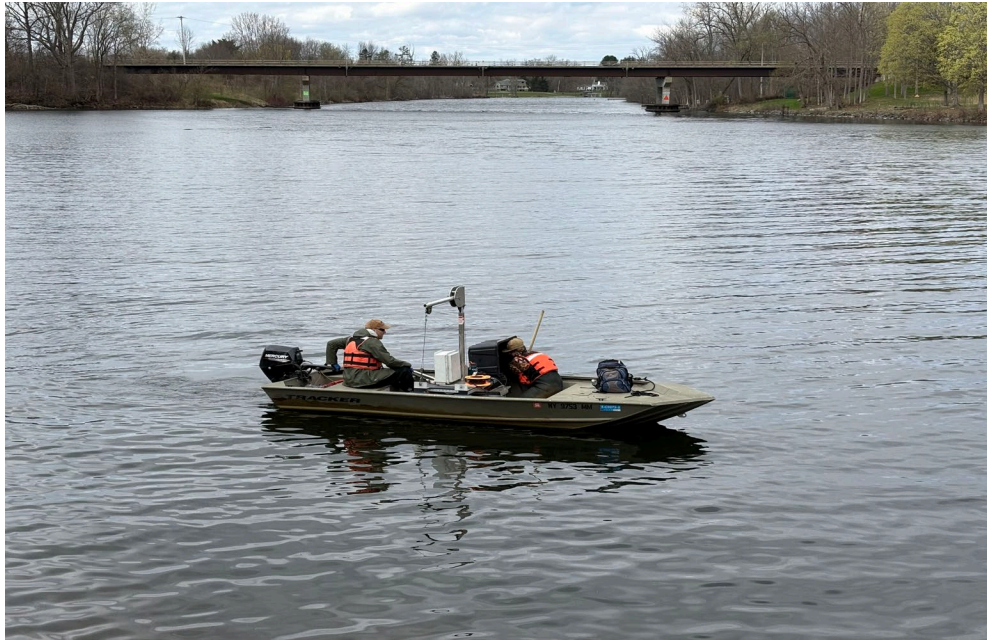
Photograph 1: Flat-bottom jon boat used for shallow water survey.

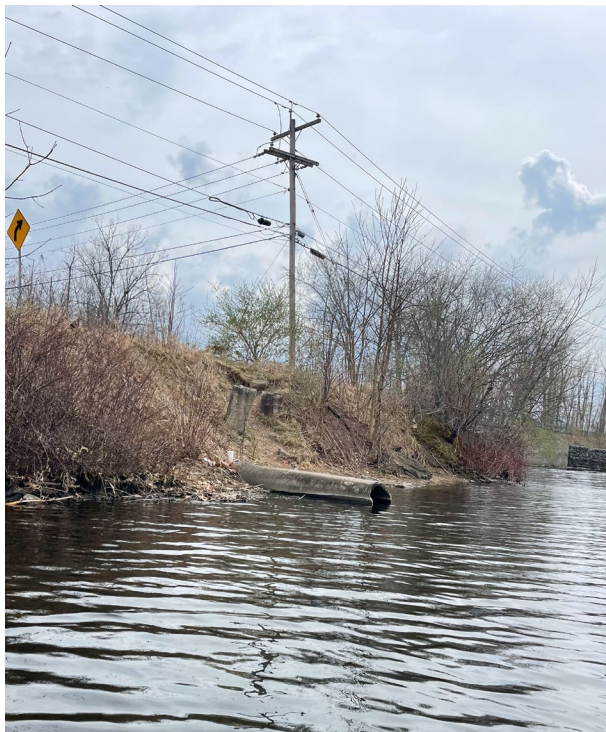
Photograph 4: Diffuser pipe location marked with concrete posts, former concrete outfall pipe.

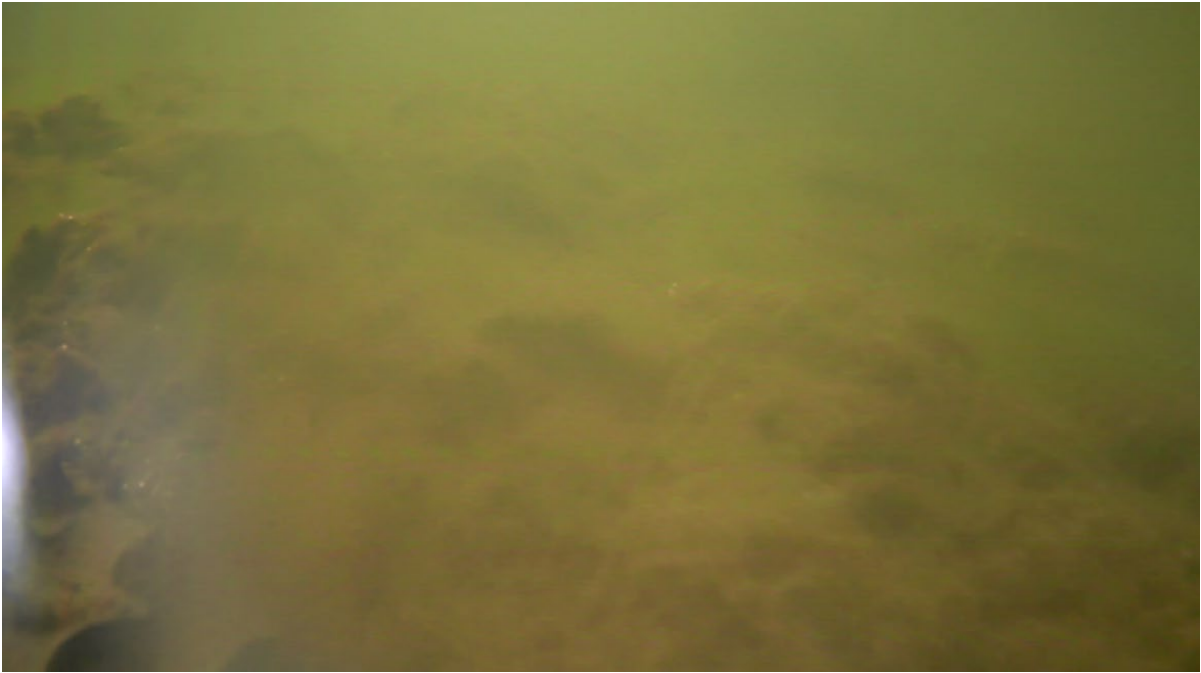
Photograph 5: Underwater still of diffuser pipe covered in sediment and vegetation.

The risers shown in the as-built drawings appear to have been broken off, because none were visible during video surveys or identified while probing. Furthermore, multiple ports were located using the probing rod, confirming the absence of the risers. Probing inside the openings revealed the presence of silt and sand (approximately 6 inches) at the bottom of the pipe, with a hard surface detected below that. Overall, probing determined the concrete structure surrounding the pipe is intact. Immediately beyond the end of the pipe opening, the water depth increases to 11 feet. Buildup of

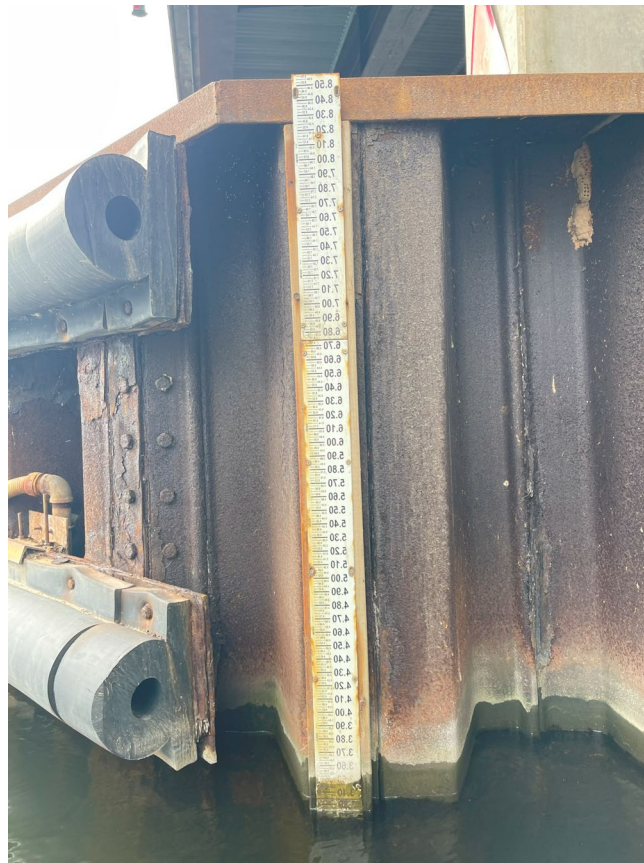
Photograph 8: USGS staff gauge in good condition.

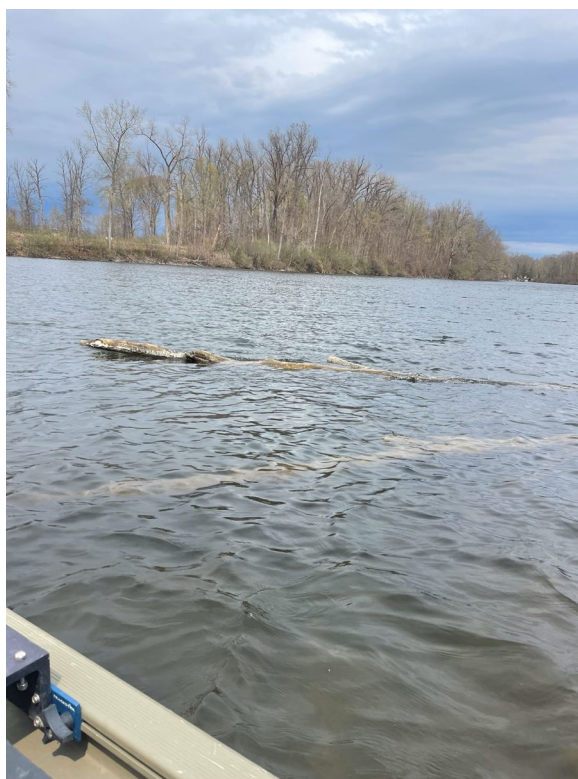
Photograph 12: Large partially submerged tree located on sandbar south of the navigation channel (Figure 3).
