Final Report

Brewerton Water Pollution Control Plant Comprehensive Facility Assessment

Prepared for: Onondaga County Department of Water Environment Protection, Onondaga County, New York

CRA Infrastructure & Engineering

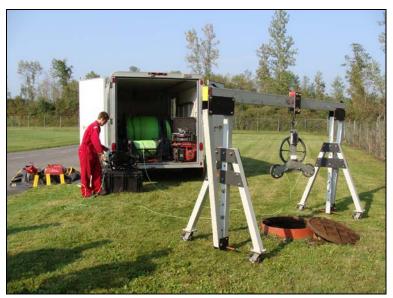
Figure 8: Manhole #12; Gantry with Metering Sheave

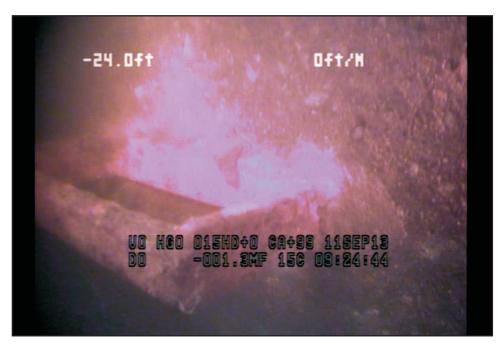
Image 3-01: 0 ft - Ladder in Manhole #1

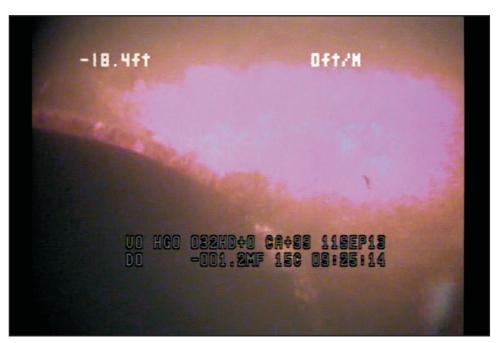
Image 3-02: 0 ft - Outfall transition in Manhole #12

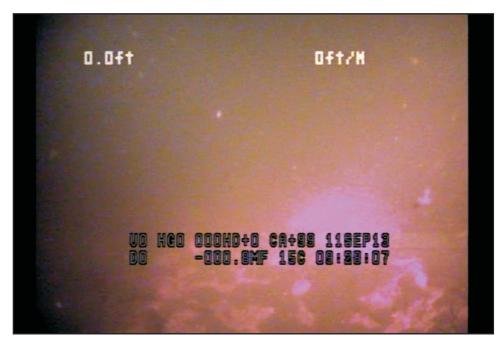
Image 3-03: 0 ft - Invert near Manhole #12; clean invert

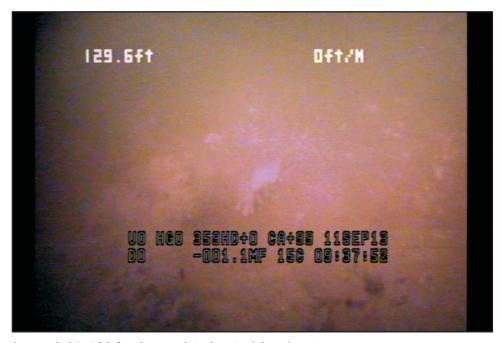
Image 3-04: 130 ft - Accumulated material on invert

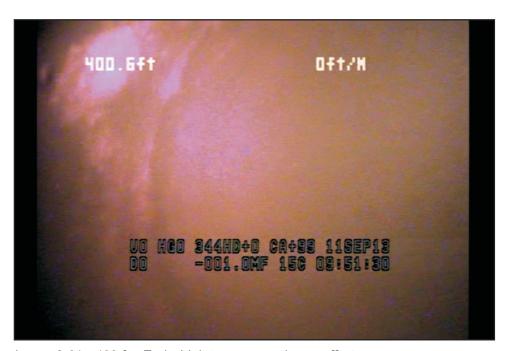
Image 3-06: 400 ft - Typical joint; no separation or offset

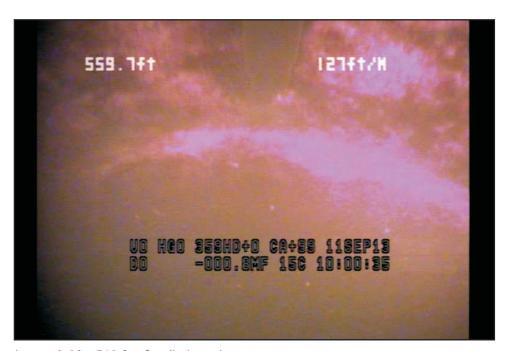
Image 3-08: 560 ft - Small air pocket at crown

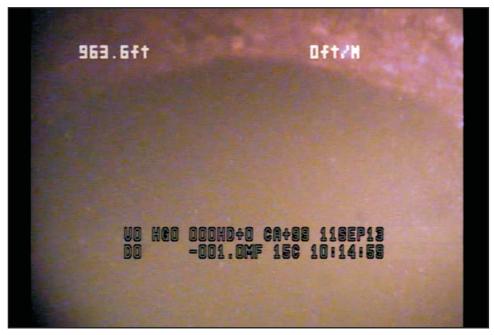
A change in elevation of the outfall was observed between 875 and 970 ft.; going down approximately 5 ft. at 875 ft. at a sharp angle, leveling out until 967 ft. and transitioning back to the previous elevation (see Appendix 3, Image 3-10). This siphon-like anomaly is not indicated on the drawings provided by the client (see Appendix 1 – Drawings, Sewer Profiles), however it appears to correlate to the location of Comstock Road.

Image 3-10: 964 ft - Siphon

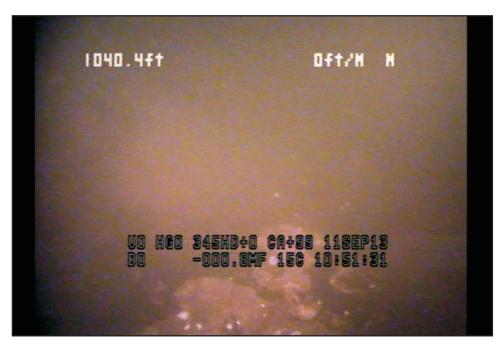
Image 3-11: 1040 ft - Minor accumulation on invert

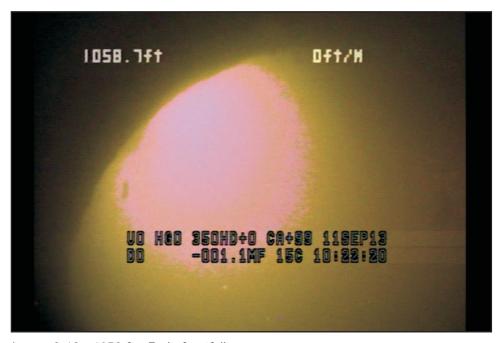
The discharge end of the outfall, located in the Seneca River, was observed at a cable out of 1060 ft. The opening appeared free and clear of debris (see Appendix 3, Image 3-12).

Image 3-12: 1059 ft - End of outfall

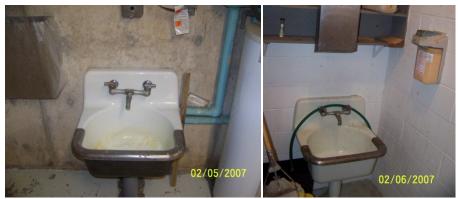
White Metal Sinks

Located in the Janitor Room of the Control Building, in the West Gallery under the stairs to the Blower Room, in the East Gallery near the Gallery intersection, in the Lab in the Chemical Room.

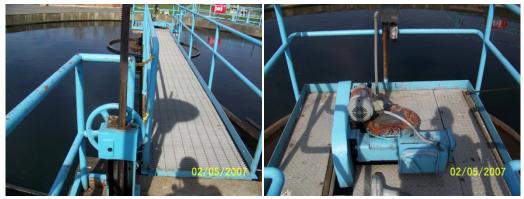
6 Blue Metal Valve Wheels & Assembly

Located around the aeration tanks west of the Raw Sewage Pumping Station Building and around the aeration tanks between the Control Building and the Chemical Building.
